REGISTERS

V8

Cooling system pressure testing and leak detection on the MGBGV8

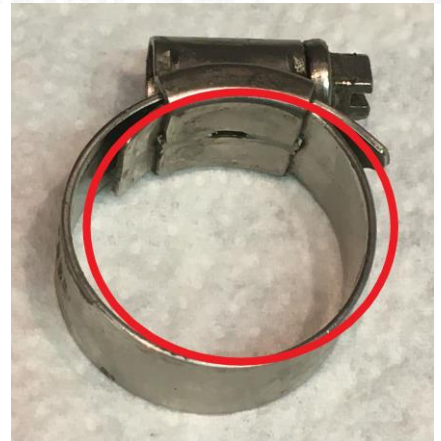
Worm drive clip showing distortion if the wrong size is used

More troublesome are the numerous hose to pipe joints. With 8 hoses and 16 joints, sealing requires careful
