## MGB V8 Roadster restoration project – Report 24

**Easter Sunday 5<sup>th</sup> April 2015**

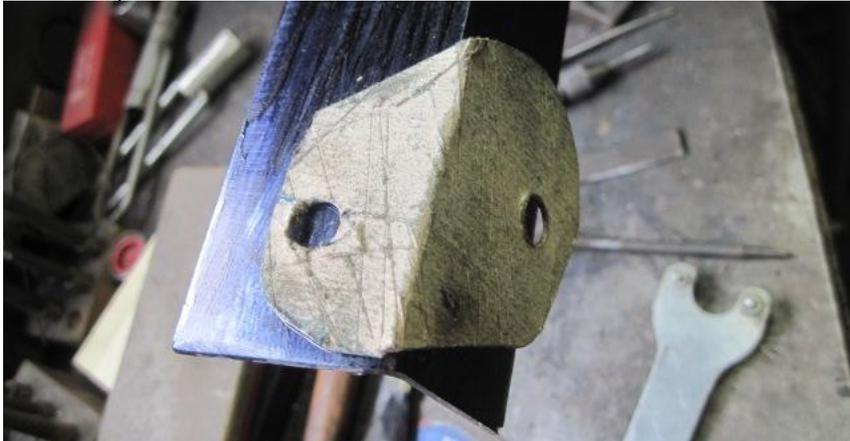
Anyway on from where I ran out of space in my last report. . . . . After the engineer marking blue had dried, I scribed a line around the outside of the cardboard pattern and around the inside of the holes onto the metal.

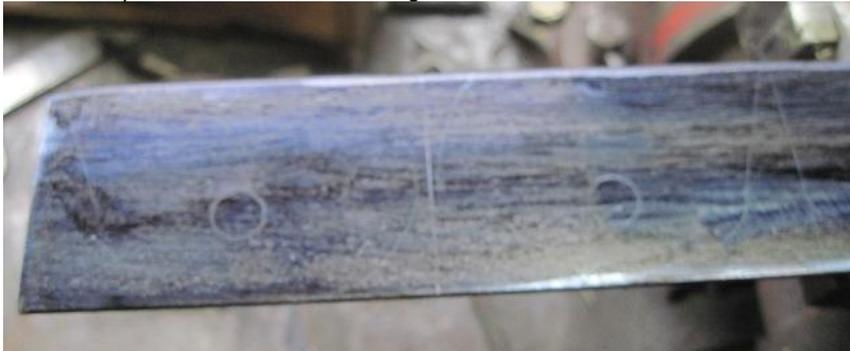
Folded the pattern over and traced it again onto the metal.

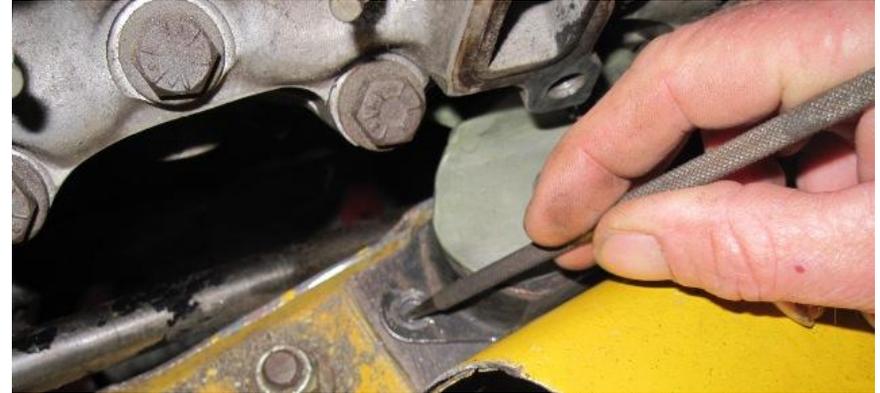
From the photo it looks as if it is only attached to the engine by one 5/16" UNC bolt. The part you can't see is the large plate underneath that has 2 x 3/8" UNC bolts that go into the engine block. Next job is to scribe the hole positions the threaded rod or high tensile bolt thread that will be threaded into, and welded to the 3/16" metal plate that will eventually be welded to the top of the chassis rail.

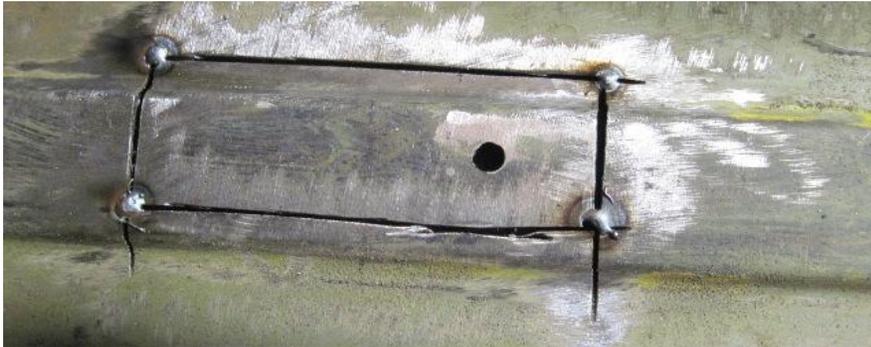
It was then time to weld the floor back in. First of all I tacked the corners.

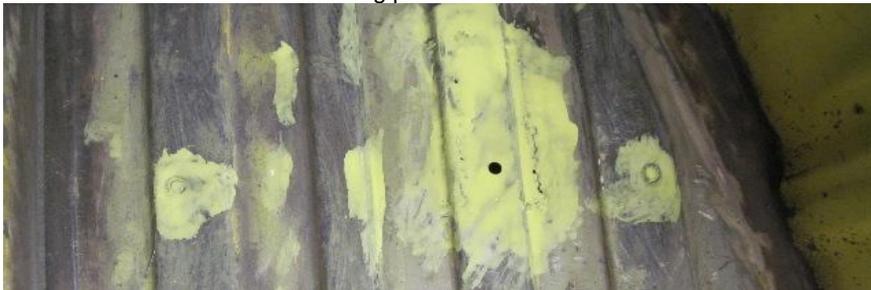
Then tacked all around the outside of the plate removed from the floor, so as not to get too much distortion from the heat build up. After grinding the welds flat it was time to coat the bare steel in etching primer.
