## MGB V8 Roadster restoration project – Report 37

Thursday 11<sup>th</sup> June 2015

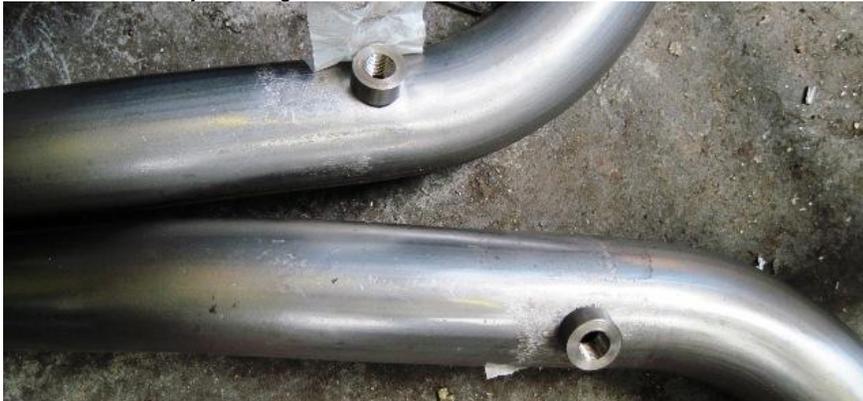
The down pipes with the threaded collars ready to TIG weld into the exhaust down pipes.

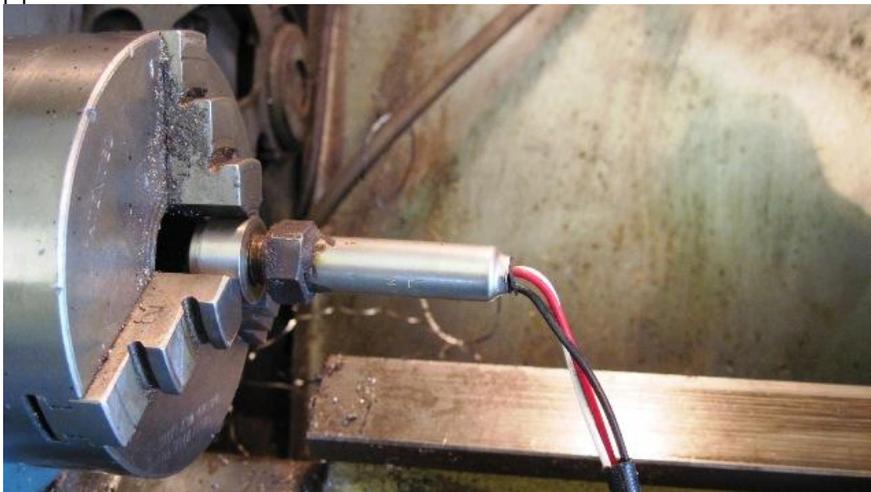
Checking that the oxygen sensor will fit into the threaded collar before the collars are welded into the exhaust down pipes.

Note that the oxygen sensors on the RV8 are 3-wire. This means that they have a heating element in them to bring them up to temperature quicker than the 2-wire type. They are also different to many oxygen sensors on the market. If you need to replace them you need to get the correct type. I believe, I read that Toyota used

the same type that Rover used and are cheaper, but don't believe me. Check before you buy.

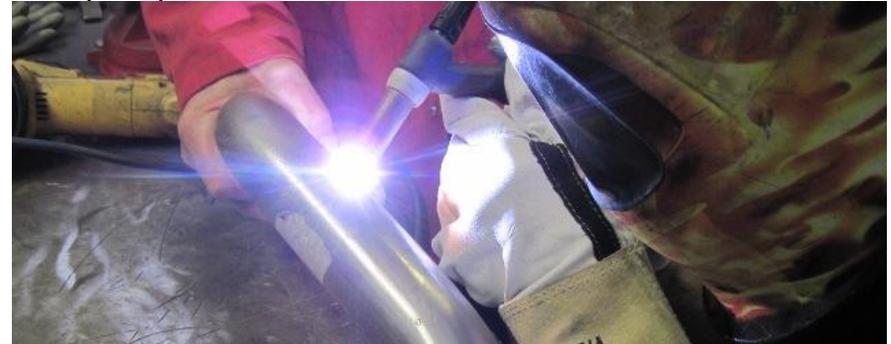
TIG welding the collars into the exhaust down pipes.

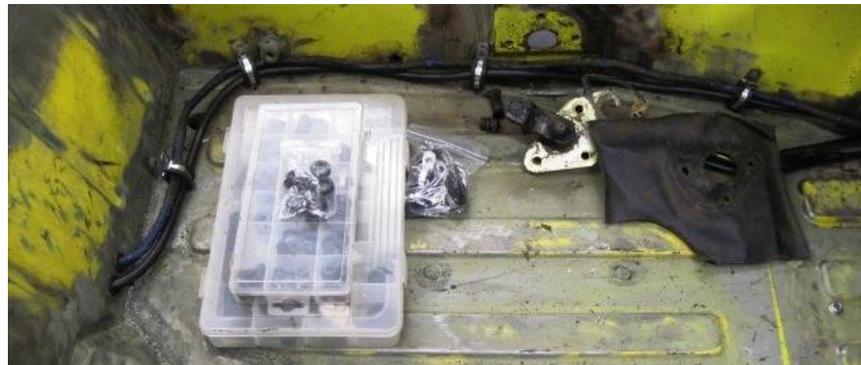
After lunch I did not feel like grovelling about on the floor fitting the exhaust system, so I went for some easy stuff. Fitted the rubber grommets for the cables and spaced out the double stainless steel clips to see where I needed to fit them for the cables to the rear and the battery positive to the front.

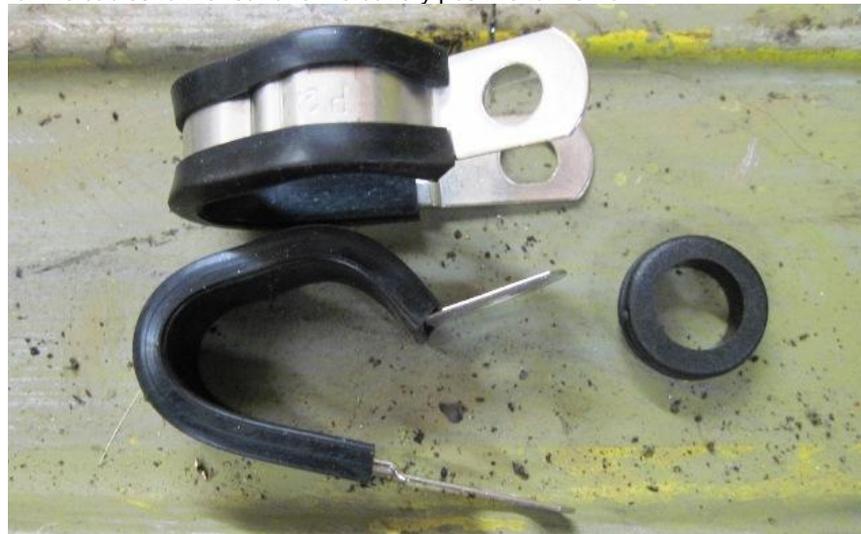
These double 13mm stainless steel clips for pipe work or wiring are available from Car Builders Solutions. 01580 891309 or [www.carbuildersolutions.com](http://www.carbuildersolutions.com)

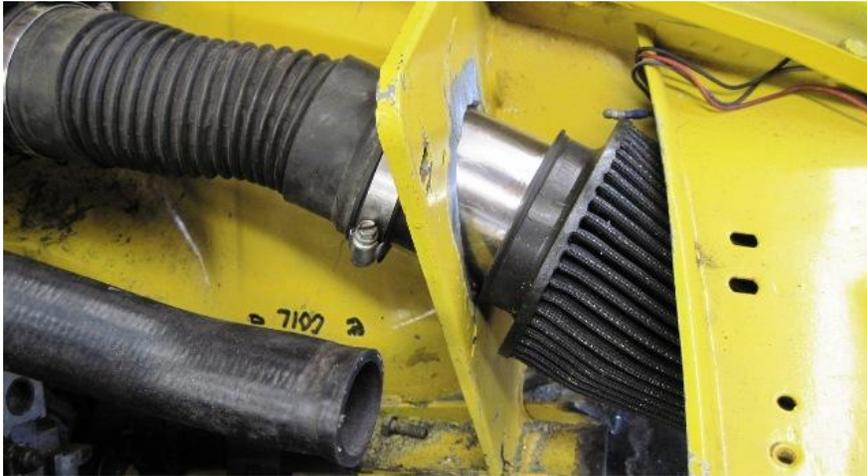
At last I managed to get the air intake pipe; I got made up, to fit through the radiator mounting panel at the correct angle. I must make sure that the radiator and electric fans fit before I weld the pipe in place. I made the pipe 3" long, but it would have been better to have made it 4" long. It is surprising how that when you mount the pipe at an angle, how much of the length of pipe you lose.

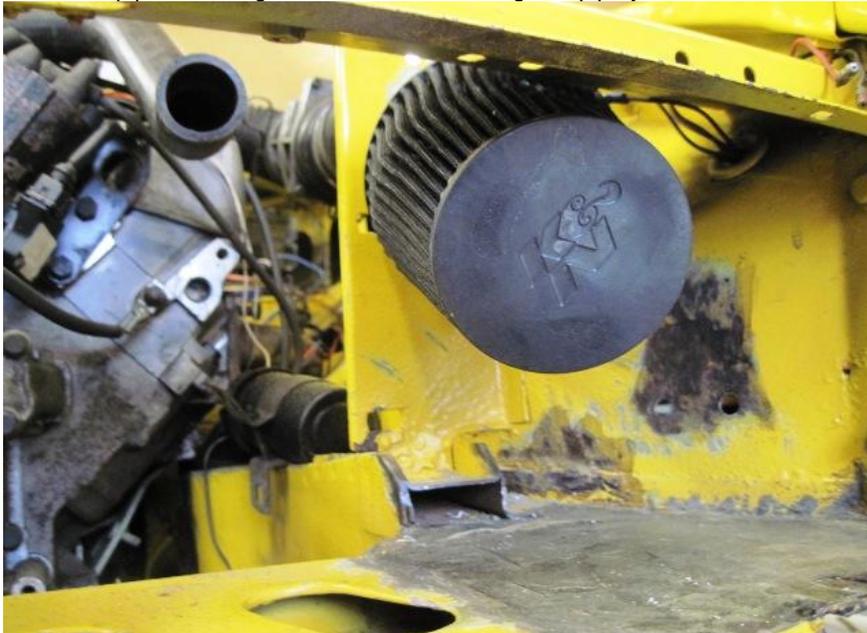
This should give the engine some nice cold and dense air. Cold air is denser than hot air and hence has more oxygen in it. That is why cars seem to run better and give more power on cold damp days than on very hot days.
