MGB V8 Roadster restoration project – Report 158

24th July 2017. A DOOR MIRROR THAT RATTLES

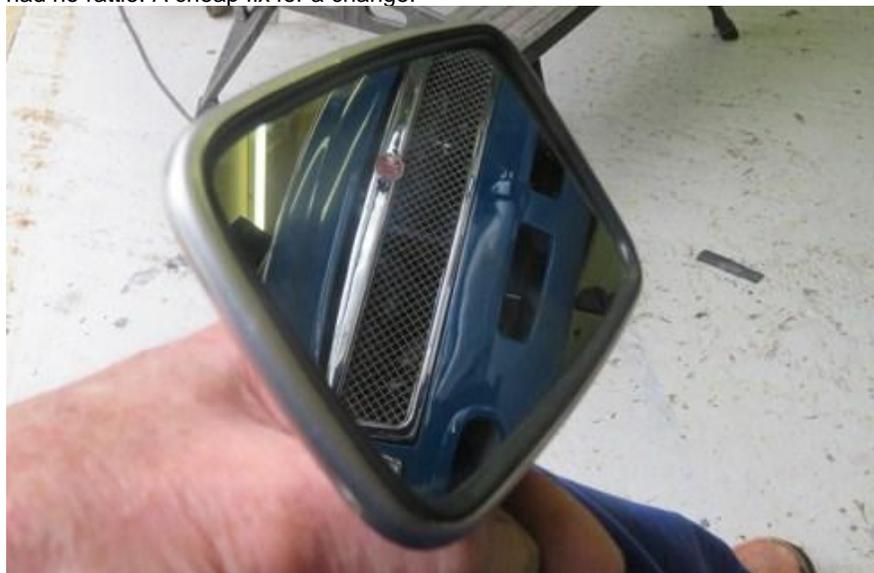
The black plastic moulding that holds the door mirror glass in place on the driver's side was loose in its stainless steel housing. Very carefully I tackled getting the black plastic part away from the glass and the housing without breaking the plastic. Eventually, it came away in one piece and was reusable. When I took the glass out the four grey flexible pads seemed to be too thin to hold the glass in place. I used four more bits of closed cell foam that I cut from some spare sound deadening material. When I refitted the glass and the black plastic moulding the mirror glass had no rattle. A cheap fix for a change!

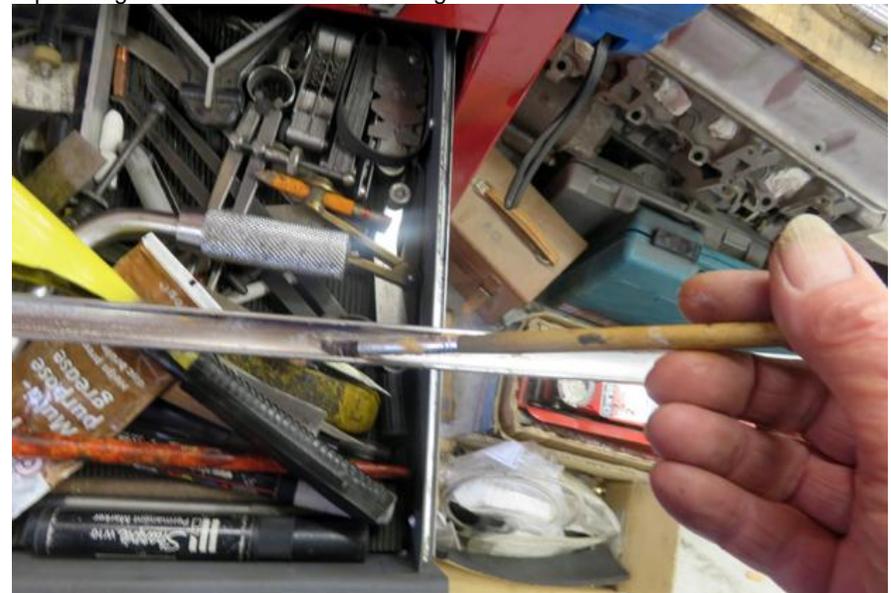
The next job on the list was to fit the front wing and door waist mouldings. To help against corrosion I coated each hole and clip with Waxoyl before fitting it. Luckily I did not need to drill any holes in the front wings for the clips, Apart from drilling one extra bolt hole for an extra trim clip at the front of the wings. With only one bolted clip at the front the trim sat about 1/8" away from the wing on the curve. Two bolted clips brought the trim in line with the wing.

The inside of the mouldings also got a coat of Waxoyl.

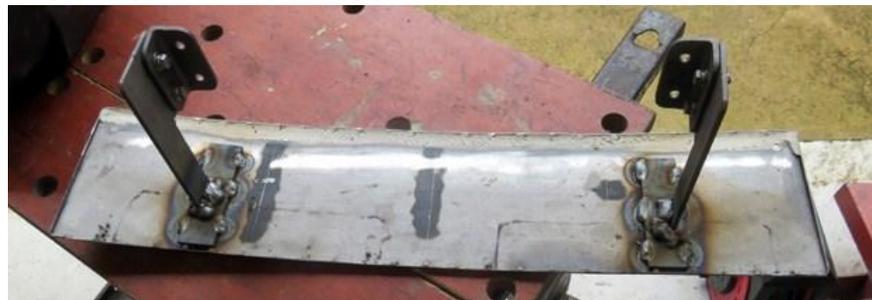
FRONT NUMBER PLATE MOUNTING

I suppose I have put off fitting the number plate for long enough. I got Jane to hold the number plate in the correct position. We had used masking tape, a rule and a black felt pen to mark the position previously. While she was holding the number plate mounting bracket in position I tack welded the arms to my curved number plate mount. It was then unbolted and the brackets fully welded away from the car.

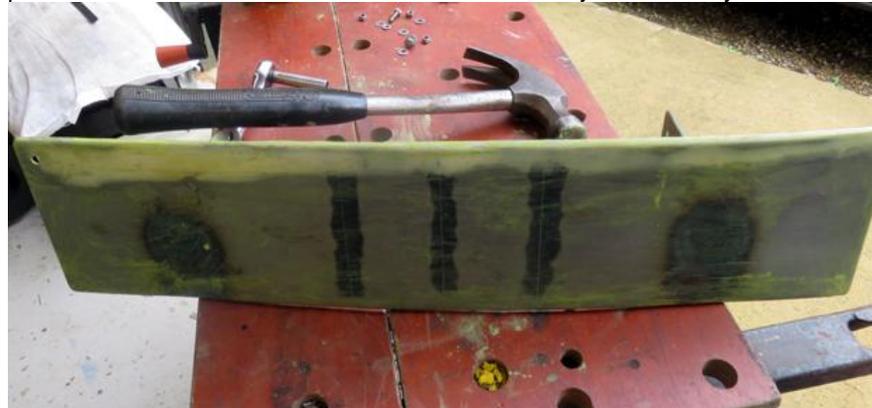
Etch primed.

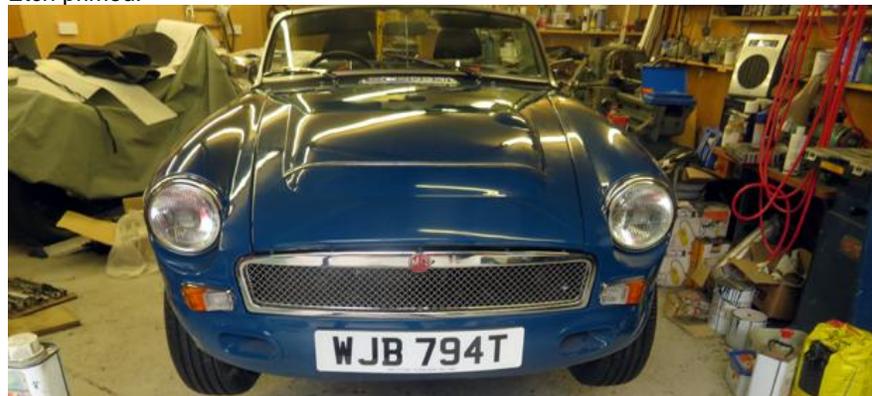
Sprayed and number plate fitted with double sided sponge tape.

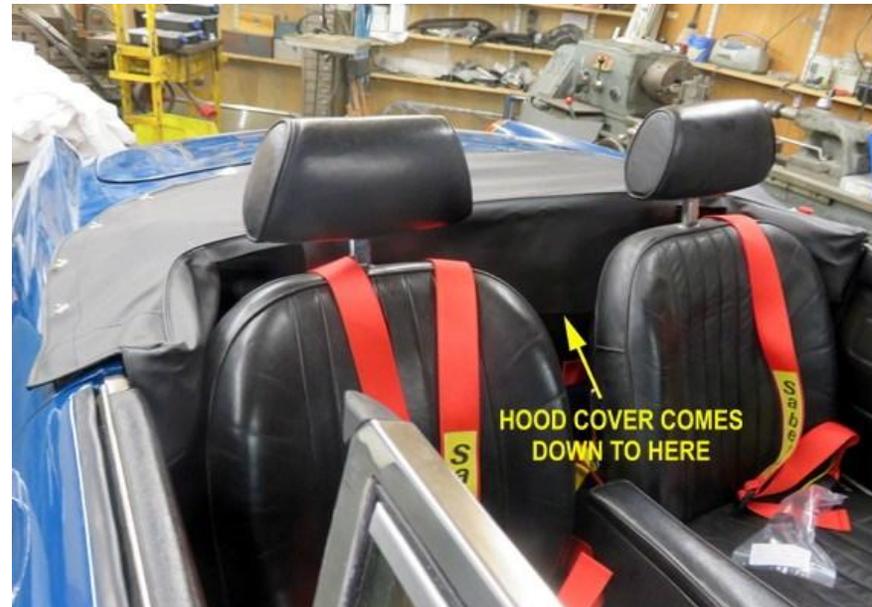
HOOD COVER

The full tonneau cover when folded up behind the rear seats seemed a bit bulky. It also got in the way of the full harness seat belts. I tried looking on the internet for some photos of how the hood covers fitted behind the seats and how far down the cover came behind the seats. Try as I could, I could not find a photo showing this view of the hood cover, all the views seemed to be of the back or side of the MGB. I contacted Moss and managed to purchase a hood cover to try, on a sale or return basis. I have included the above photo as it may help others in the same predicament.

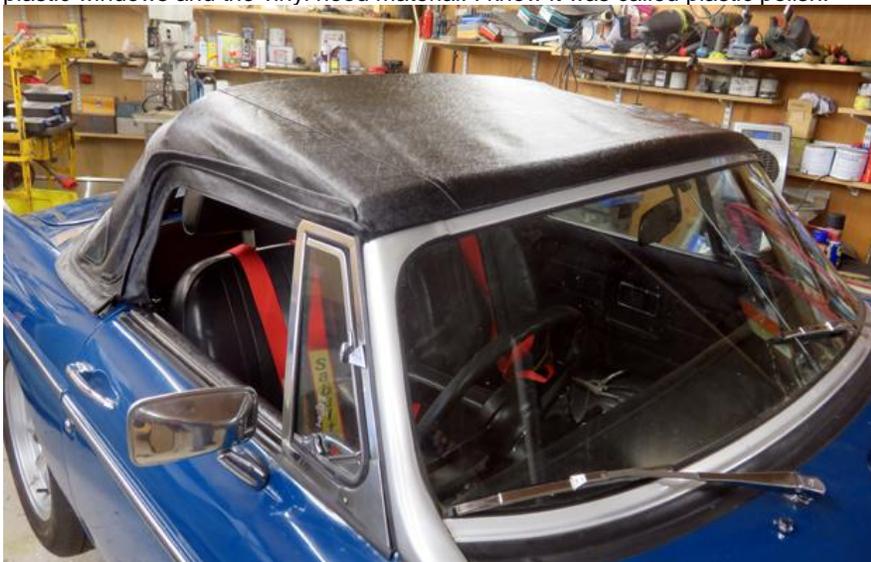
Although the hood isn't brilliant it will do for the time being as it still has a few years life left in it.

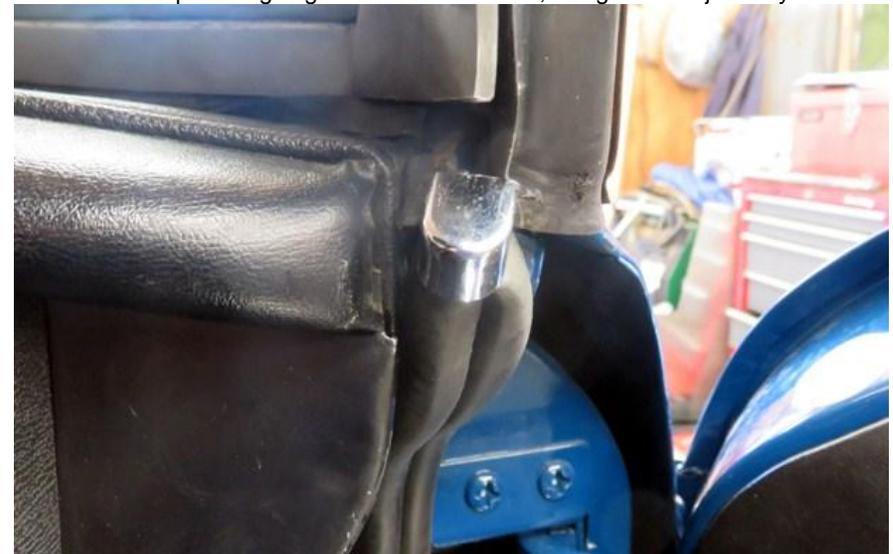
I have played about with fitting a chrome finisher to the top of the front door seal. I tried cutting down an old rear one to fit to the front, I think that may work. I am still 'cheesed off' that I didn't realise you had to fit this chrome trim before the screen and the dashboard were fitted.
