### Clip on the damper in an HIF carburettor

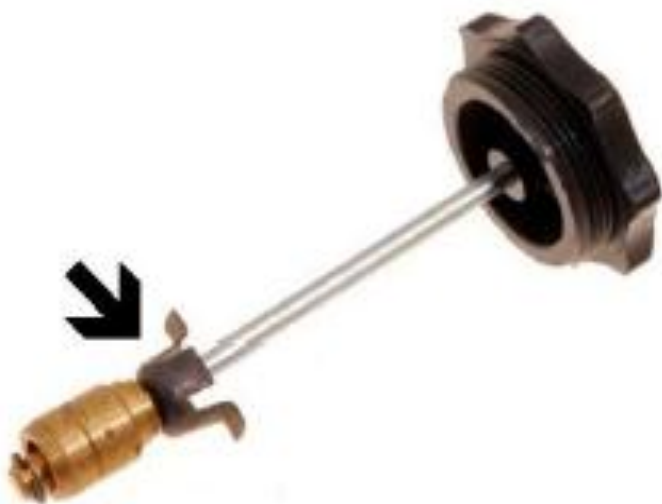
**Victor Smith** responded saying "I attach a diagram from page 46 of Tuning SU Carburetors 3rd Edition by Speedsport, Feb 1975. It's a useful 128-page A5 size [book](#) on tuning SUs I have had for years which provides detailed exploded diagrams of SUs and information on how to dismantle, service them and tune them. The book is mentioned on our "MGBGTV8 Manuals" [webpage](#) via the "Technical Support" link on the V8 Website homepage."
