Ignition problems again

In 2015 Peter Spurrs had serious ignition problems. Sometimes the car would run well, but at other times not at all and at random times in-between it would fail. There was always a slight hesitancy when accelerating, but he took that to be normal. The previous owner had fitted Aldon ignition, but everything else was pretty much original. He re-made all of the earth connections – no change. The vacuum advance was seized; he replaced it - no difference. He then replaced the spark plugs, rotor arm and distributor, and then fitted Magnacor plug leads and an Aldon Flame-Thrower coil - still no improvement. The solution turned out to be an intermittent fault in an earth lead. He ended up with a working ignition system with lots of new parts. In 2019, half way through a 50 mile journey, the car went from running smoothly to spluttering, then a few minutes later, it backfired a few times and stopped. After a while it restarted, but it had no power and stopped. A recovery vehicle got him home. Here he explains how the problem was solved.

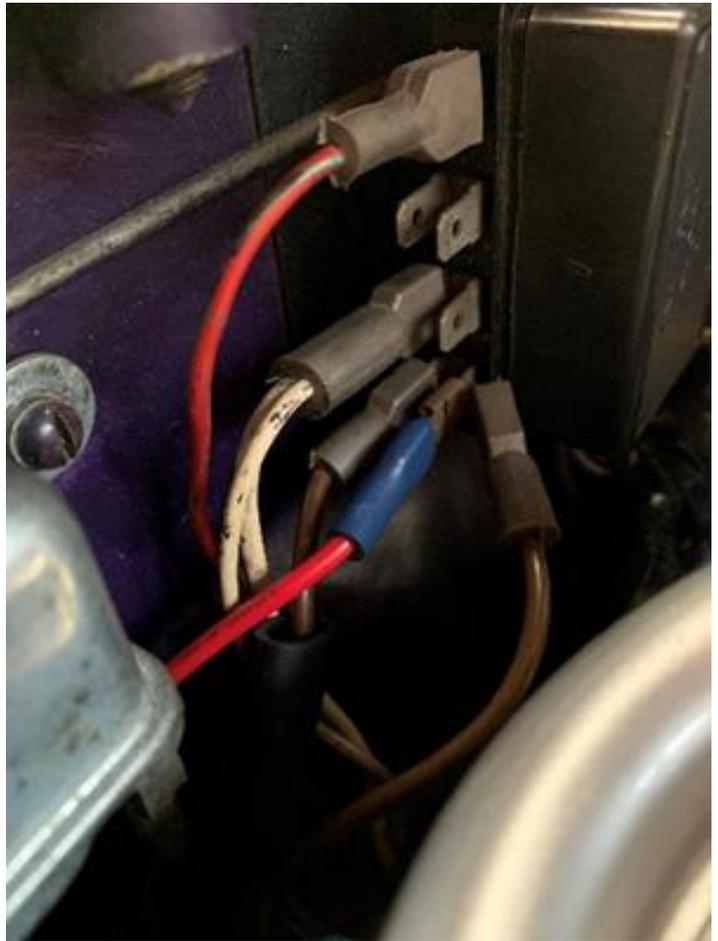
The ballasted wire was cut at a convenient point where it emerges from the loom on the nearside of the car. The feed from the fusebox was made electrically safe and a bullet connector fitted to the feed to the coil. The new wire and the old connection to the coil were joined.
