MGBGT V8 – Strategy for Dealing with a Sheared Engine Fastener

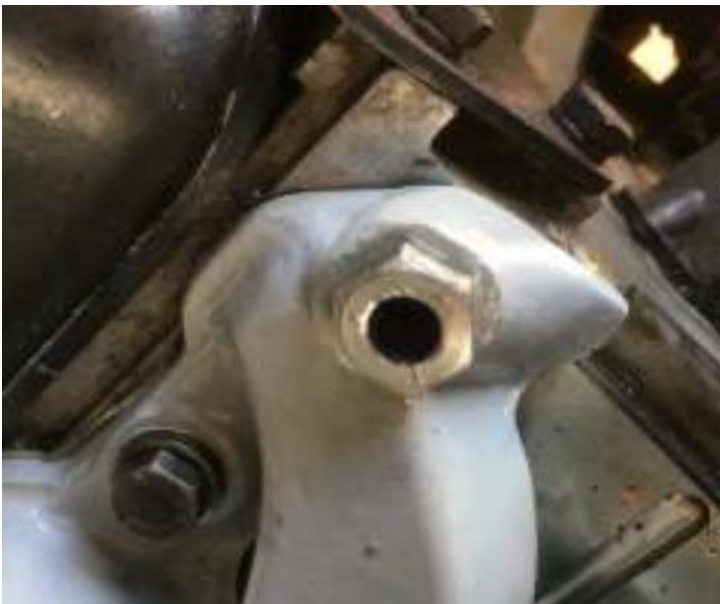
Drill bush in position in the inlet manifold

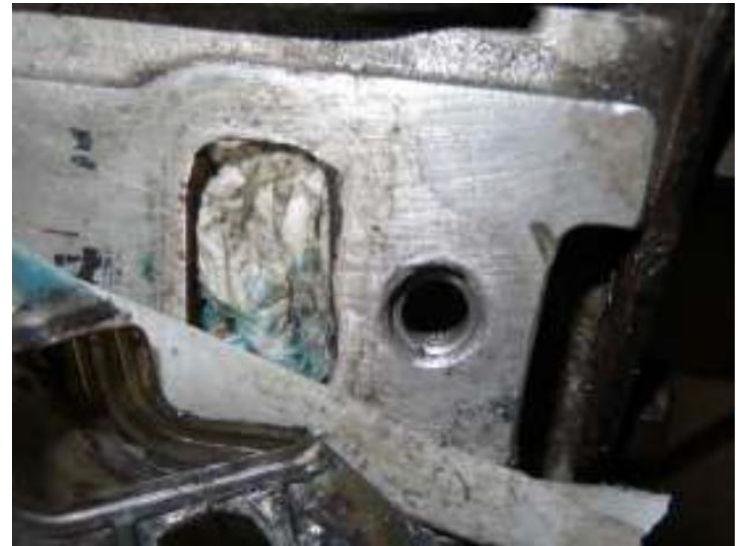
Wire thread insert installed
