## MGBGV8 – Cylinder Head Removal and Replacement

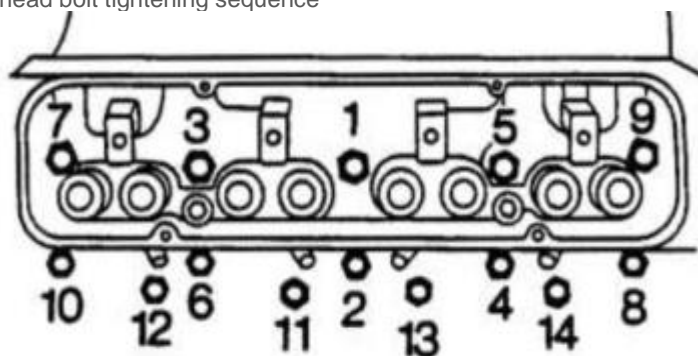
The original Rover V8 engine has an oddly asymmetric head bolt pattern. The service loadings on the head bolts are affected by multiple factors (cylinder pressure, bolt strain, thermal expansion, etc) and are consequently not evenly distributed but why the inlet side of the head should have 5 bolts while the exhaust side has 9 has puzzled this writer. Rover appear to have recognised this anomaly by relaxing the clamping force on the exhaust side by first reducing the assembly torque on the outer (exhaust) row of bolts and later by deleting the bolts altogether. Rover also adopted a more conventional diagonal bolt tightening sequence which contrasts with the MG recommendation which sees the inlet side tightened in advance of the exhaust side. The different sequences are contrasted in **Images 2 and 3**.

Image 3: 2003 Rover Overhaul Manual cylinder head bolt tightening sequence

1. Remove the cylinder head having progressively loosened the bolts in the reverse order to that specified in **image 3**.
2. Retain the bolts in their original positions – **see image 4**.
3. Clean the head, block and manifold joint surfaces with a plastic scraper and inspect both for flatness and damage – **see images 5, 6 and 7**.

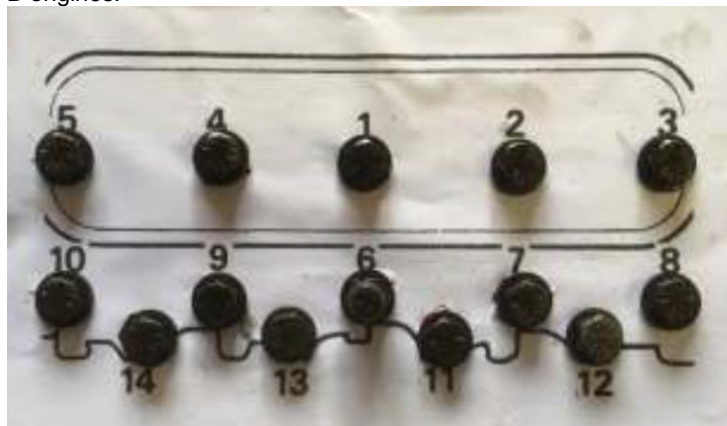
**Image 4:** Bolt storage (using a MG template stuck to the lid of a shoe box)

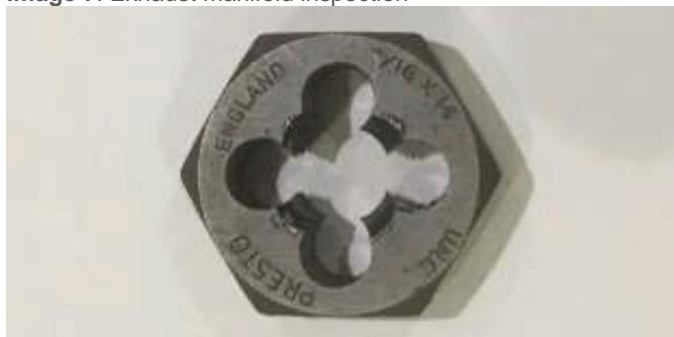
**Image 8:** 7/16" UNC die nut for bolt thread cleaning

4. Clean any residue of sealant from the head bolts with a 7/16" UNC die nut and from the block threads with a 7/16" UNC tap – see **image 8**.
5. Place a new metal gasket on the block dowels.
6. Carefully lower the cylinder head on to the dowels  
Note: to avoid damaging the head surface on the steel dowels screw a couple of 7/16" UNC studs into block holes **12** and **14** in **image 3**.
7. Lightly oil the head bolts and assemble them with their washers into their original holes.
8. Progressively tighten the bolts in the order specified in **image 3**. Take all up to 60 Nm and then only 1 to 10 up to 90 Nm.  
Note: If your torque wrench has not been calibrated recently it may be prudent to confirm its accuracy at 90 Nm. The writer did this with a digital weighing device – see **image 9**.

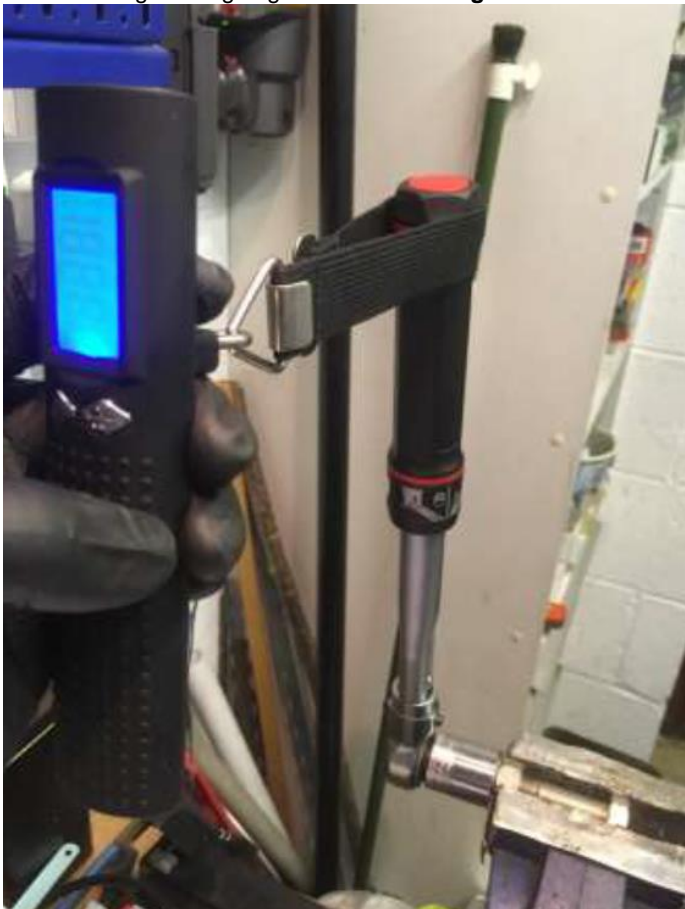
**Image 9:** Confirming calibration of torque wrench
