Door mirror instability

Peter Spurrs found the two door mirror fixings on his MGBGTV8 were unstable. Here is how he resolved the problem.

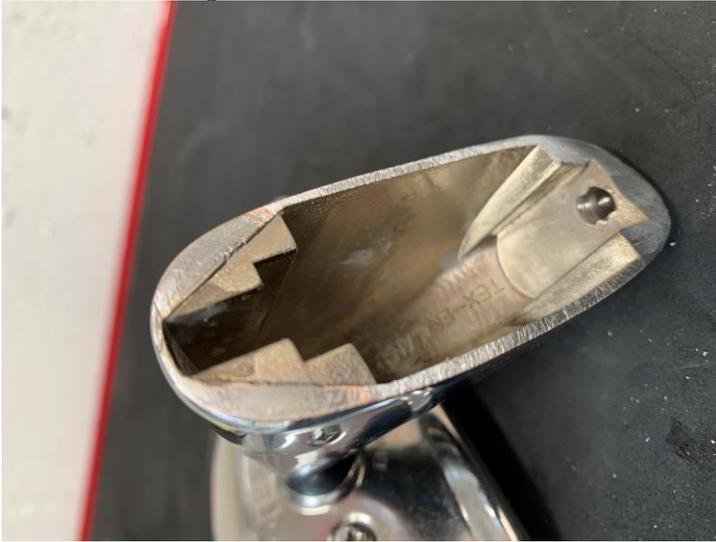
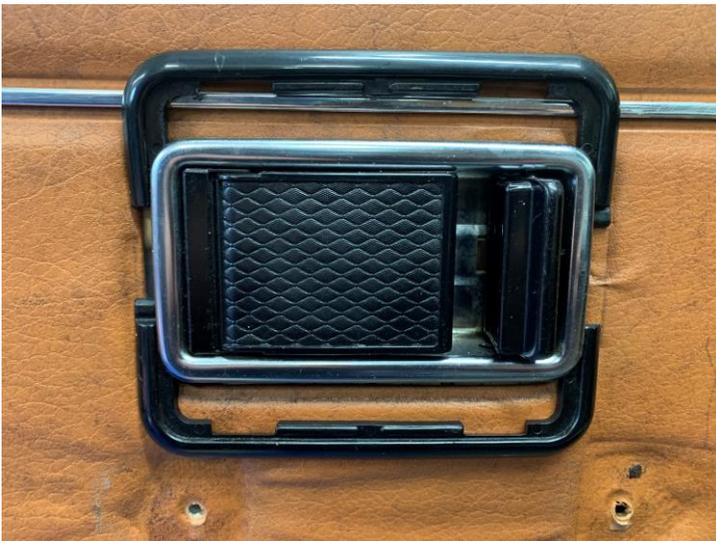
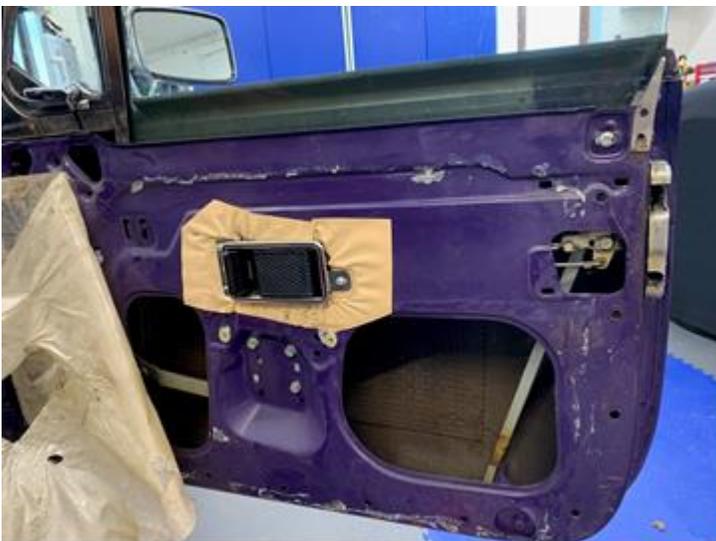
4. The door lock surround is in two pieces which can be pushed apart. The upper surround needs to be fed carefully over the trim strip to avoid damage.
5. With all of the components taken off, the door card can be removed. It is held in place with a number of plastic push-on clips. In my case, finger pressure around the edge of the door was adequate. It may be necessary to use a lever of some sort. Whatever it is, some padding may be needed to prevent damage to the door paint.
6. The final layer is a plastic sheet used to form a waterproof barrier between the door card and the door inner. It is glued in place. Careful removal will allow it to be reused.
7. Repair any damage and corrosion. In my case, the rust around the mounting holes needed to be addressed.

The first job is to remove the door card to gain access to the inside of the door,

1. Remove the four screws holding the door capping and lift off the capping.

2. Remove the two screws on the door pull.
3. Remove the single screw on the window winder.
