WELCOME TO THE V8 NEWSLETTER

MGBTV8 – Gearbox Remote Control Housing repair of a stripped thread

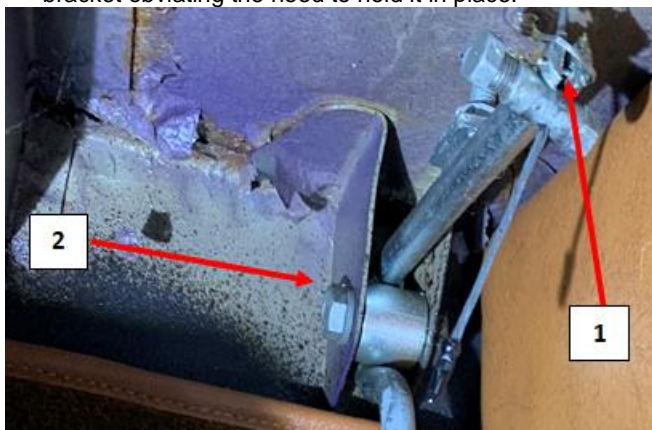
Removal is straightforward:

1. Extract the split pin securing the throttle cable.
2. Remove the bolt holding the pivot. The nut is fixed to the bracket obviating the need to hold it in place.

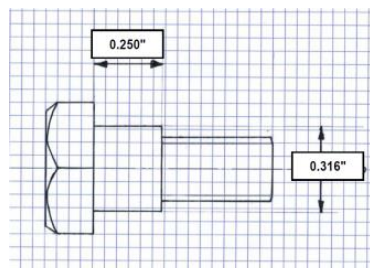
Cover Plate, bolts and spring washers

The bolt holes in the cover plate are 0.338" diameter indicating that a radial clearance of 0.011" was the design intent. The thickness of the plate is 0.085" which with a

compressed spring dimension of 0.080" suggests movement of 0.085" was allowed for. The free length of my fifty year old springs varied from 0.225" to 0.275" so compression in the order of 0.060" to 0.110" is still available.
