## MGBGV8 engine mountings

Since the launch of the V8NOTES series in early 1979, the topic of engine mountings has often come up, often with the offside mounting knocking the steering column. This article brings together the various notes on engine mountings published in the V8NOTES series over the years. An easy way of checking whether the series covers a topic is to check with the detailed Index to the series – a copy comes with each set of V8NOTES and a copy is also available on the V8 website where it can be accessed and a copy easily downloaded via the link below. 150223

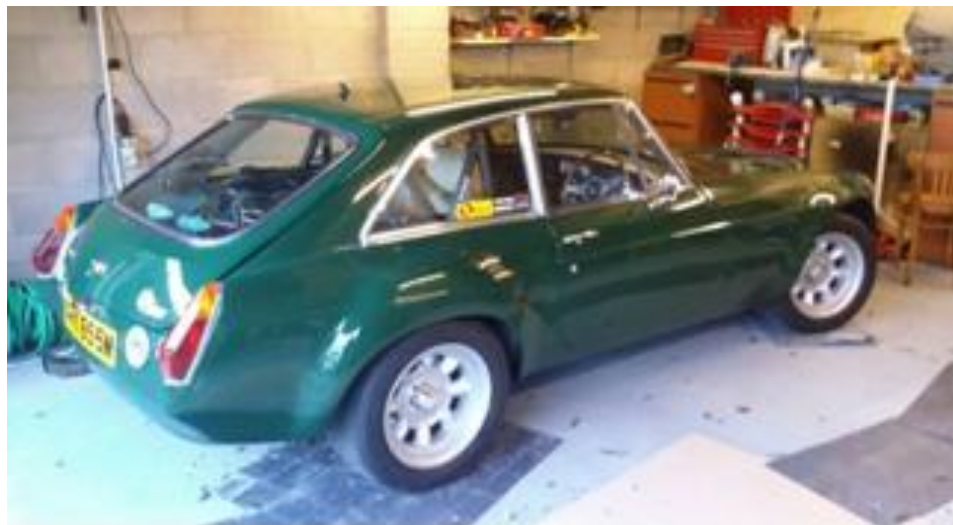
To make this even more secure in terms of engine movement from the torque, I also fitted a Clive Wheatley front engine steady bar. This, together with up rated V8 engine mounts, has prevented any movement in this respect, so it should not happen in the future.

So when the water radiator was removed I took the opportunity to remove the engine pulley and cut down the lugs that protrude farther out than the bolt heads. These lugs are for the Rover SD1 air conditioning drive and are not needed in my application, so they were duly cut off and more care was taken with the location of the antiroll bar and clamps before the securing bolts were tightened and hey presto the clearance is fine and again and no more strange noises under braking.
