### **MGBGTV8 – confirming the position of the Top Dead Centre Identification**

#### **Introduction**

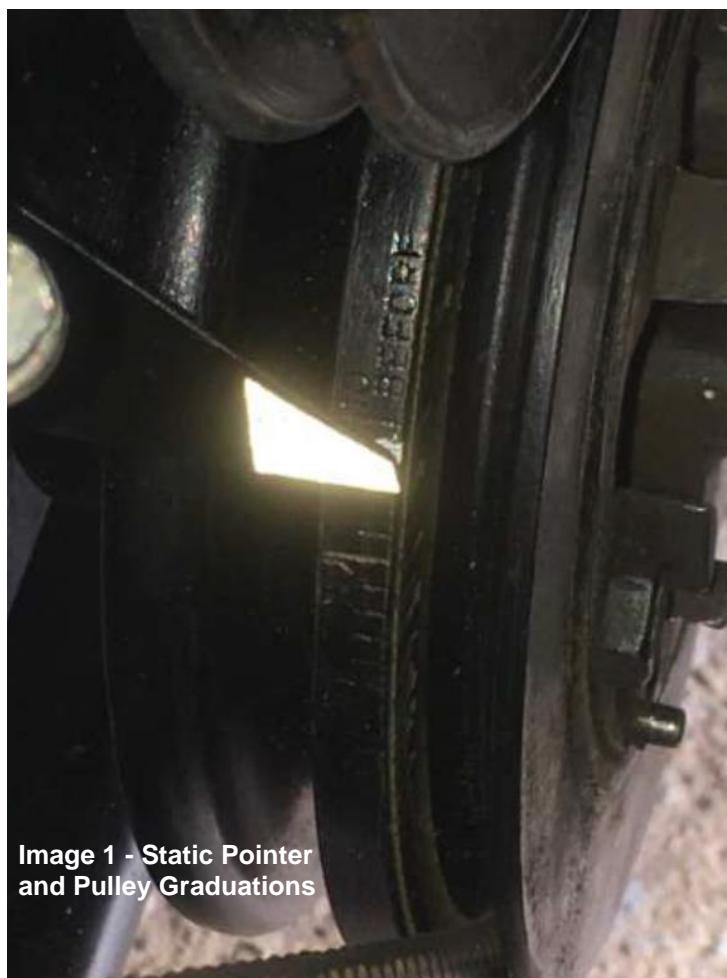
**Image 1 - Static Pointer and Pulley Graduations**

- This is an opportunity to clean, derust and paint the static pointer and crankshaft pulley and reapply any highlighter to them – **Image 1**.
  - Clockwise rotation of the crankshaft is specified throughout the procedure. The reason is to avoid any risk of loosening the pulley bolt if a socket is used to rotate the engine and to eliminate backlash in the powertrain. Either eventuality is highly unlikely in this instance.

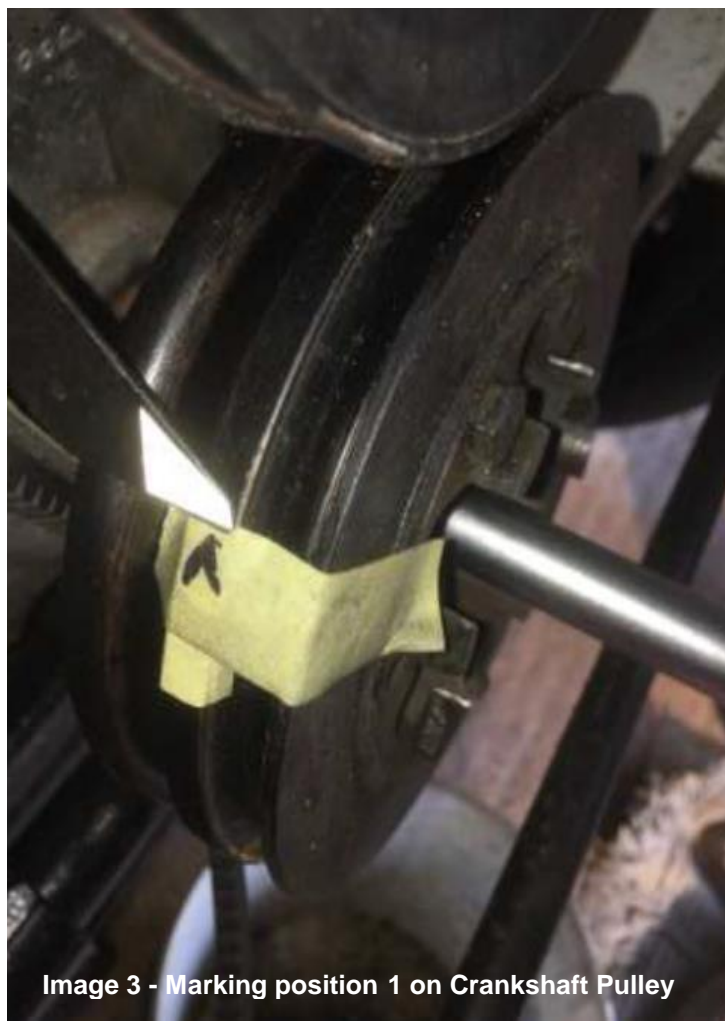
Image 3 - Marking position 1 on Crankshaft Pulley

4. Position the DTI to contact the piston crown and zero the dial – **Image 2**.
5. Mark the crankshaft pulley in line with the static pointer. This is position 1 – **Image 3**.

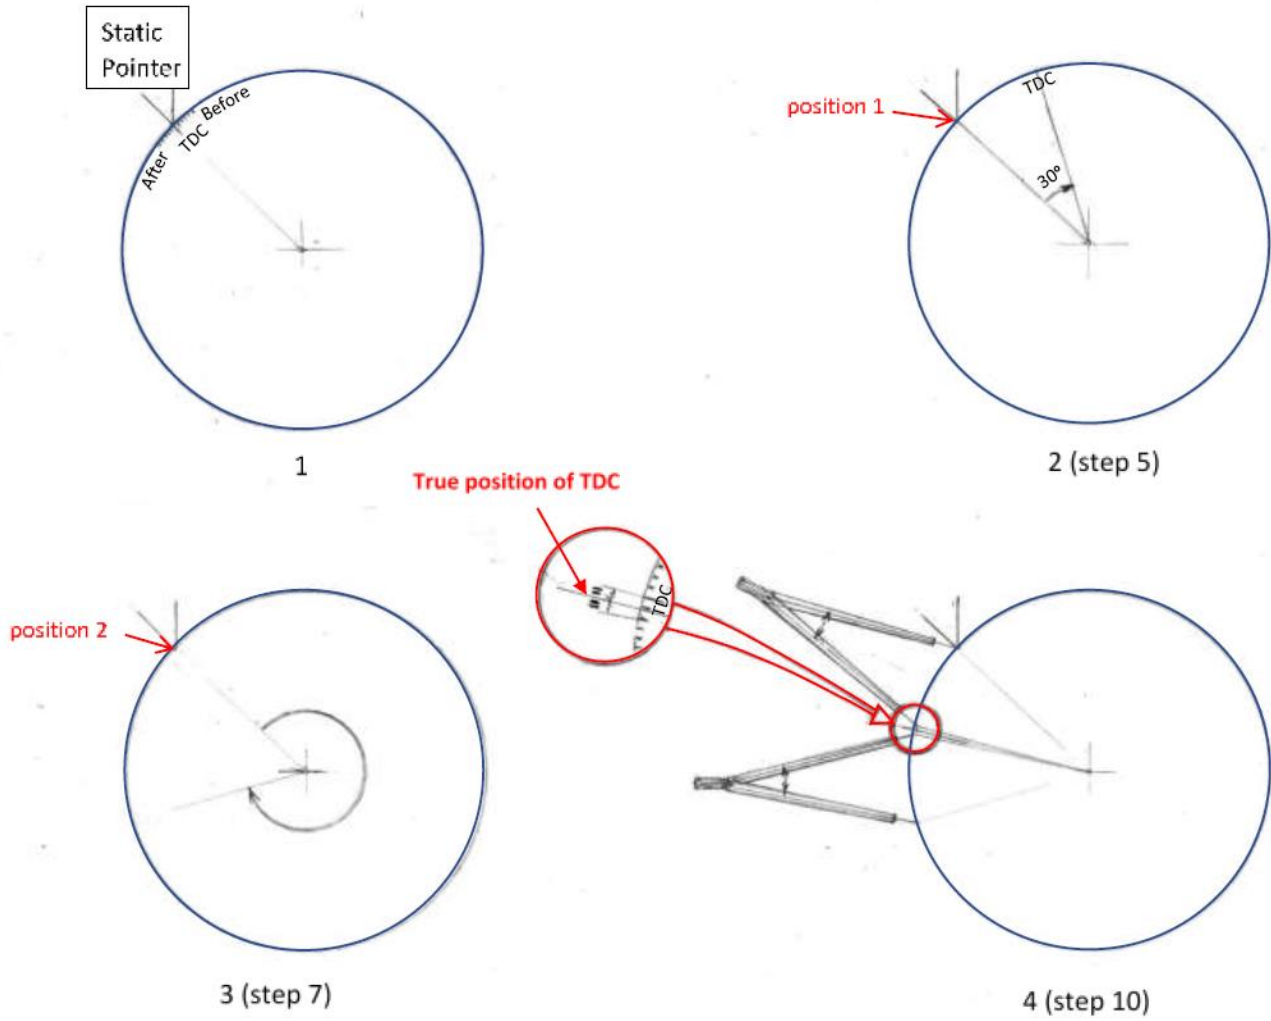
Image 4 - Schematic of the Process

- A schematic of the process is shown in the final image on page 3 - **image 4**.
  - As a starting point it is assumed that the cylinder head, all spark plugs and the alternator belt are removed and the engine rotated to Top Dead Centre (TDC).

8. Position one leg of the dividers on position 2 on the pulley and set the radius to the TDC mark.
9. Reposition the divider leg on position 1 and retaining the radius set in step 8 scribe a mark on the pulley adjacent to the TDC mark.

10. The true position of TDC is midway between the original TDC identification and the scribed mark.
11. Temporarily mark this position – **Image 4**.
12. Repeat this process and, when satisfied, establish a consistent position for the temporary mark.
