### DEV 2, the second Project Adder development car

### Solving a problem with an LH overdrive cycling in and out

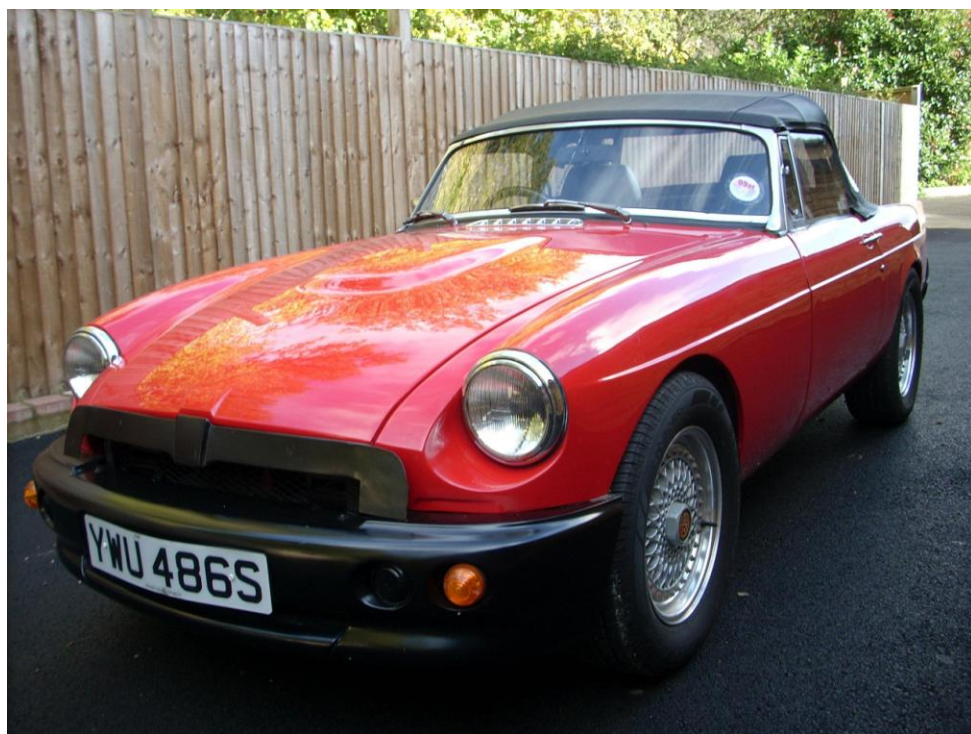
It was built in 1990 as an RV8 pre-development car by Mark Gamble at BMH as part of the Adder project using a new Heritage MGB shell fitted with a 3.9 injection engine supplied by Land Rover Engineering and a 5 speed box. It may look like an ordinary MGB, apart from its RV8 bonnet and prototype styled front end, but with uprated suspension and brakes, its performance is far from ordinary. It is a very fast, usable car in very good condition which has been owned by Trevor Ripley for many years, but has covered only just over 26,000 miles. He has decided to sell it so there is a real opportunity for an enthusiast to get an interesting car which comes with a comprehensive history file and documents relating to its ownership with BMH and Rover Group.

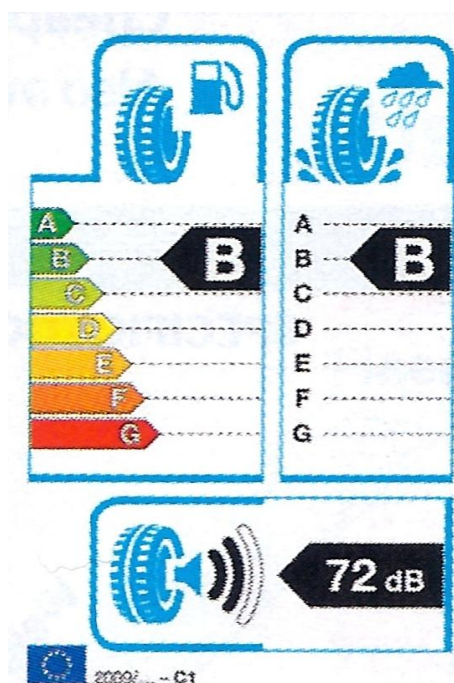
Below is an example of the new tyre label. Fuel efficiency (upper left) is rated A to G with typically a 75% difference in fuel economy between ratings A and G. at a steady 50mph. Wet grip (upper right) is rated A to G and a the typical difference in braking distance between A and G tyres is around 30% or four car lengths. External rolling noise - two black curves means it meets EU noise limits.

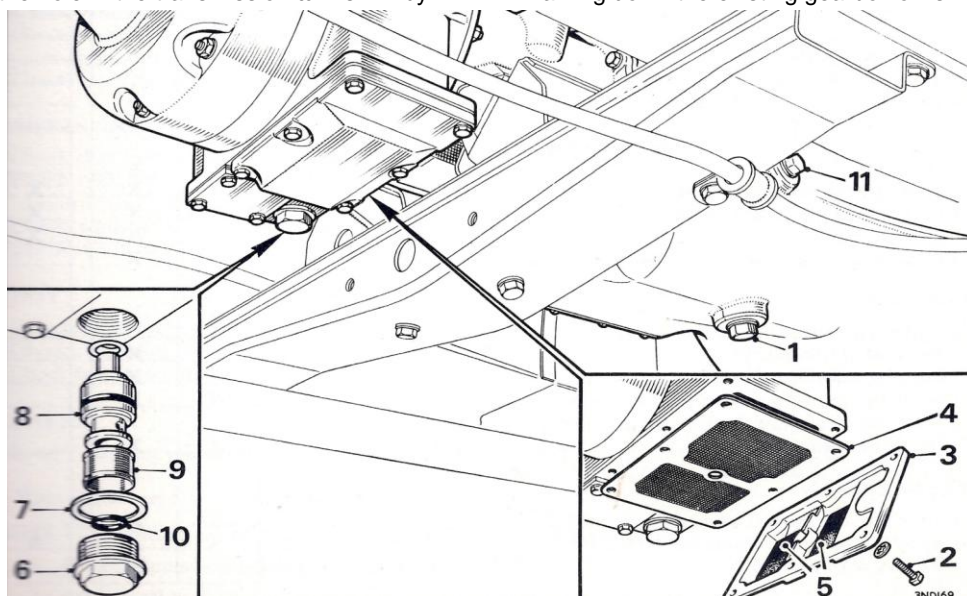
Drain plug (1), Cover (3), Filter & gasket (4), Magnets (5), Relief valve filter plug (6), Sealing washer (7), Relief valve (8), Filter (9), Seal (10) and the Combined filler & oil level plug (11).

The second check would be the oil level in the gearbox since it also serves the overdrive and a low oil level could cause the overdrive to be slow to engage, fail to engage or cycle in and out. A related issue may be the oil is dirty, so if it’s been in there a while, drain down through the sump drain plug (1) below. The filter and gasket (4) are located under the flat plate (3) on the underside of the overdrive. Also clean any metal fragments attached to the two magnets (5) and replace the plunger O-Ring too. The service manual says the gearbox and overdrive unit should be drained and the overdrive sump filter (4) and relief valve (6) cleaned every 24,000 miles or 24 months.

You also need to remove the relief valve filter plug (6) and the sealing washer (7), withdraw the relief valve (8) and remove the filter (9). Replace the seal (10) fitted in the plug and wash the filter, plug and sealing washer in petrol. Insert the seal (10) into the plug, fit the filter to the relief valve, push the valve upwards and refit the plug and sealing washer.

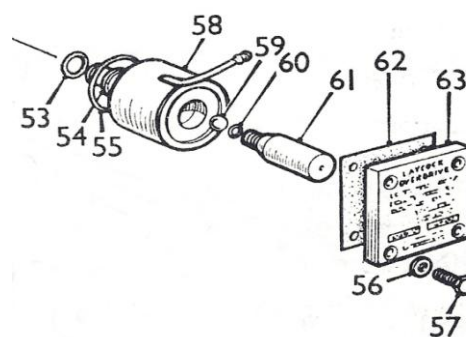
Solenoid: O-Ring (53), Solenoid valve body (54), O-Ring (55), Washer (56), Screw (57), Solenoid coil (58), Valve ball (59), O-Ring (60), Solenoid plunger (61), Gasket (62), Solenoid cover (63), Sump filter and gasket (64) and Filter magnets (65).

Laycock LH overdrives feels it is a weak solenoid with not a great deal of energy, so if the O-Ring (60) becomes hard over time or the ball valve seat deteriorates producing a leak, that can contribute to a slow operation when engaging overdrive.

Peter Eglington of Overdrive Repair Services in Sheffield, run by an ex Laycock team, mentioned "the repeated action of the ball (59) on the valve seating can work harden the seat and lead to a reduced seal. The seat can also show signs of pitting and scoring. With pressures of around 550psi that deterioration can lead to pressure losses. It's an item they check when servicing overdrive units.
