Replacing dashboard instrument bulbs with LEDs

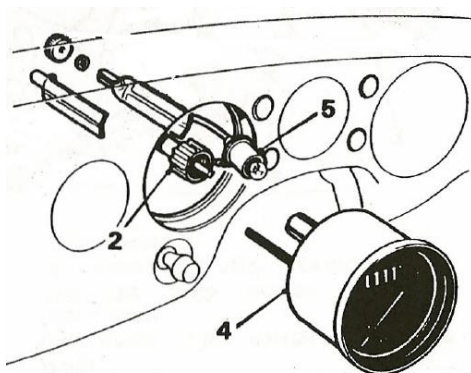
Nic Houslip responded saying the dashboard instrument lamps are easy to get at if you can get upside down in the driver's seat, feet in the air and head under steering column. In that position you will find the instrument lamps are in a small "plug in" holder that inserts into hole about 1/2" dia in the back of each instrument. They are spring loaded. Nic provided a document showing the lamp holder out of the speedo adding the document is from a workshop manual for a 1978 car, but others are similar.
