## MGB V8 Roadster restoration project – Report 3

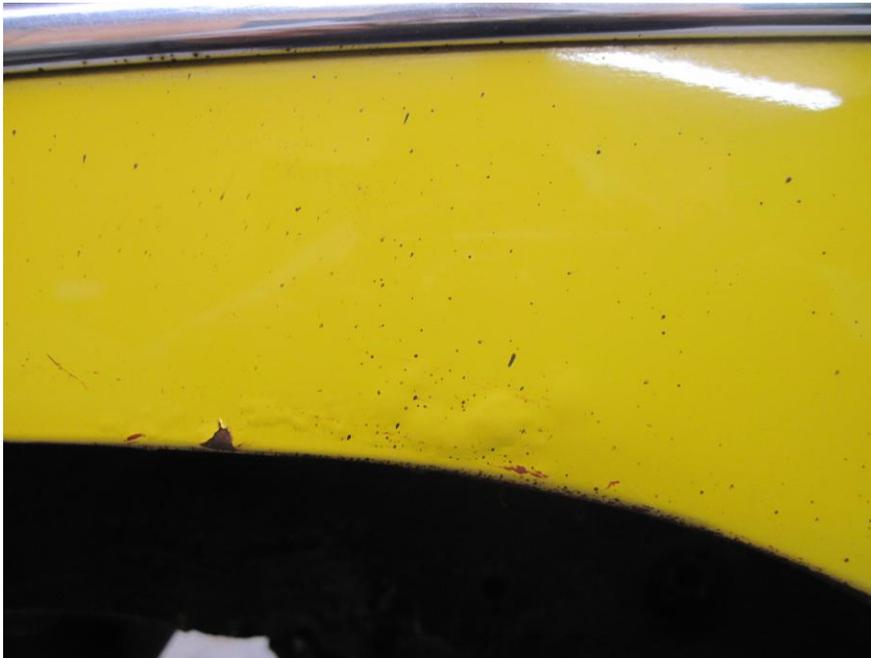
**Rust in the rear wheel arch** although the MGB has been fitted with new wheel arch panels in the past. Micro blistering to the paintwork at the rear of the car where filler primer has been left without coating with a topcoat soon after the primer has been rubbed down. This will mean that the bodywork at the rear will need to be stripped to bare metal and any rust removed before painting again. Always use an acid etching primer straight after taking the panel down to bare metal. This will stop the panel rusting again before you put primer or filler on to it. You only need a very thin coat of etch primer to protect the metal. When restoring a car it is a good idea to always have a bit of heat on in the garage and a dehumidifier is an excellent investment. You will be amazed how much water it collects every day.
