Restoring a rubber bumpered MGBGTV8 – Roger Powell Nixon reports on progress

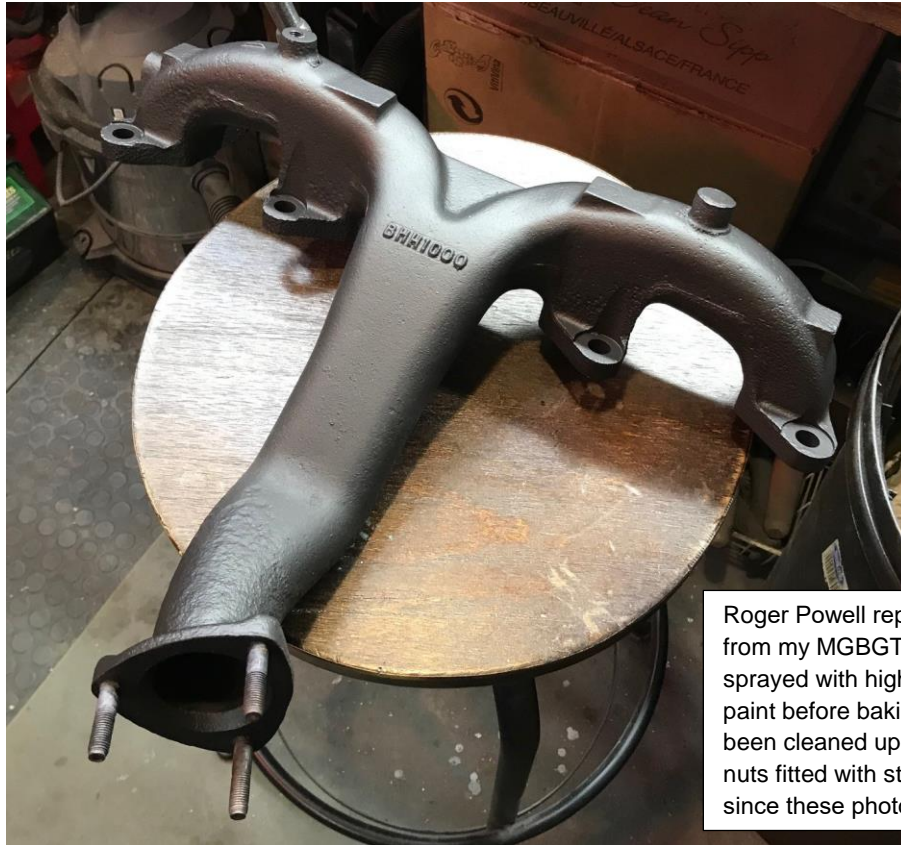
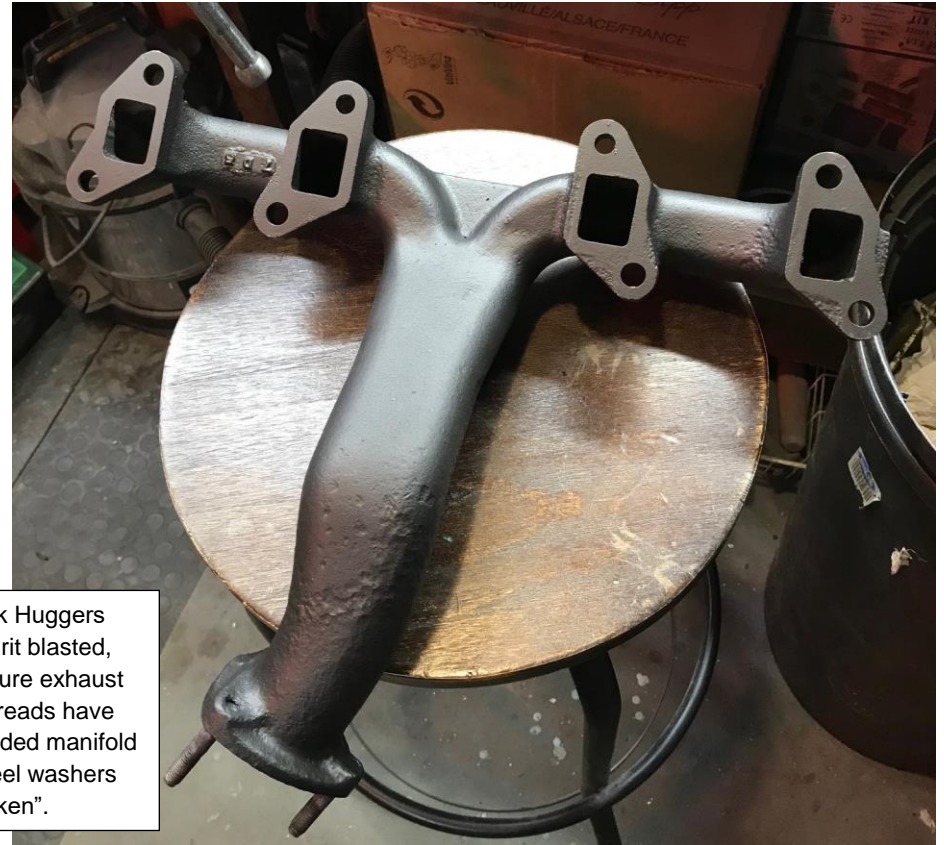
Roger Powell reports "Block Huggers from my MGBGTV8 that I grit blasted, sprayed with high temperature exhaust paint before baking. The threads have been cleaned up and extended manifold nuts fitted with stainless steel washers since these photos were taken".

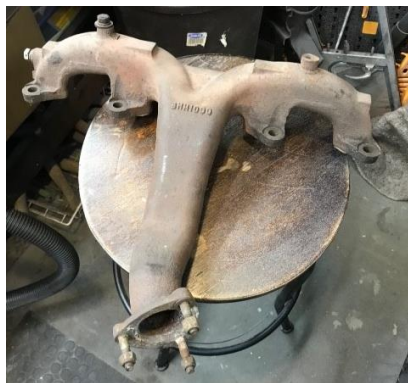
Manifold before blasting
