RV8 thermostat – drilled vent or undrilled?

In a V8BB posting Dave Morris sought clarification on whether the thermostat is vented.

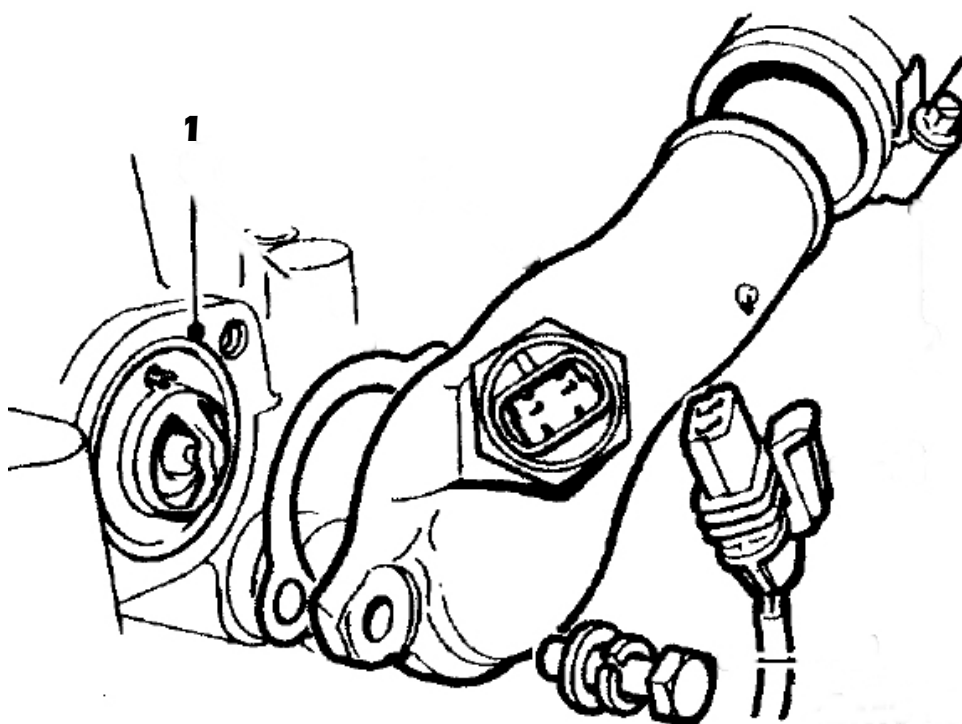
Looking at the service repair section (Cooling system: Repair, page 3) of the RV8 Repair Manual AKM7153ENG the procedure for replacing the thermostat is set out. The illustration in the workshop manual shows the thermostat (1) mounted horizontally and a note specifically says “fit the thermostat to the housing with the vent pin (2) in the 12 o'clock position – caution, failure to position the thermostat correctly can lead to air locks and overheating”.

So it is clear the thermostat originally fitted to the RV8 model had a vent pin (2) and it is important that it is located correctly in the thermostat housing.

Nic Houslip added “the small drilled hole is a bleed hole, primarily to allow a small amount of heated water to go past the thermostat and ensure that the wax bulb gets heated and allow the thermostat to open. It also allows any air trapped (which may also prevent the bulb getting heated) to pass. The bobble valve allows a reverse flow of water during cooling down when the thermostat may be closed. You need to check carefully the replacement part has a vent”.
