## RV8 rusty fuel tank

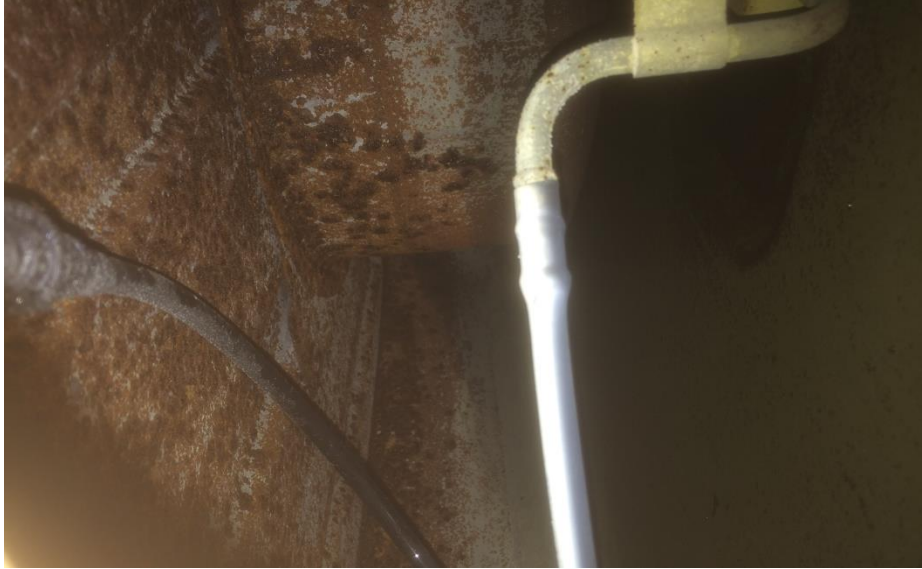
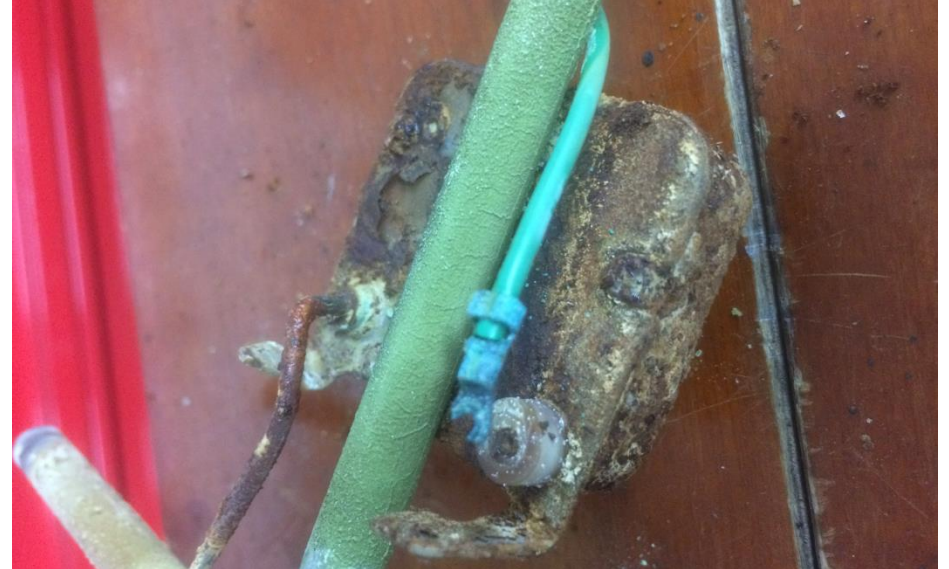
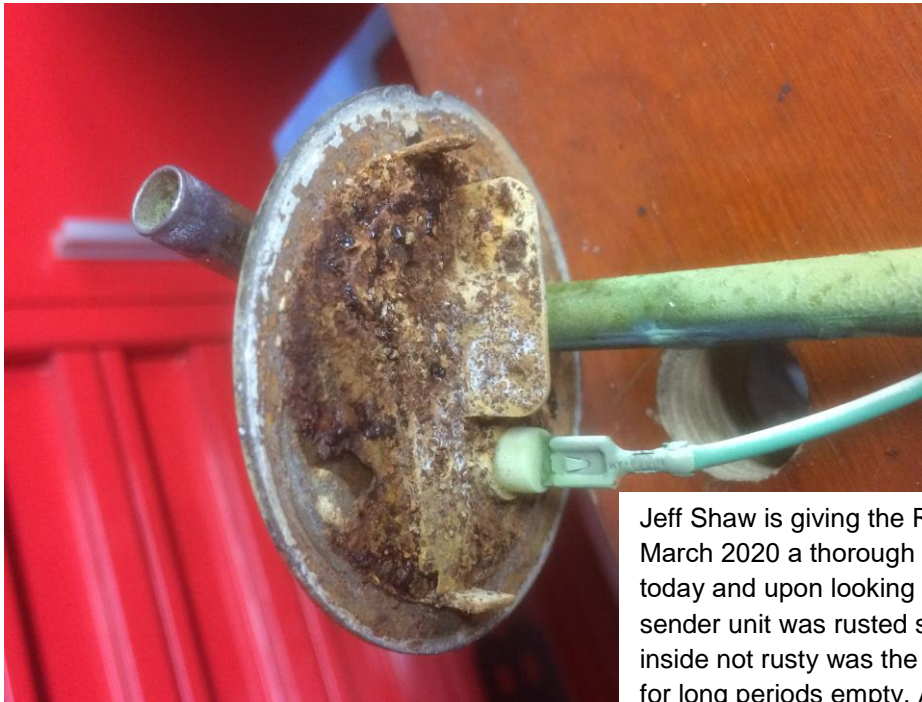
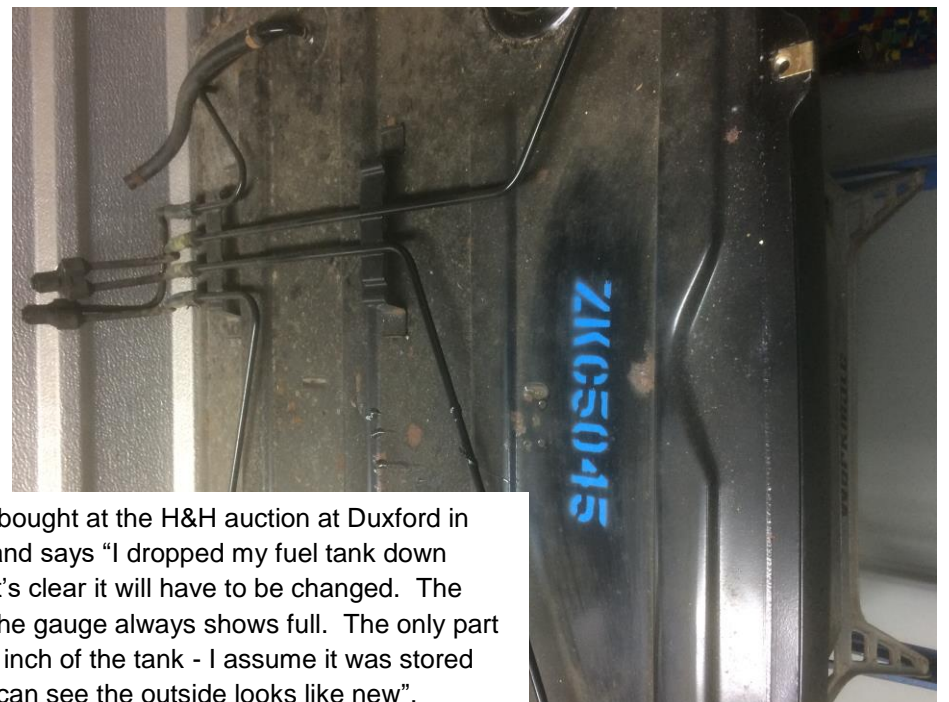
Jeff Shaw is giving the RV8 he bought at the H&H auction at Duxford in March 2020 a thorough check and says "I dropped my fuel tank down today and upon looking inside it's clear it will have to be changed. The sender unit was rusted solid – the gauge always shows full. The only part inside not rusty was the bottom inch of the tank - I assume it was stored for long periods empty. As you can see the outside looks like new".
