Refurbishing RV8 wheels – a photo record from Hugh Boddington (RV8NOTE317)

Following the contributions to a V8BB thread on refurbishing RV8 wheels launched as a query by Hugh Boddington, he set about cleaning his wheels and replacing the removable studs. In this sequel he provides a photo record of how he refurbished his wheels. (Jan 10)

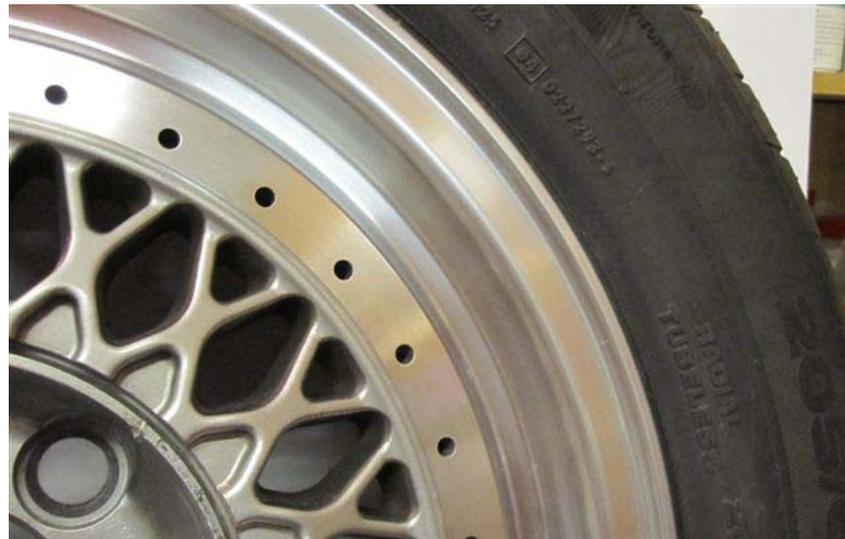
Studs removed and stripped

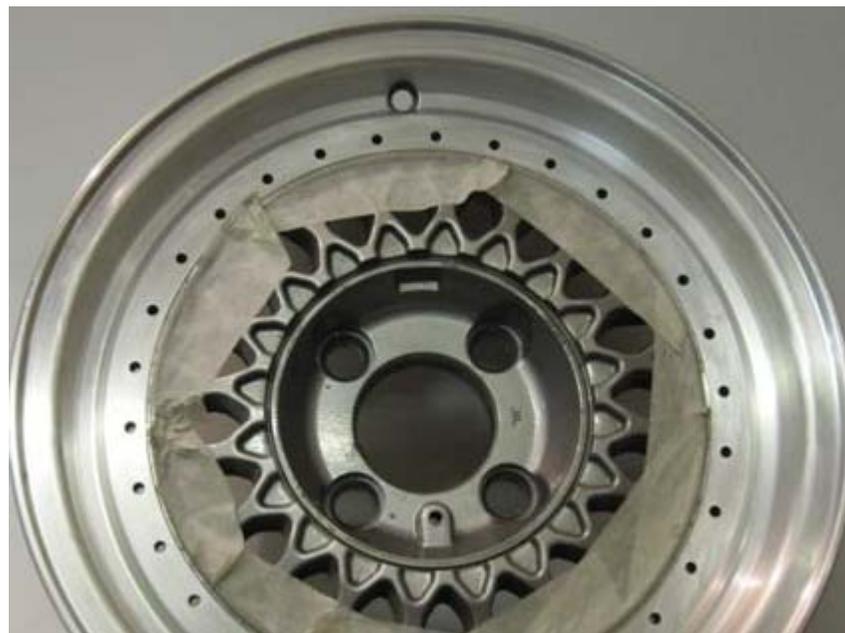
Masking tape protecting centre section which is not to be stripped

- Remove tyre and air valve.
- Apply the Nitromors paint and varnish remover.
- Clean the wheel with Rustins grade 1 wire wool.
- Finish with wet and dry 400 through to finest 1200 paper.
- Polish up with Autosol chrome, aluminium and metal polish.
- Buff with electric drill and mop.

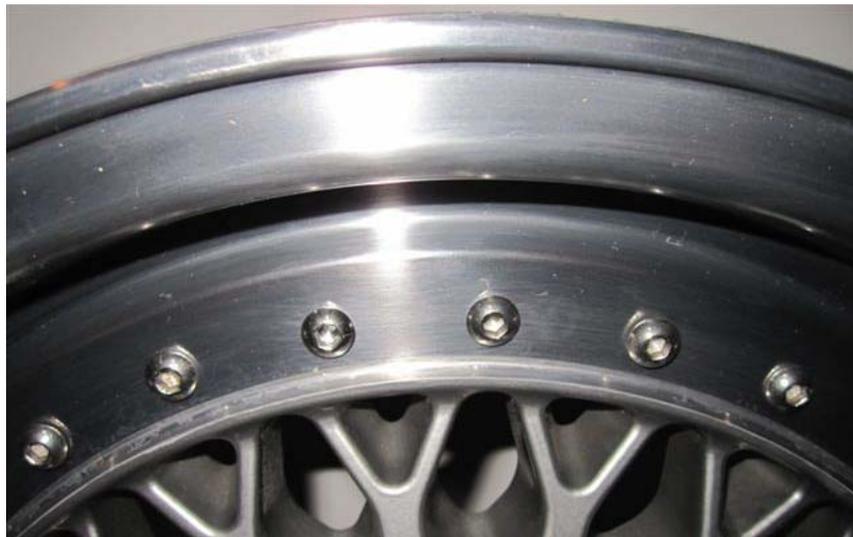
Socket Button Head stainless steel bolts (M6 thread x 20mm length) which I prefer to the original studs as I feel they are rather angular in shape and ugly. The problem is whether the alloy and stainless steel will mix without problems over a long period? Angus Munro suggests "this could be solved by the use of a nylon washer between each of the stainless bolts and the aluminum surface."

Angus Munro says the problem of, visible to the eye, intermetallic corrosion could be solved by the use of a nylon washer between each of the stainless bolts and the aluminum surface.

I assume that Hugh intends to use Nylock nuts to retain the Stainless Steel set screws. With the number of set screws and Nylock nuts involved this would be very expensive however with the use of plastic washers to the head of the screw and the face of the retaining nut the amount of force required to tighten the screw will have to be light or the washers will deform or crush. This is the ideal application for a Nylock nut as the screw and nut can be lightly nipped and yet be certain to remain connected.

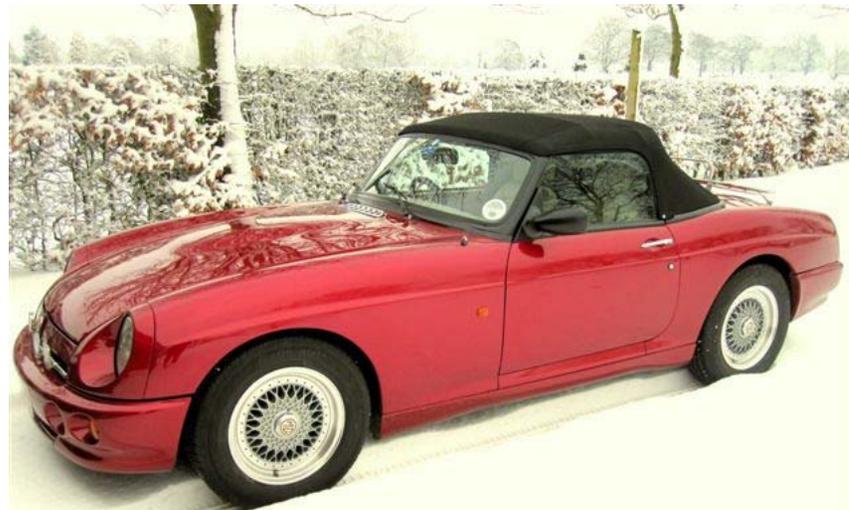
Completed job – Hugh says "the Nightfire Red colour has been adjusted to show off the wheels"

I am leaving the original studs out and not re-lacquering for the time being, hoping to be able to keep them clean with polish and/or the 0000 wire wool.

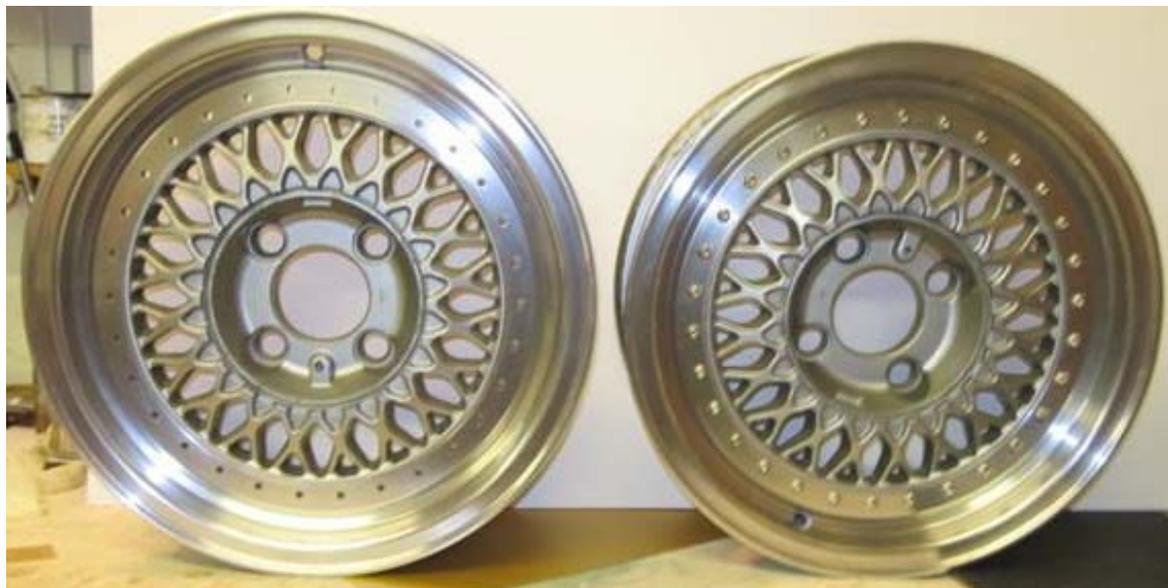
Left: stripped wheel without studs. Right: fitted with socket button head bolts.
