MGB V8 Roadster restoration project – Report 49

Mid June 2016

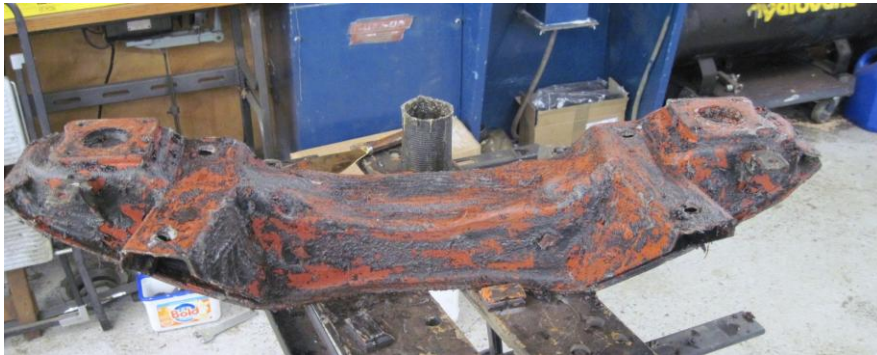
More hard work with the muleskinner to get the paint and rust off the crossmember.

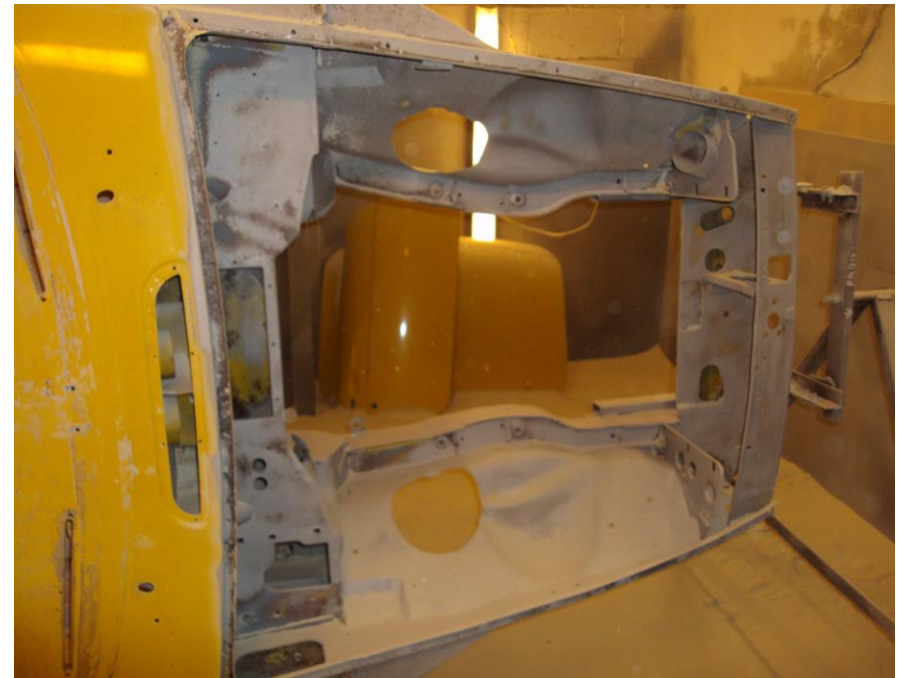
SBL had the shell and the 'spit' to make life easier for them to blast.

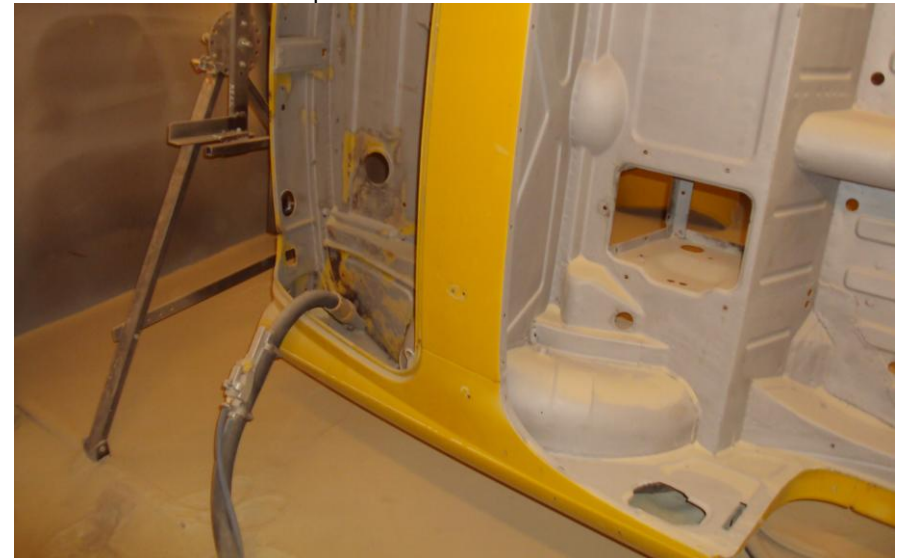
The old paint soon comes off. If all the old yellow paint comes off there may be no reason to stay with the yellow. Perhaps I may change the colour?

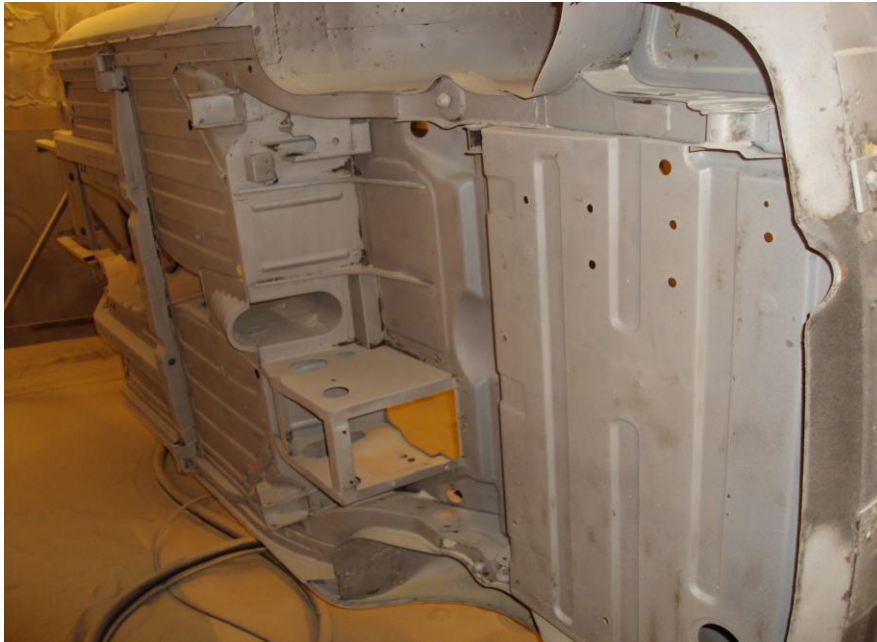
The underside of the shell starting to look nice and clean. I think the soda is used first and then some blasting media used to clean up any rusty bits.

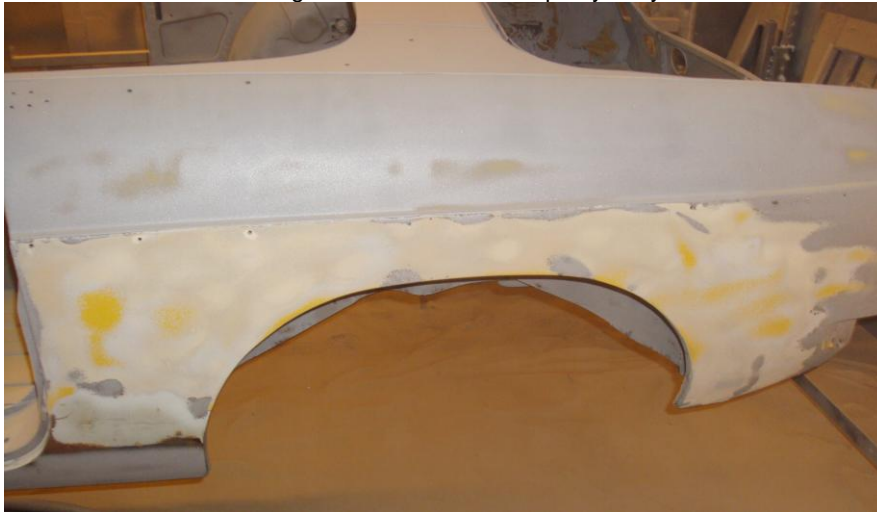
Apparently, body filler is a bit of a problem to remove with soda and blasting media. SBL did clean this area up to bare metal.

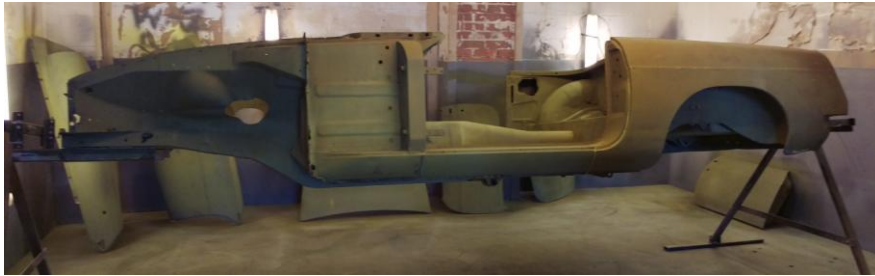
The bodyshell etch primed to stop the clean metal going rusty.

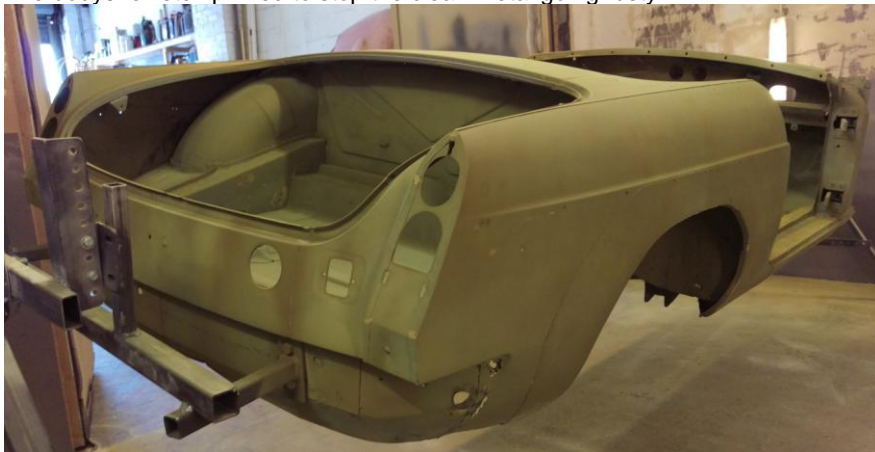
They coated inside and out with etch primer.

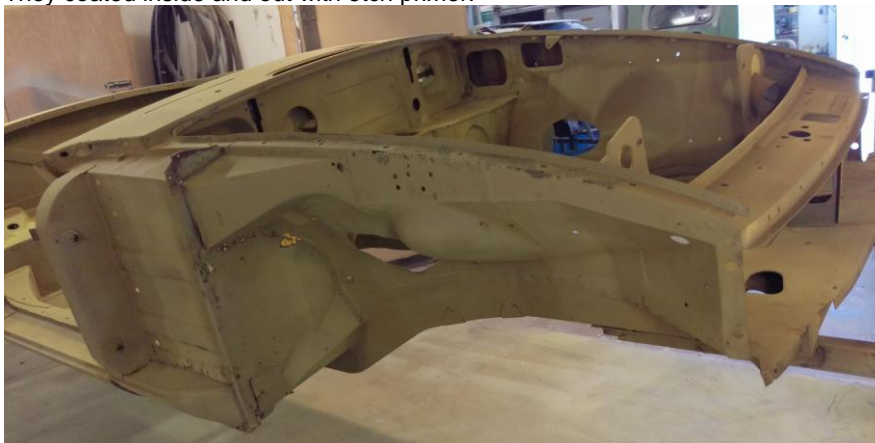
The bare bones of the bodyshell. SBL, blasted, etch primed the two doors, both front wings, bonnet and boot lid. I asked them to etch prime the shell so that it would not start to go rusty. They also, free of charge, painted the shell in 2-pack primer as they said "It came in yellow; we did not want it to go back yellow!"

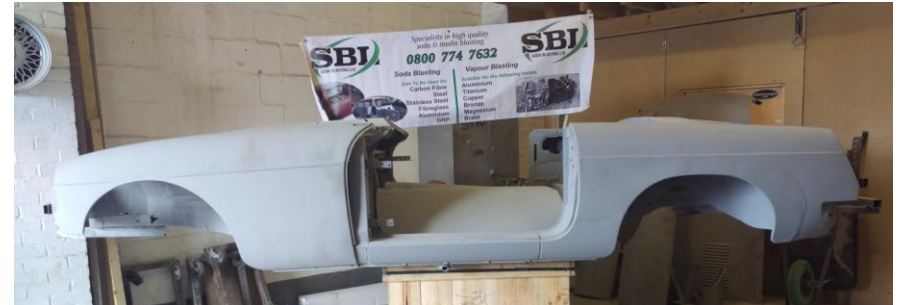
The front wings are just resting on the inner wings in this photo.

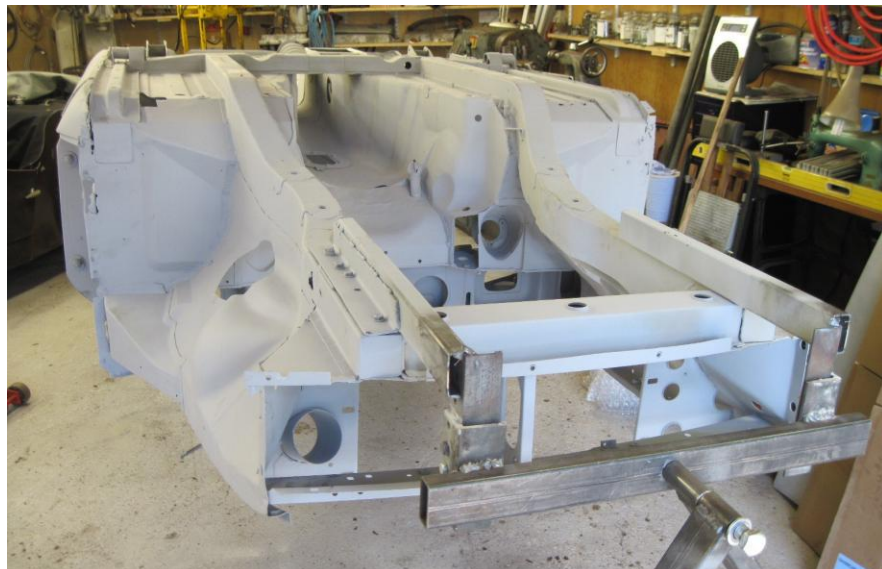
The bodyshell mounted on the spit and turned upside down. Just to prove the shell does rotate easily.

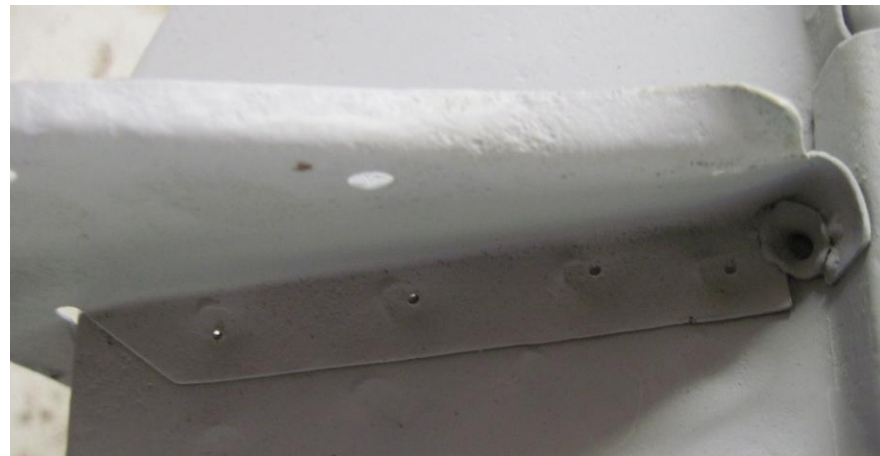
OK, let's get down to some work. Centre punch the spot welds.

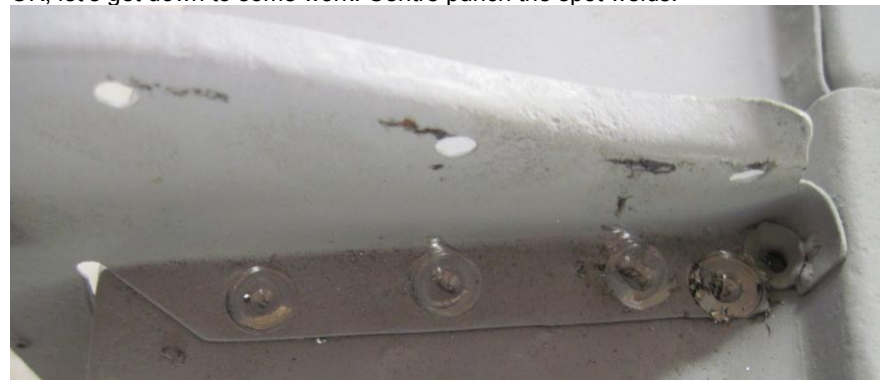
Drill out the spot welds with a cobalt 'spot weld' drill.

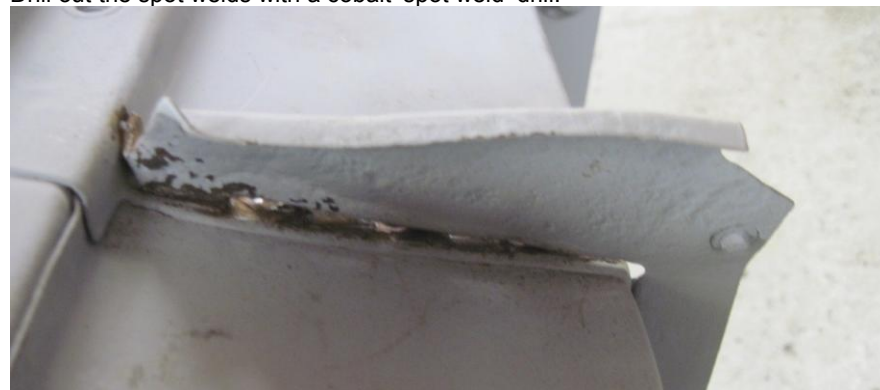
Use a chisel to start breaking the rusty part away from the top of the inner wing. Any comments, suggestions to mikemacartney@btconnect.com 18th June 2016
