## Further progress with an MGBGTV8 restoration Michael Pancheri has sent in photos and a report of progress with his restoration.

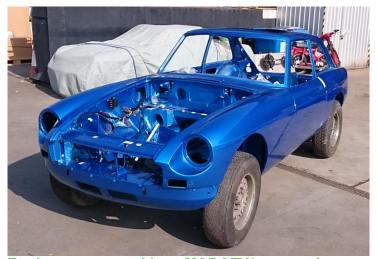
Michael reports "a brief update on the restoration of my V8. The body has now been painted and all panels assembled except for the bonnet and tailgate which will be fitted later. The undercarriage at both ends has been fully overhauled and refurbished, and mounted to the body, and the engine rebuild has been finished and tested. All five original Dunlop composite wheels have been refurbished and are ready for tyres.

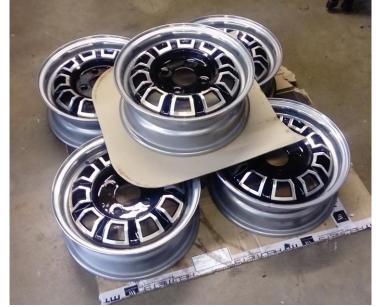
A start has been made to installing the wiring loom. This is the original loom which has been stripped, cleaned and reassembled with new bindings. Attached are photos of the wheels and the engine on its test rig. It was great to hear it running again. The original cast iron manifolds are fitted for testing, but the offside manifold is damaged (it always seems to be the offside one) and she will be fitted with stainless steel manifolds which will fit inside the original inner wings, rather than through them.

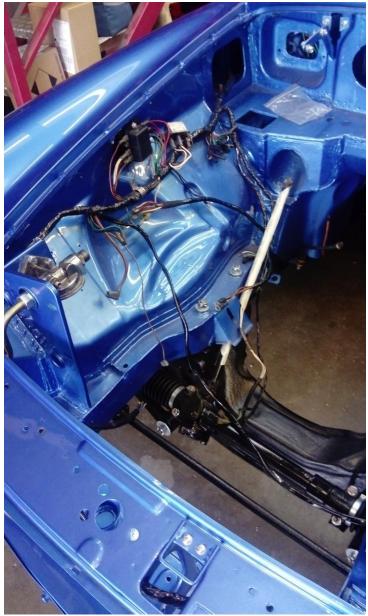
There are also a couple of photos showing the engine bay being fitted out, and the body out in the sunshine sitting on borrowed Scimitar wheels.
