Frustrations with tracing and solving a starting problem

Dave Wellings (Black 0974) from Yorkshire describes a frustrating route to solving a starting problem on his MGBGT V8. But it's a tale which fellow members could very usefully recall should they ever meet similar difficulties. He also mentions some very useful tools to help remove the starter motor with the manifold and column in place.

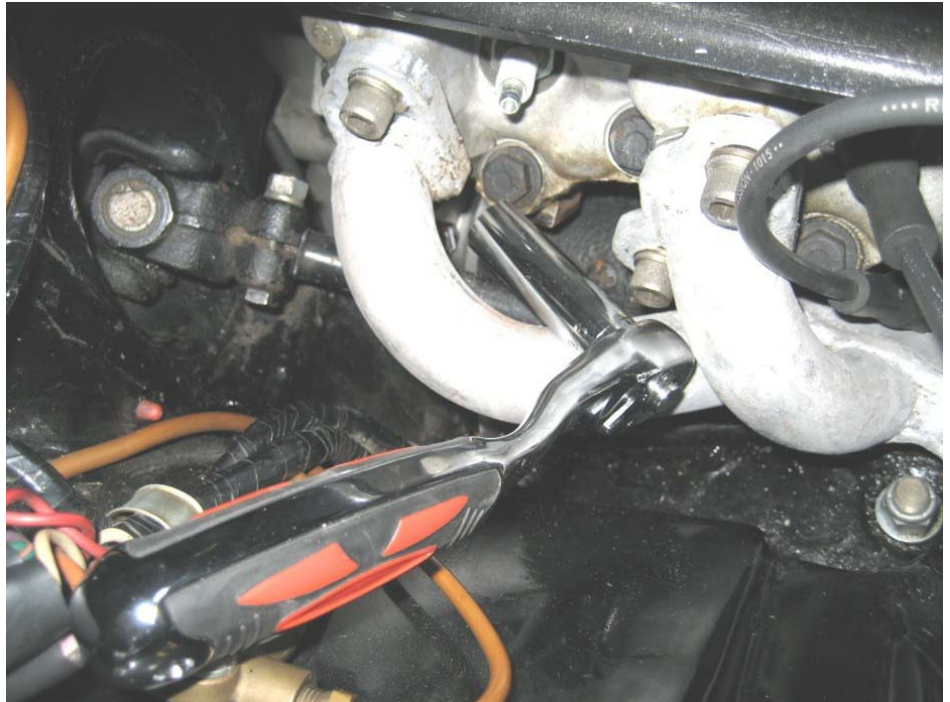
Socket in position - the shiny cylinder just above the steering U/J pinch-bolt nut is the socket in position, and this is the alignment required for an open ended spanner to be applied.

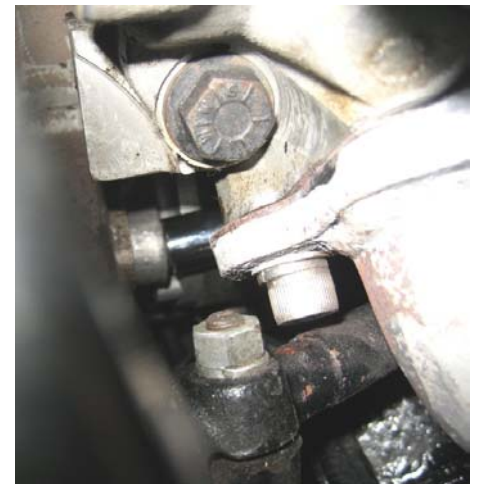
Extended reach socket - this photo shows the length of the extended reach socket in relation to the access.

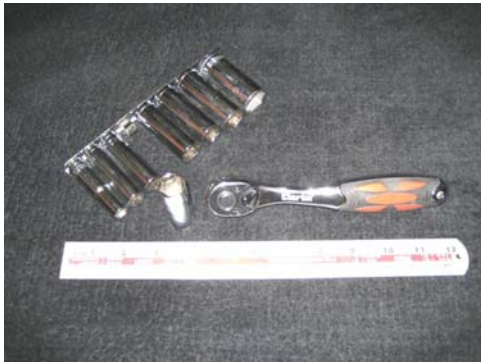
New socket set and Clarke handle in all its glory.

In the meantime I'd been onto the Machine Mart site and ordered some **special tools to help do the job** - a Clarke fine ratchet 3/8 drive socket handle (PRO131 Clarke 72 tooth pro ratchet (code 040215131), and a set of long reach AF sockets (PRO35 8 Piece 3/8 drive - deep AF socket set - flat drive code 040212467).

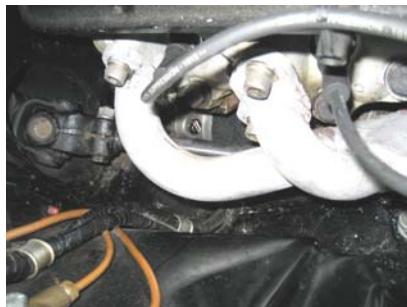
Shows the upper starter motor bolt, centre of picture with the screwdriver slot shown in white. Note the proximity of the upper column.

The **starter motor** has not been off since I fitted it in 1992. I didn't know at that stage whether it would come off without removing the right hand exhaust manifold or the steering rack and lower column. The upper starter bolt was a real challenge. No question about that. It's 9/16ths AF, by the way, and should have a screwdriver slot in it, (as original) which is no use whatever in that position since all horizontal access is blocked by the manifold (mine is a Janspeed tubular system) and upper steering column. I got this top bolt out with an open ended spanner right up against the bulkhead, one flat at a time. It was touch and go, and difficult to get started.

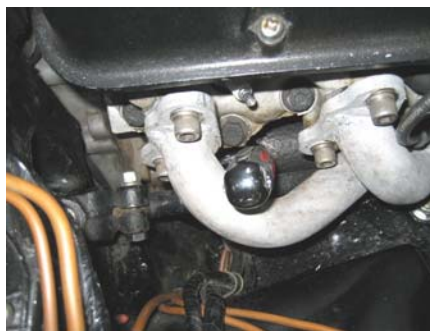
This shot shows the ratchet handle in position with socket engaged. The handle is at the bottom of its travel, and can move up almost as far as the spark plug electrode.

All arrived just in time for the refitting the starter motor. The motor slotted back in. Note that it's a heavy weight to handle with one hand and in a very restricted space. It helps to temporarily remove the rubber cap which protects the end bearing. Cover the end temporarily with masking tape. I fitted the lower starter motor bolt and tightened as 'finger tight' as it would go. Then I used my new ratchet handle with the long reach socket which just fits between the exhaust manifold between the third and fourth cylinder on that side. Using a screwdriver with my left hand to stop the bolt unwinding on the ratchet stroke, this arrangement worked really well, a couple of clicks at a time until the bolt was tight. All power was re-connected and finally **'Daggadaggadagga'.**
