### Rebuilding an MGBGT V8

### Strengthening a V8 gearbox

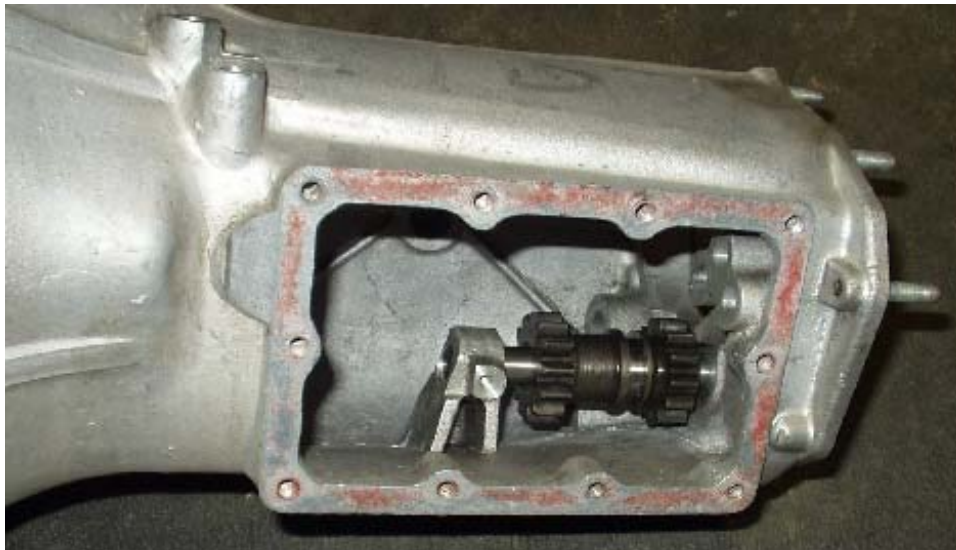
The photo of the main casing clearly shows a weak point. Looking through the side access plate you can see the support pillar for the reverse gear shaft. Notice how it attaches to the bottom of the casing. During my training as an engineer,

I was taught that there should always be a radius at such joints. The larger the radius, the less likelihood there is that the joint will fracture. So far as I can see, there is no radius at all, so the local forces would be extreme.

I have seen several V8 gearcases with hairline fractures on the outside, corresponding to the location of the support pillar on the inside, and my local MG specialist assures me that he has seen a few where the entire pillar has ripped out, complete with part of the casing. I intend to get a local specialist to provide fillets of alloy weld around the base of the pillar to provide additional strengthening.
