### Wipers failed? – test the relay as well as the fuse

### Warning with V8s fitted with an RV8 front suspension and crossmember upgrade

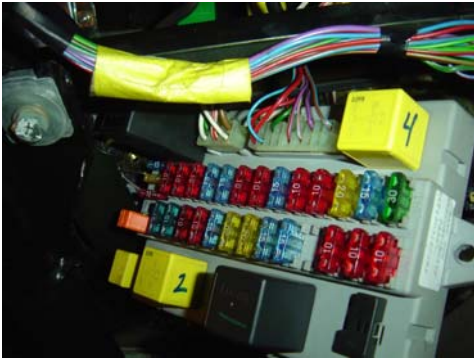
Simon later reported he had installed the new relay/control unit but the wipers still failed to function. Working with the workshop manual wiring diagrams, he determined the power routing ran through the ignition relay (#4 on the fuse panel) through the #15 fuse and then to the wiper control unit #8. The fact that there was no power showing at the #15 fuse confirmed that the #4 relay was

suspect. By switching the #4 relay with the identical one at position #2 (cooling fan), this activated the wiper/washer system. These relays are a common, 4-terminal relay (fortunately) available at any auto parts supplier.

So, if your wipers fail, check the fuse first, then the #4 relay and if those are good, then the wiper control unit on the back of the fuse panel (#8). Wiper control unit is part number YWC 10152.
