## Solving loose exhaust manifold bolts or studs on a Rover V8 engine

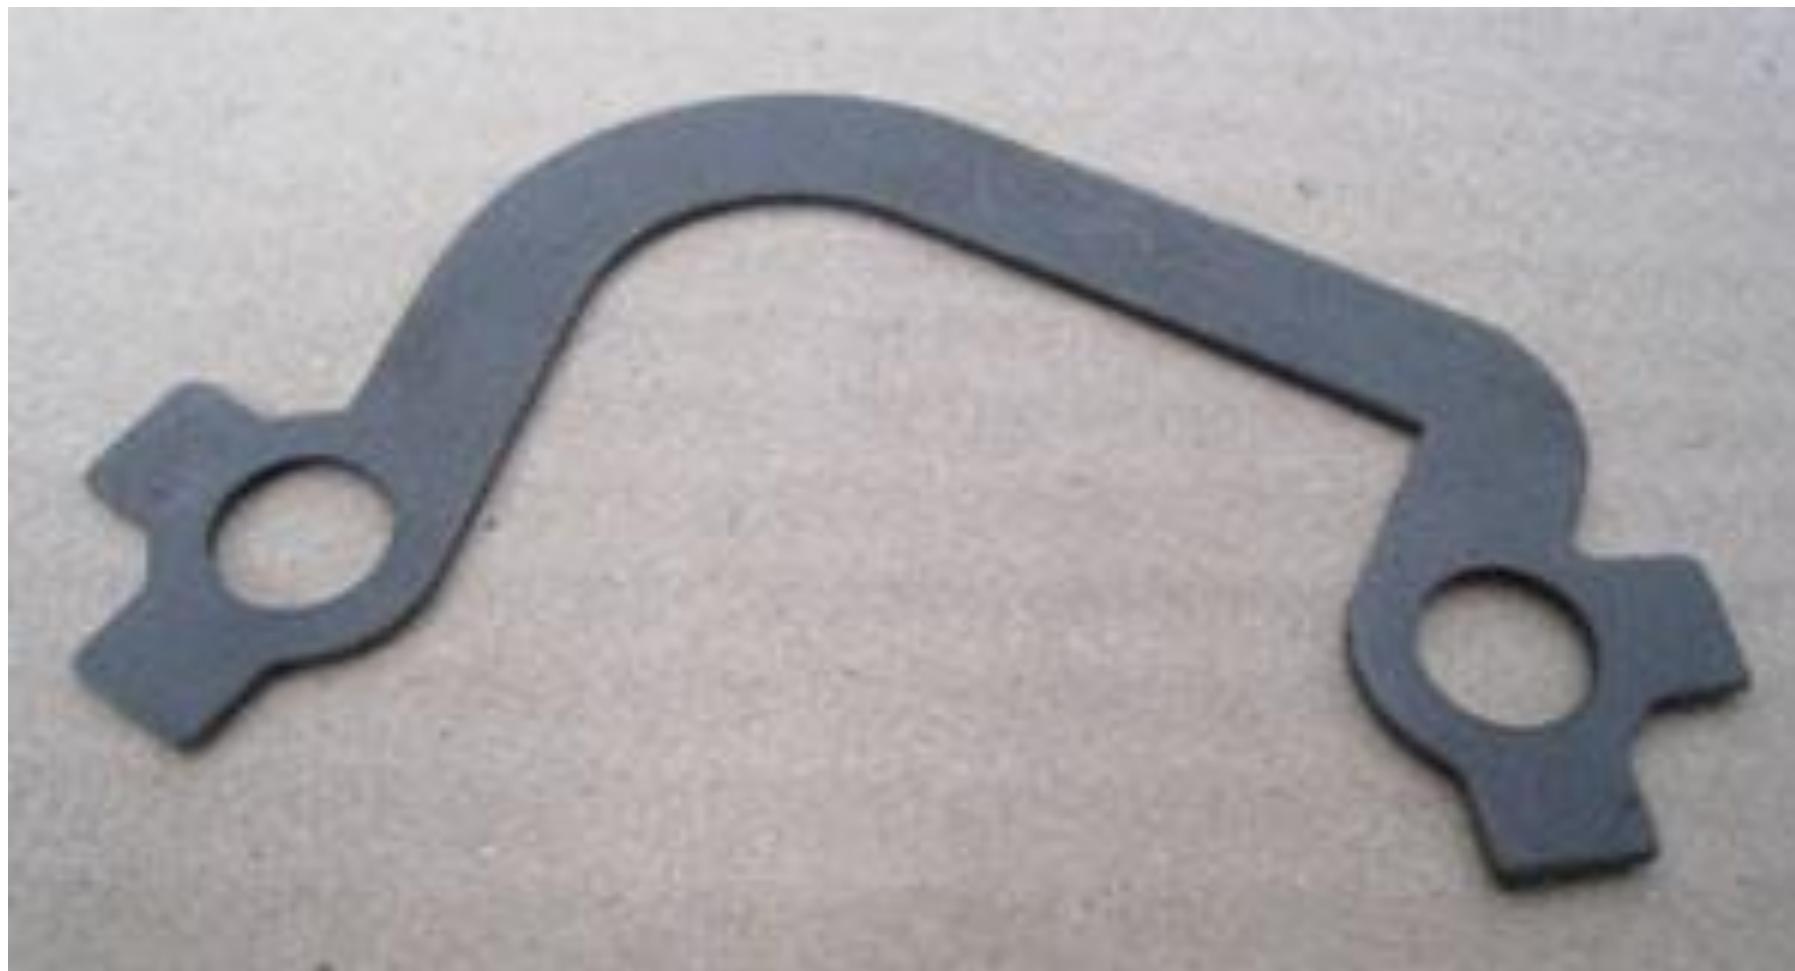
**Jim Gibson** added “I think the original spec has plain washers for the manifold bolts but it's been a while since I looked. I've seen suggestions that spring washers might weaken when heated, but I don't know how true that is. So, might I suggest Rover Part No. **602951**, or Land Rover Part No. **ERC7321**. After refitting the manifolds, you might want to wait until the engine has been run a while before a re-tighten of the bolts and bending up the tabs.”

**Geoff King** helpfully provided a link to the LRDirect website where there is a **photo of an ERC7321** at [www.lrdirect.com/ERC7321-Manifold-Locker-Rr/](http://www.lrdirect.com/ERC7321-Manifold-Locker-Rr/) which is available at around 60p. He added “John's car has apparently been fitted with studs so his car may have a history of a problem with the standard exhaust manifold bolts. The Rover SD1 and Range Rover used locking tab washers and if the bolts (or nuts on studs) are becoming slack the locking plates may prevent this.”
