The importance of the seemingly insignificant – breather pipes on an SU fuel pump

Peter Cook highlights the need to ensure the breather pipes are connected to the vents on an SU fuel pump to avoid the ingress of water. Here he explains.

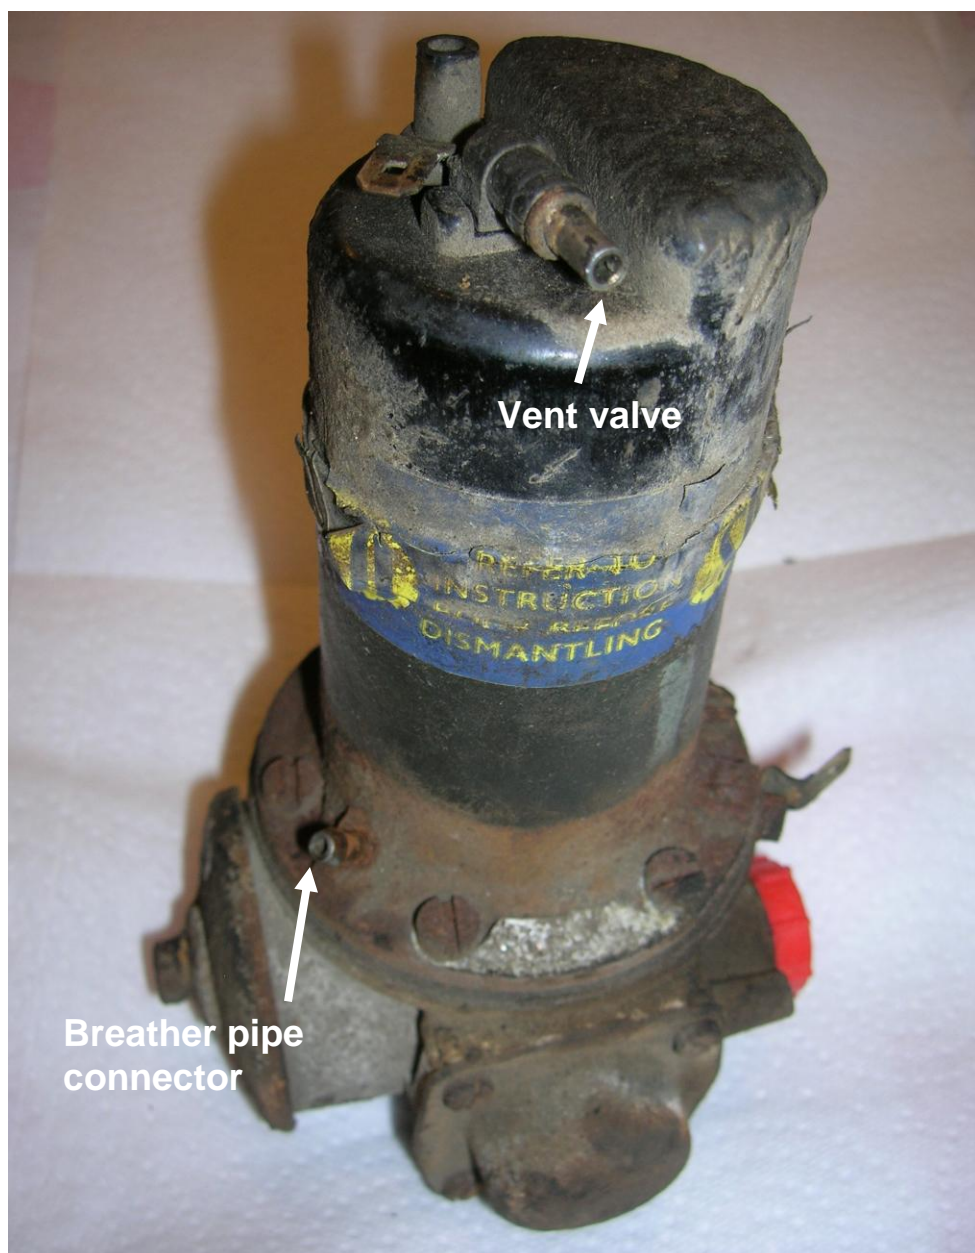
Further dismantling revealed the cause. Inside the main body the diaphragm assembly seemed fine until it was removed when a large amount of rust was discovered inside the main body of the pump, the coil housing. It was apparent that the armature spring, the spindle and the diaphragm backing plate were all seriously corroded. The accumulation of rust and the rust on the

spindle meant that the spindle's up and down movement was seriously constricted. Eventually the spring would have been the first to disintegrate completely such was the severity of the rust. Most of the components have to be pure steel given steel's magnetic properties so a stainless steel or brass solution is not possible.

So what had caused the rust? The answer is that whenever the pump had been fitted, although the plastic vent pipe was correctly fitted to the vent on the pump, the rest of the plastic pipe was loosely wrapped around the adjacent battery cage. Therefore as the vent operated, especially in heavy rain and on sodden roads, it had been drawing in moisture from the outside which was then rusting the pump's innards. The correct destination of the vent pipe should be through a grommet in the spare wheel area about six inches to the left of where the wiring loom enters that area. The plastic pipe should be topped with a 'T' piece as is used on the windscreen washer assembly. This way the pump can breathe but does not ingest water.

Roger Williams mentions this in his book (Expert guide to MGB problems and how to fix them, published by Veloce) saying "the fuel pump on chrome bumper cars needs the two breather pipes. The top breather pipe (arrowed) was omitted from rubber bumper cars since the top vent was protected by the boot. Failure to use the airtight breather pipes applicable to your car will result in an ingress of water". That can then damage the fuel pump resulting in poor fuel supply.

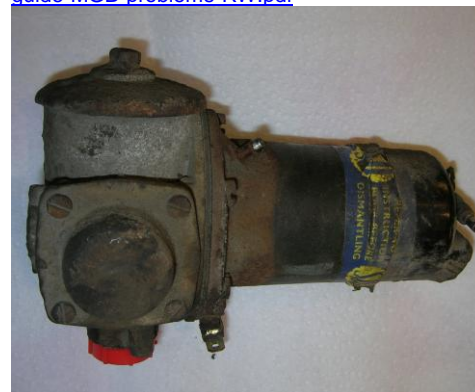
Fuel pump on a chrome bumper V8 needs the two breather pipes
