V8NOTE569 - keep your back axle breather clear to avoid moisture build up

Keep your back axle breather clear to avoid moisture build up

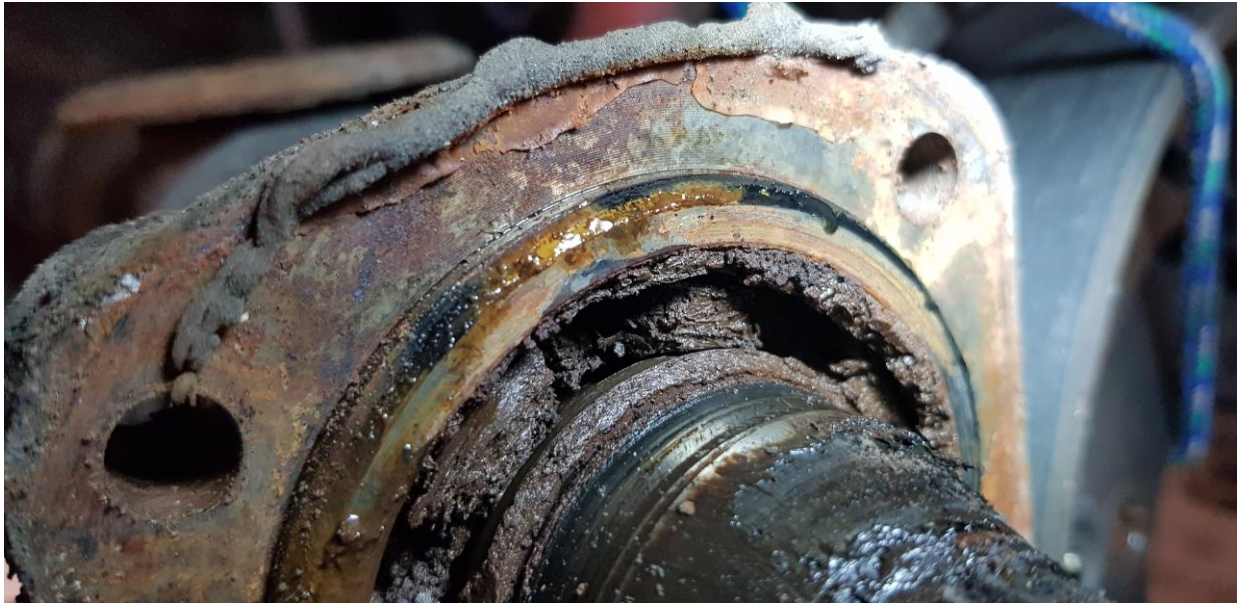
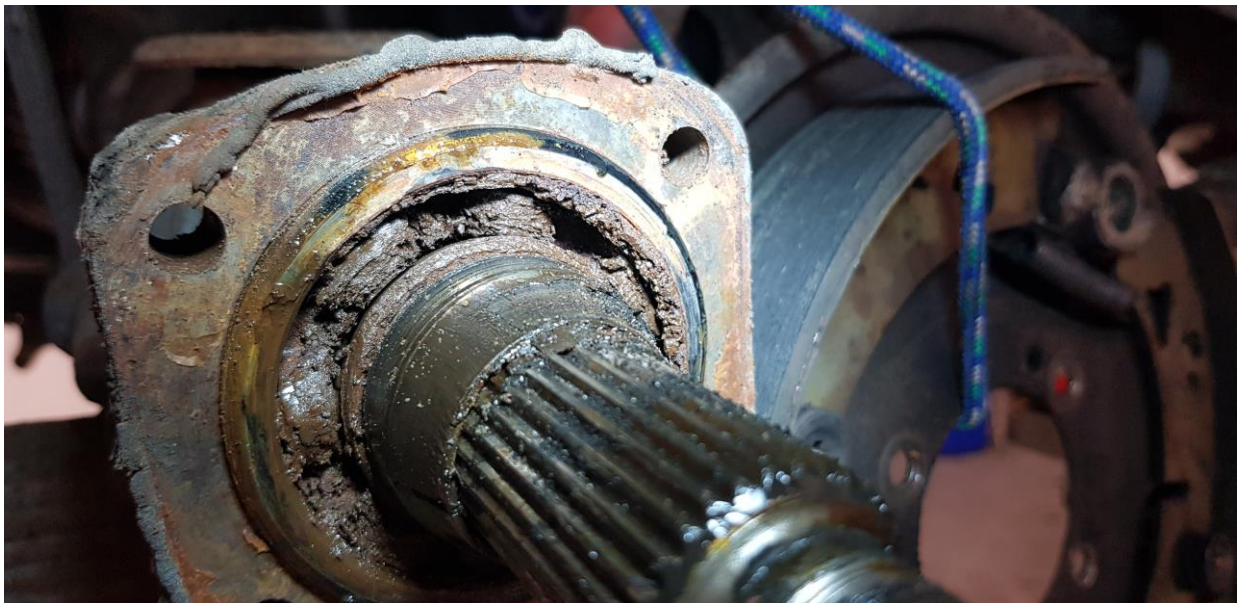
Ralph Hardwick recently purchased an MGBGT V8 and dropped it off with Brown & Gammons for a check over and service during which Ralph reports "they picked up a few issues, so it will remain there for a while until they are sorted. One issue they found was it appears that the rear axle breather was blocked - the resulting condensation build up together with having only covered 1,000 miles in the last seven years, has caused some corrosion and bearing issues".

See V8NOTE498 contributed by Derek Squires recommended checking your back axle breather is not missing and replacing it with a brass item which is much more durable. [V8NOTE498](#)
