### Restorations of Dunlop composite wheels

## MGBGT V8 road wheels – a design overview and salvage prospects

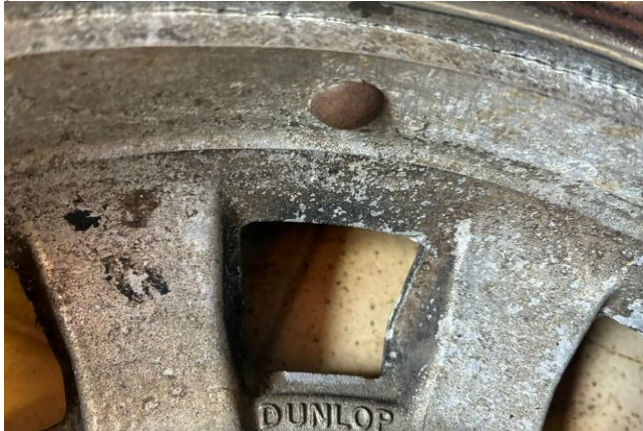
Cast aluminium centre is riveted to a rolled steel rim with iron rivets which create a galvanic corrosion risk

- **Joint geometry.** The fit at the interface between rim and centre is critical to load transference. Any loss of clamp force can cause fretting from cyclic loading. The presence of ten rivets also introduces a risk of air loss.

- **Dissimilar materials.** The combination of iron and aluminium creates a galvanic corrosion risk, particularly in the hostile environment experienced by a road wheel. [Link galvanic reaction](#)
