Rebuilding an MGBGTV8 – Damask 0450 (Part 20 of a series of reports)

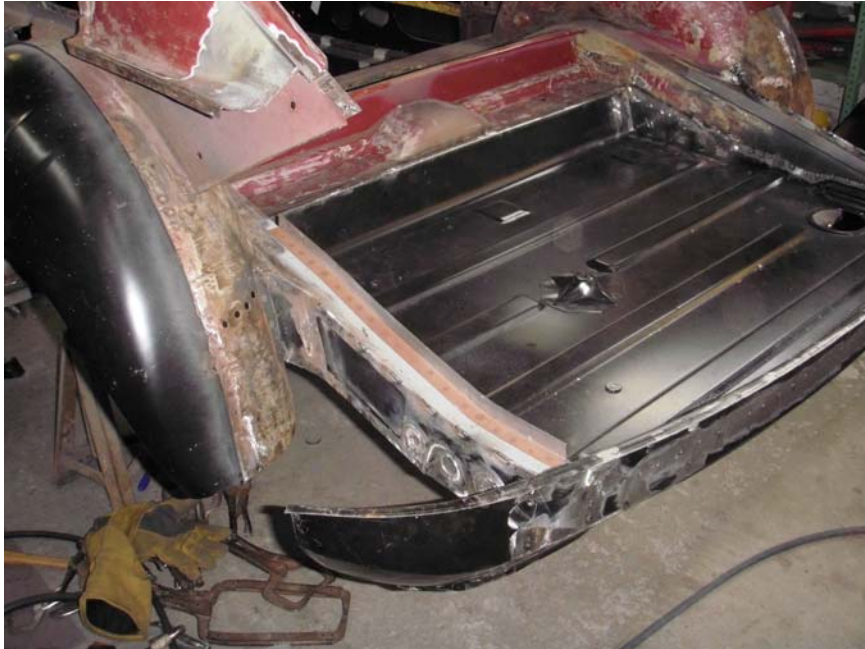
Inserting the boot floor was found to be easier with the whole of the rear bodywork removed from the shell. This also gave good access for welding the outer closure plates to the rear chassis extensions.

Note the extension to the inner wing which I am trying out. I am surrounded by farms, so the roads around here get very muddy, and I have a continual problem with mud being thrown up into the rear valence. Hopefully, this will help.
