Rebuilding an MGBGTV8 – Damask 0450

Damask 0450 seen here advertised on eBay in April 2008, was bought by Barrie Jones as a restoration project.

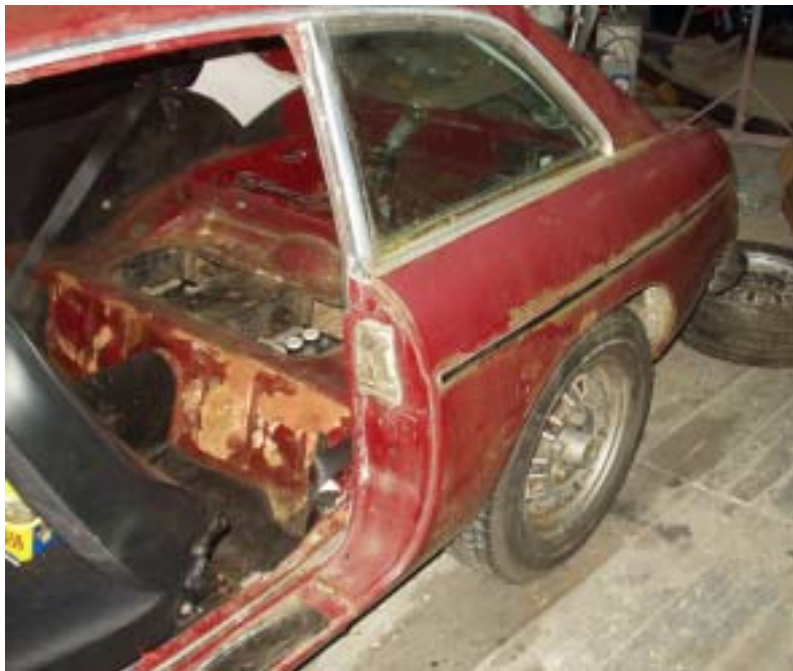
Battery box area from nearside door

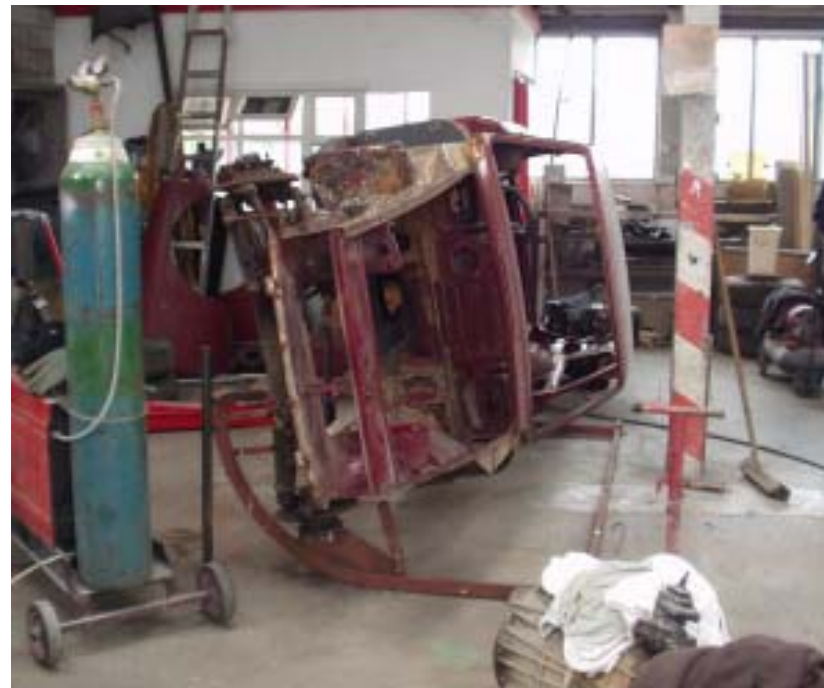
Installed in the roll-over cradle.

You may remember that I saved this V8 from the scrap pile. It was on eBay, with a shed blocking it into the driveway. Anyway, I have now stripped her down to a bare shell and all is revealed. The car is remarkably original, but with the usual rust in sills and the floorpans. For the record, overdrive engages on 3rd and 4th. I attach a photo of this car in a roll-over cradle.

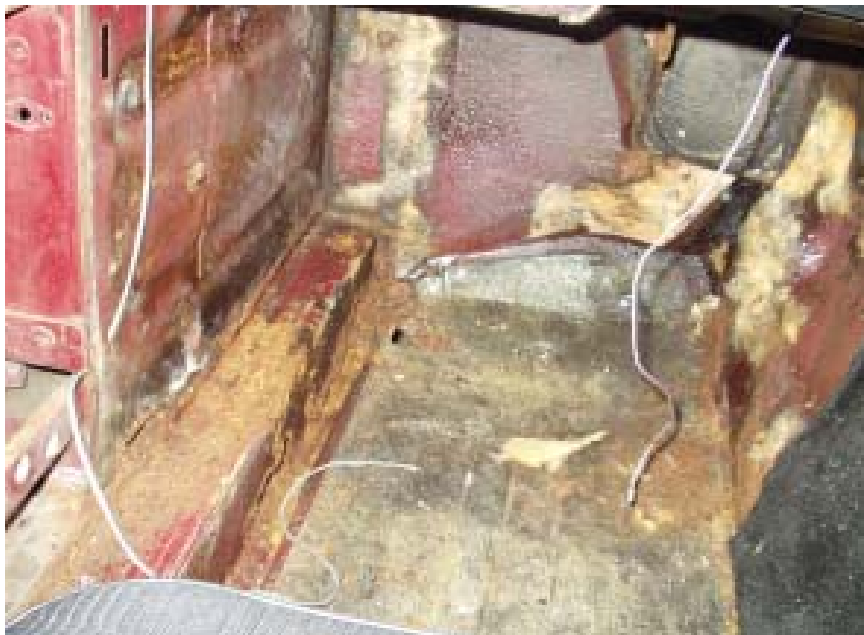
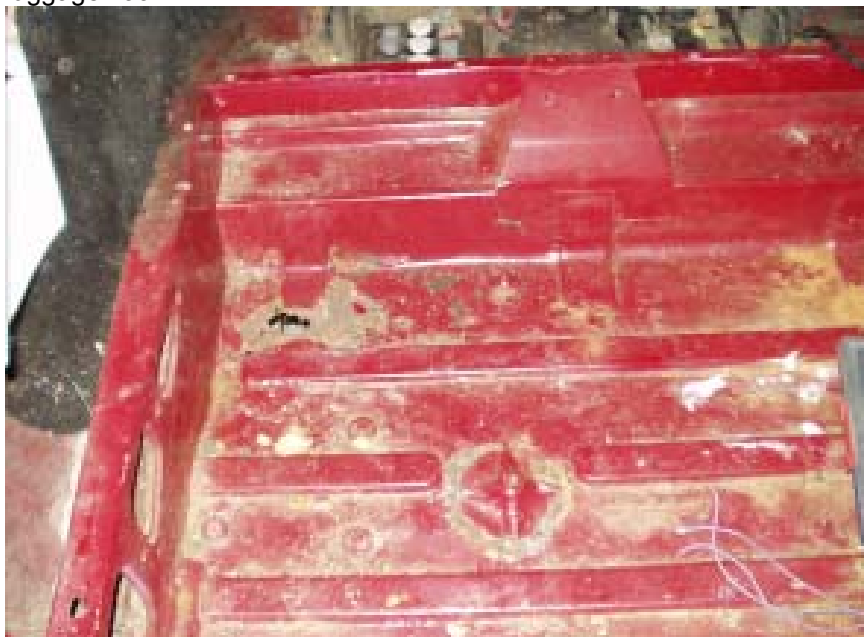
Above: Nearside legwell. Below: Spare wheel bay below rear luggage floor.

I attach early photos of Damask 450 during the strip down phase. In addition to the usual problems with holed sills, rotten castle sections and doors with no bottoms, these photos show that both of the inner sills are holed and it needs two new floorpans. I will take more photos as I progress. I have already noticed the chassis has holes in the jacking outriggers, one rear spring hanger, and the triangular reinforcement at the front of the rear spring.

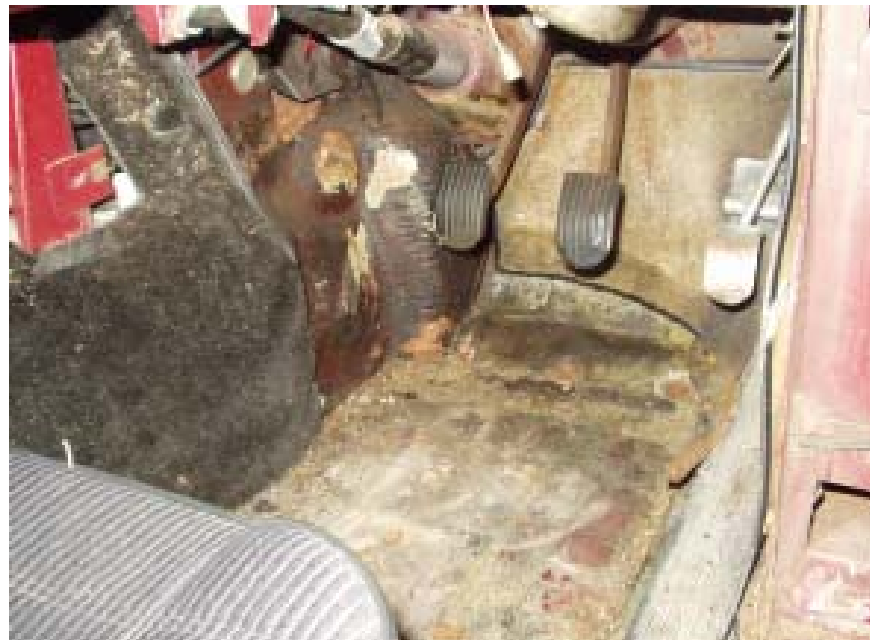
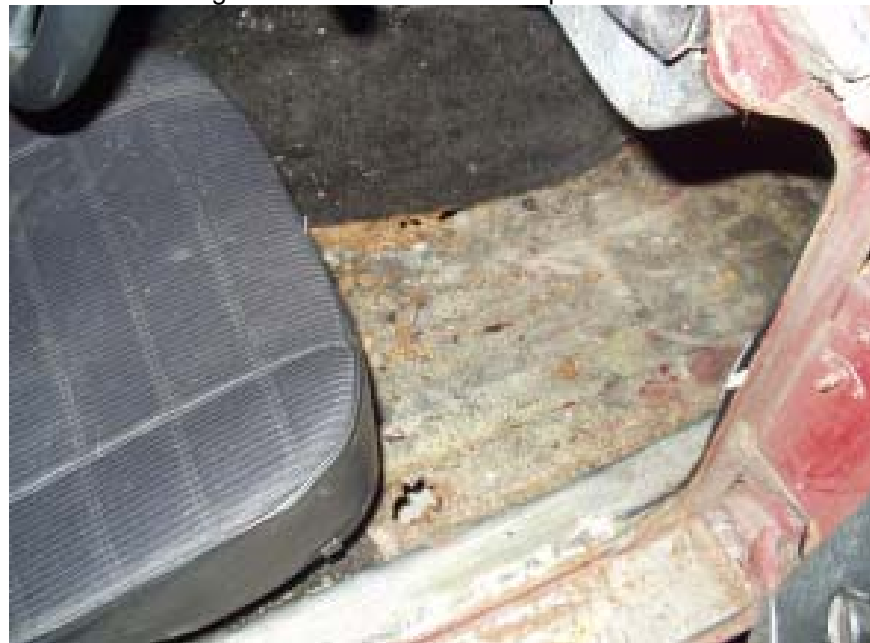
Above: Offside legwell. Below: Offside floorpan.
