Rebuilding an MGBGT V8 – Damask 0450 (Part 10 of a series of reports)

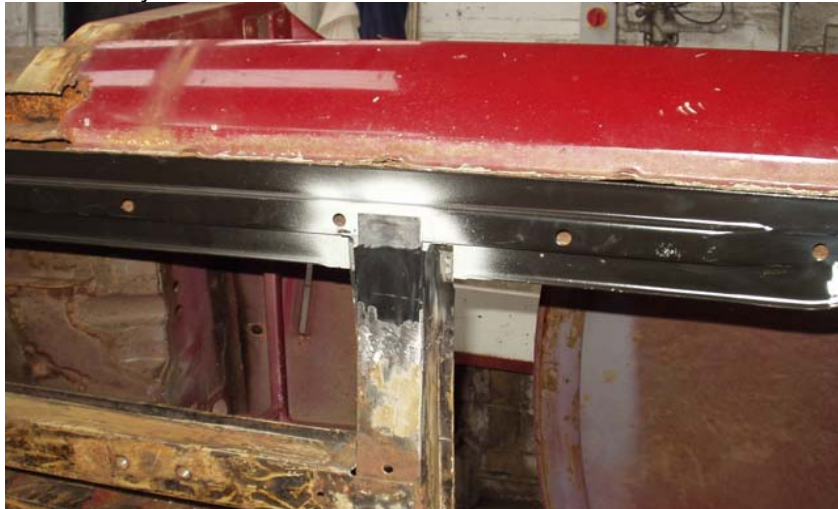
Nearside out-rigger replaced

Having removed the nearside inner sill and castle section, this area is now seriously weakened. Before proceeding to remove the outer sill it is necessary to weld in a new castle section.

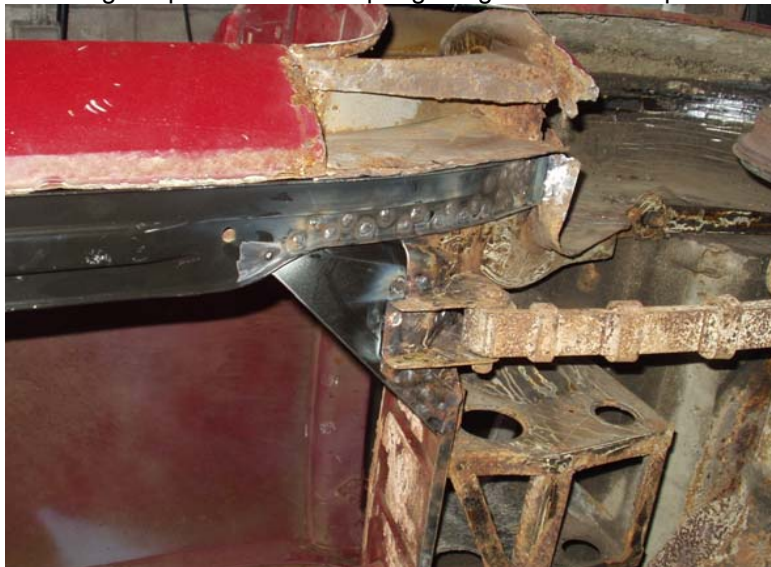
New spring hanger

In addition, the outermost part of the out-rigger has been repaired and the triangular plate under the spring hanger has been replaced.

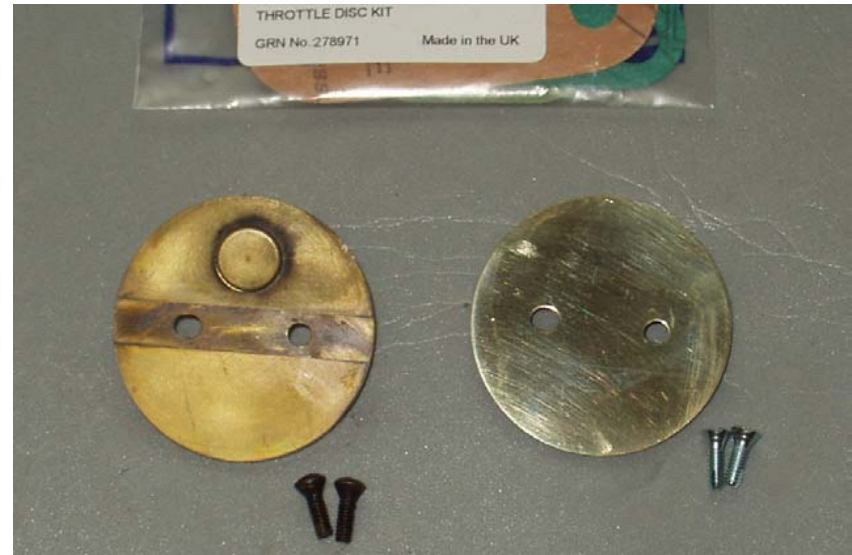
SU throttle discs

I have also been busy cleaning and restoring the SU carburettors. The throttle discs show signs of blow-by around the butterfly valve. Personally I do not like them, so I shall be replacing them with plain discs as fitted to the MGC.

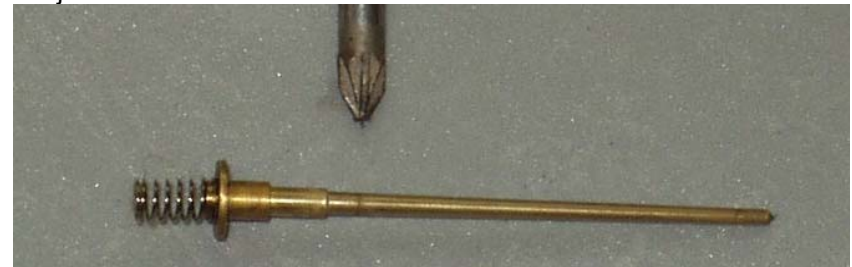
SU needle

Also, the metering needle has a distinct wear ridge all around it (in line with the screwdriver below), so these will also be replaced along with the jets.

This kind of wear can be adjusted out by raising the jets to compensate. However, if you do this, then the carburettors will be weak throughout their operating range, which would result in poor engine response and possibly overheating.
