Rebuilding an MGBGTV8 – Damask 0450 (Part 2 of a series of reports)

Rebuilding progress reports from Barrie Jones

26.7.08

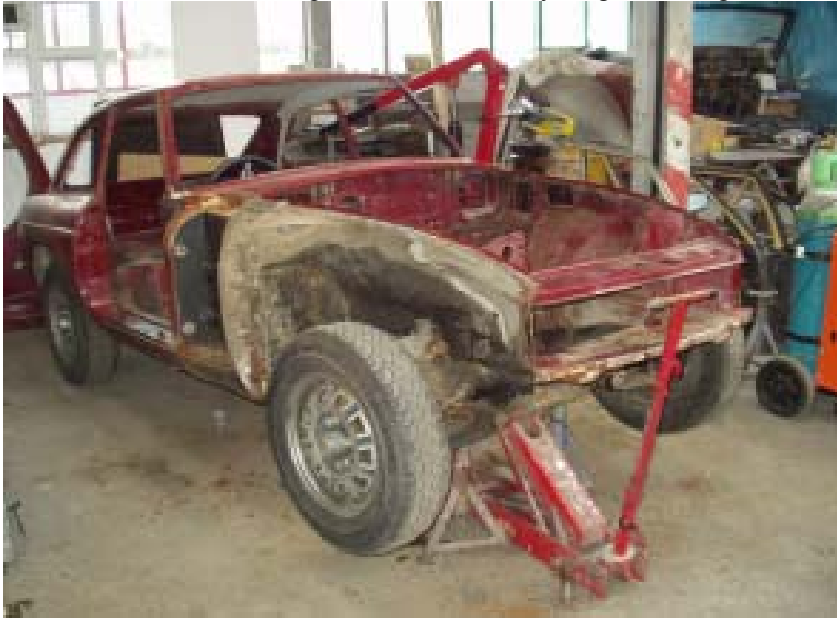
The first time I rebuilt a V8 I didn't remove the engine. Whenever I lifted the bonnet I always regretted that decision and I vowed never to make the same mistake again. This time everything is coming out.

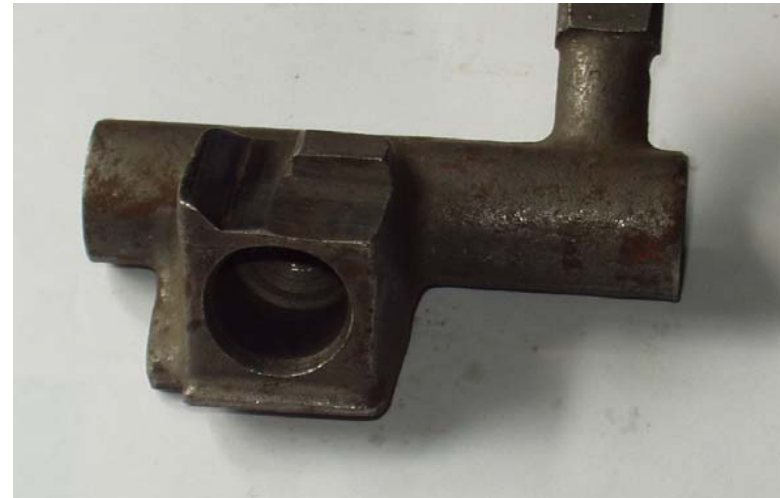
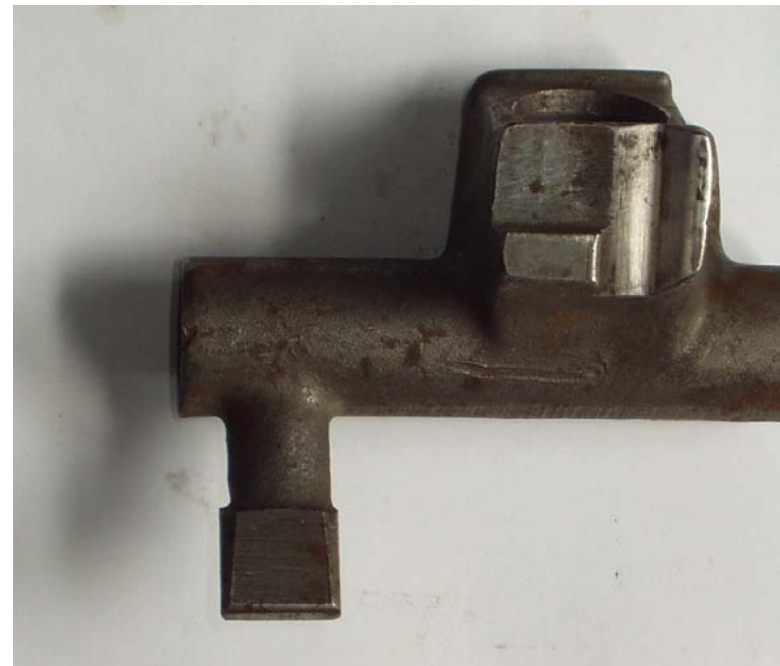
The **overdrive** unit contains a pair of gears that drive the speedometer cable. These are both made of nylon, and replacement of the larger gear is an engine-out operation, so this is the time to check and possibly replace them. When removing the overdrive unit, I noticed that the eccentric cam which drives the oil pump had slipped from its correct location next to a circlip on the output shaft of the gearbox. PANIC. This cam is keyed to the shaft by a tiny ball bearing. Fortunately, the ball was still in place. In 1974 the Factory modified the

gearbox to delete overdrive on 3rd gear. Apparently, this was done because so many overdrive units were being replaced under warranty. I have therefore decided to make the same modification myself.

The parts manual shows that two parts were changed. The selector lever 22B386 became 22B726, and the switch operating plunger 22B406 became 22B727. Fortunately, both of these parts are still available.

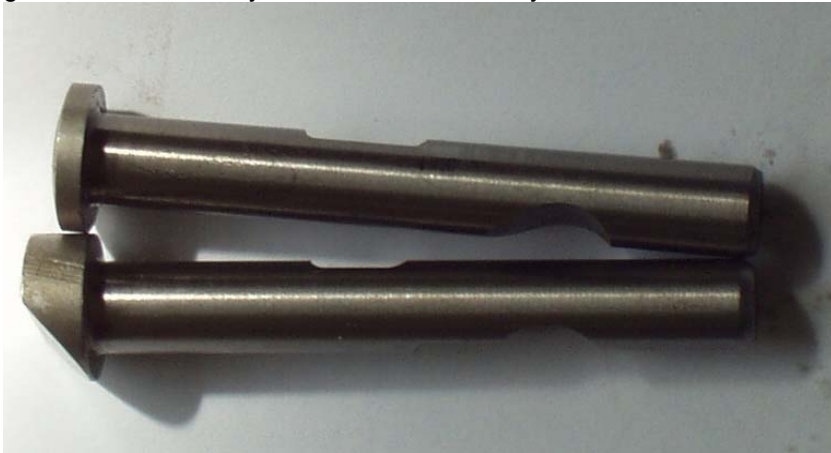
I have attached a photo of the old and the new plungers, showing that they are very different. On my previous Damask V8 I merely modified the selector lever, and it never felt right. Whenever you changed up from 3rd to 4th you could feel a baulking notchiness. Hopefully, the correct factory parts will feel nice and smooth. Time will tell.
