Rebuilding an MGBGTV8 – Damask 0450 (Part 6 of a series of reports)

This is the sixth report from Barrie Jones, part of a series on his major rebuild of Damask 0450.

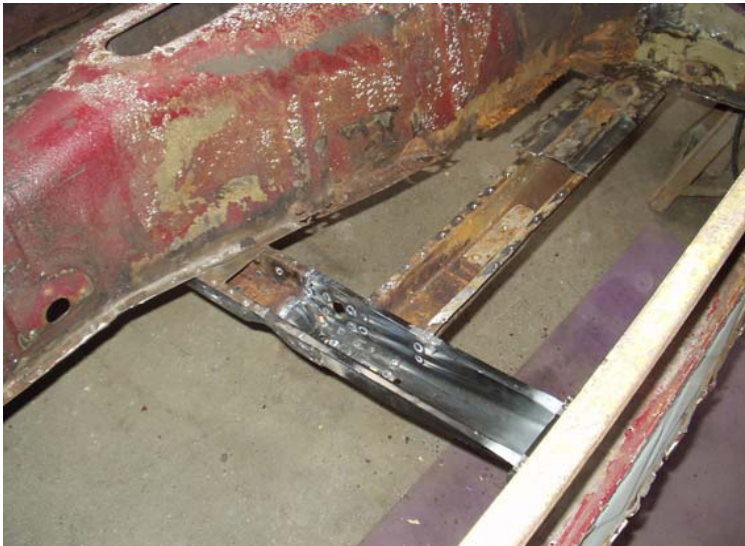
After a holiday break, work resumes on Damask 0450. The time has come to remove the outer sill on the driver's side. The floor pan has already been removed, so to prevent the shell from losing its shape a steel bar has been welded across the door frame as a temporary measure. Below is the view from inside the car . . .

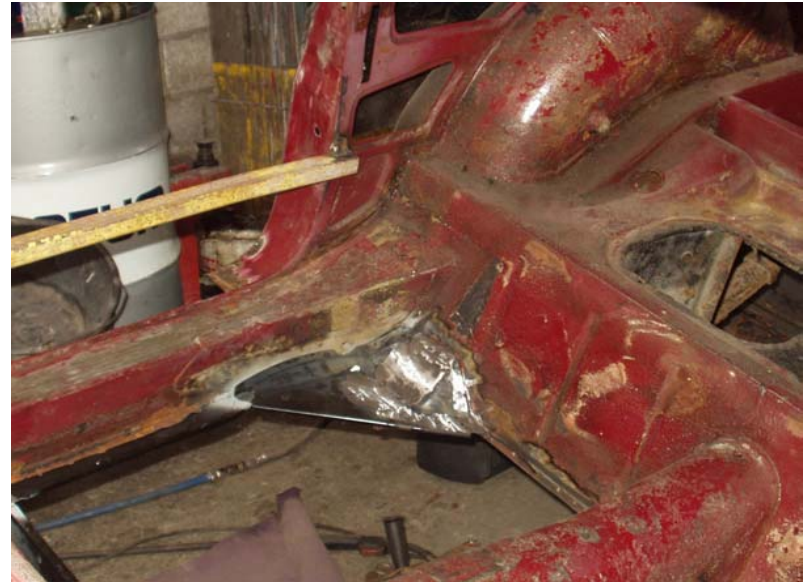
. . . and here we can see where the new spring hanger reinforcing panel has been inserted. The new floor pans will not be inserted until after the shell has been sand-blasted.

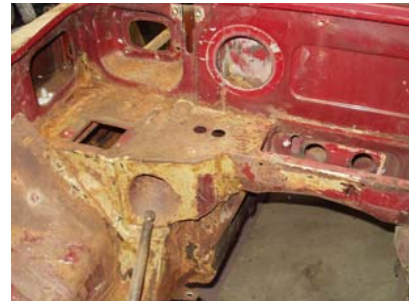
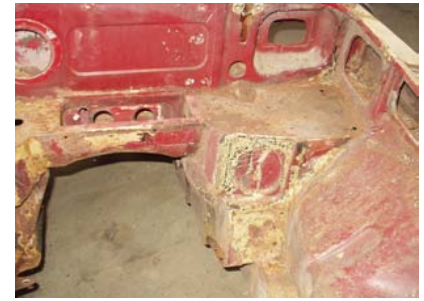
If you are considering modifying an 1800 shell to take a V8, you may find the following photos of a genuine V8 bulkhead useful. Note how the squared tops were chamfered back to clear the V8 cylinder heads. Note also that genuine V8 shells do not have any provision for LHD steering column or pedals.
