Modification to avoid a failed MGB bonnet catch

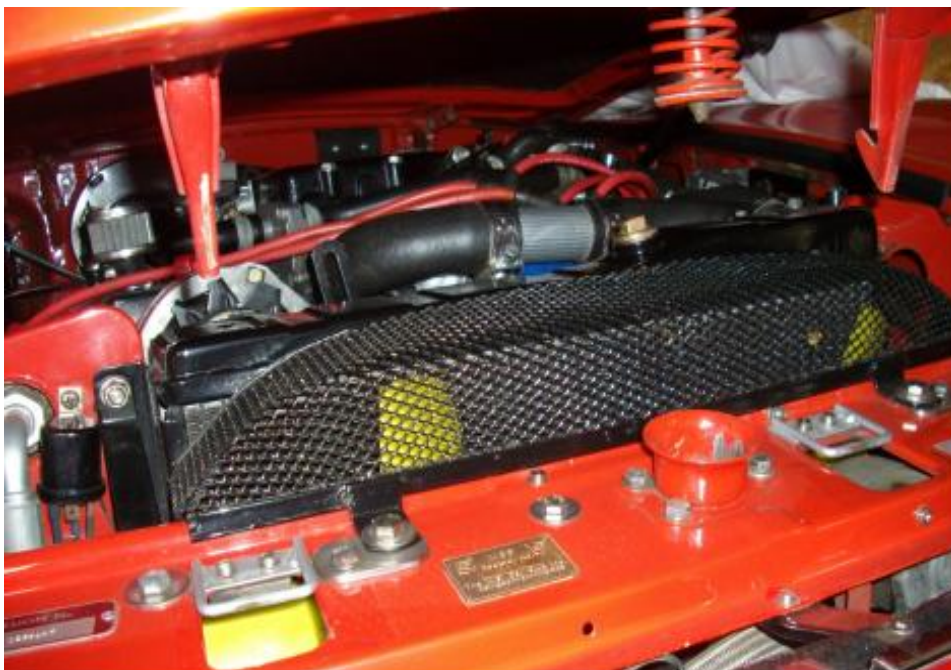
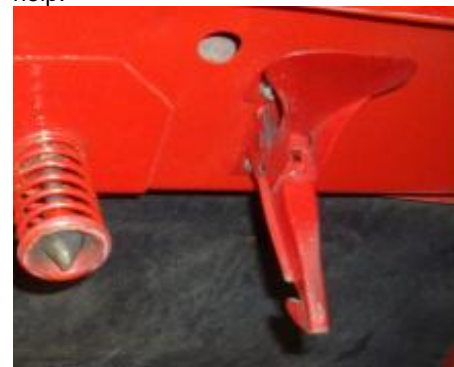
The photographs show the modification 'carried over' to my V8 Roadster Conversion, even though the Heritage body shell is noticeably stiffer. A Safety Catch and Ring Bracket are listed in the Moss catalogue and can be purchased for less than £30:00, plus a new release cable is only a further £8:95.

Installation is simple, requiring a rectangular aperture in the slam panel 'mirroring' the existing, then fitting the components using the original as a guide. Care must be taken when deciding the position of the new aperture, clearance must be allowed below for the safety catch. In my case the right hand cooling fan motor bracket dictated I position the aperture 8.5" to the right of the bonnet catch, centre line to centre line.

To secure the Ring Bracket to the slam panel, I fabricated a simple plate to fit

under the slam panel as this also has the advantage of spreading the load. The Safety Catch is secured using self-tapping screws backed up by a tack weld.

- Auto engagement when closing the bonnet.
- Raising the bonnet is simple. Just use both hands, tip the safety catches and 'up she comes'.
- In the event of involuntary release, the bonnet remains close and parallel to the slam panel thus avoiding side loading the original safety catch.
- Double the strength of a single safety catch.
- Subtle and unobtrusive.

Before using No 10 self tapping screws to fit the safety catch to the bonnet of my previous MGB, I established a single self tapping screw, in steel, would support a 400lb load, without failure. The addition of a 'tack' weld was insurance.
