Examples of MGBGTV8 Commission No plates – photos from members

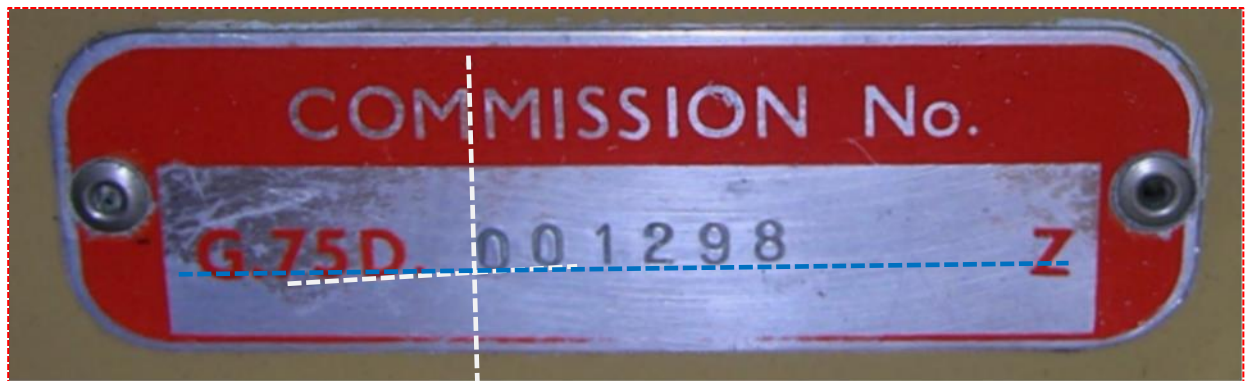
Position of the engraved numbers on the Commission No plate

All the examples of Commission No plates we have seen do have broadly similar misalignment features:

- **Very early cars** had a simple plate and the numbers seemed to have been punched almost in a casual way.
- **First zero of the Commission number** – the underside of the stamping of that zero is slightly above the horizontal line through the base of the **G.75D.** prefix. Also the lefthand side of the first zero lines up vertically with the righthand side of **first M** in “COMMISSION”.
- **Second zero of the Commission number** – the underside of that zero is slightly above that of the first zero.
- **Third & fourth numerals** - (1 and 2 in the case above) are very nearly on the same horizontal line as the second zero.
- **Fifth & sixth numerals** – the fifth (9 above) is very slightly lower and the sixth (8 above) very slightly higher.

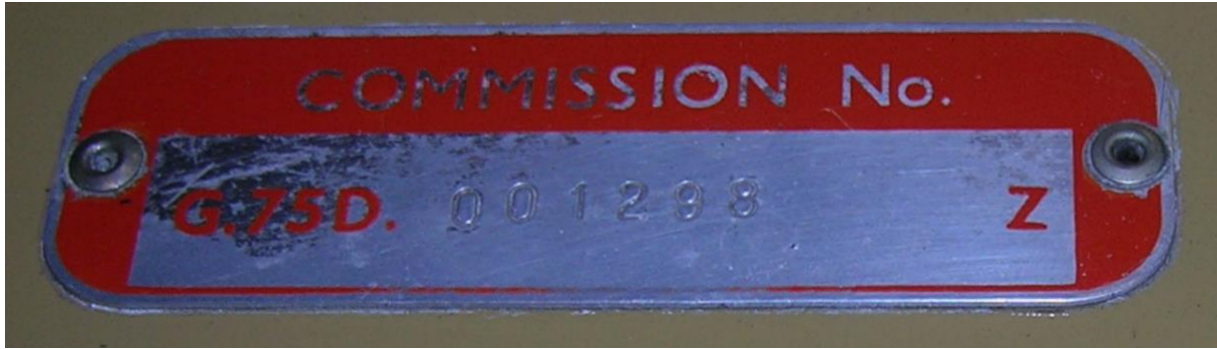
Looking at the detail of the number

Seen from an angle the Commission number is stamped into the metal plate but when viewed from above the number appears a dark colour – probably muck accumulating when cleaning and polishing the slam panel.

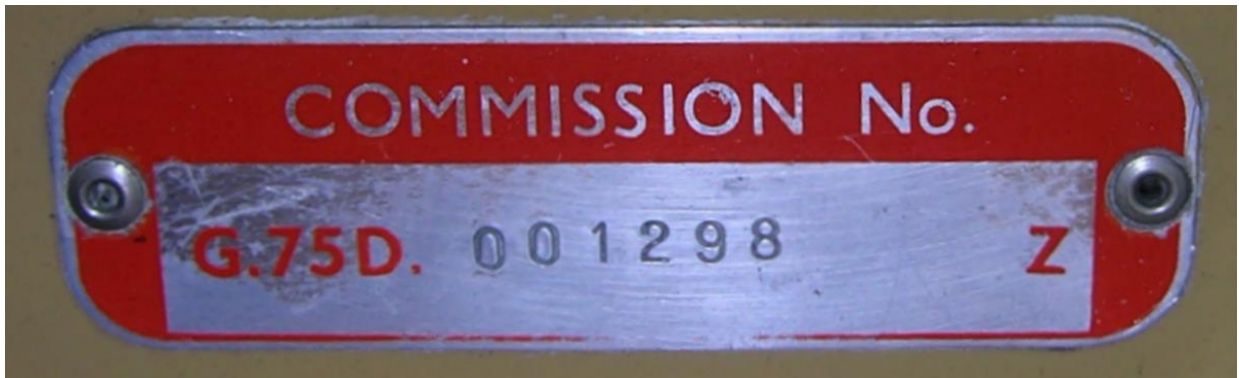
The engraved numbers can appear “black” from this angle.

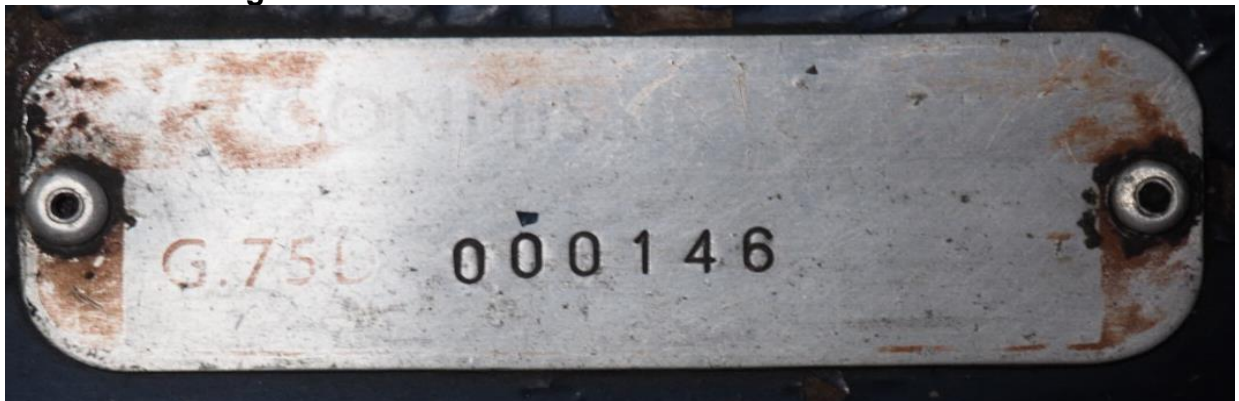
Black numbering

Another example of what appears to be a “black” Commission No.
