Restoration and conversion to a V8 Roadster

Peter Nixon has some photos of the work-in-progress on his MGB V8 Roadster project finished in Pageant Blue which he completed in November 2023. Peter reflects on his project:

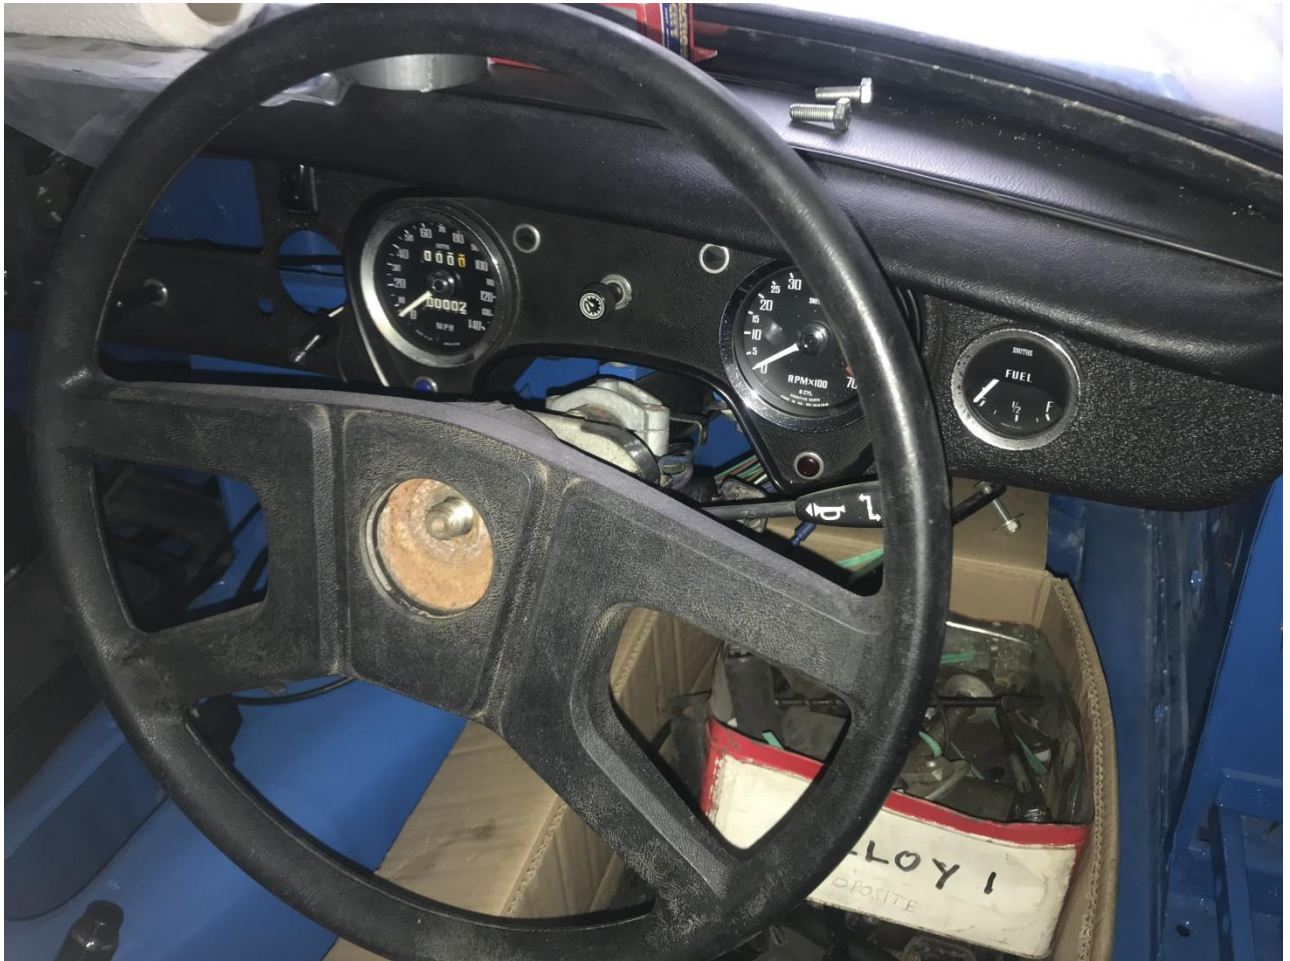
MGB Roadster with MGBGV8 dashboard. (2604)

dashboard with instruments that a Tyne-Tees member had available. I replaced the doors with American model MGB doors with internal side impact bracing.

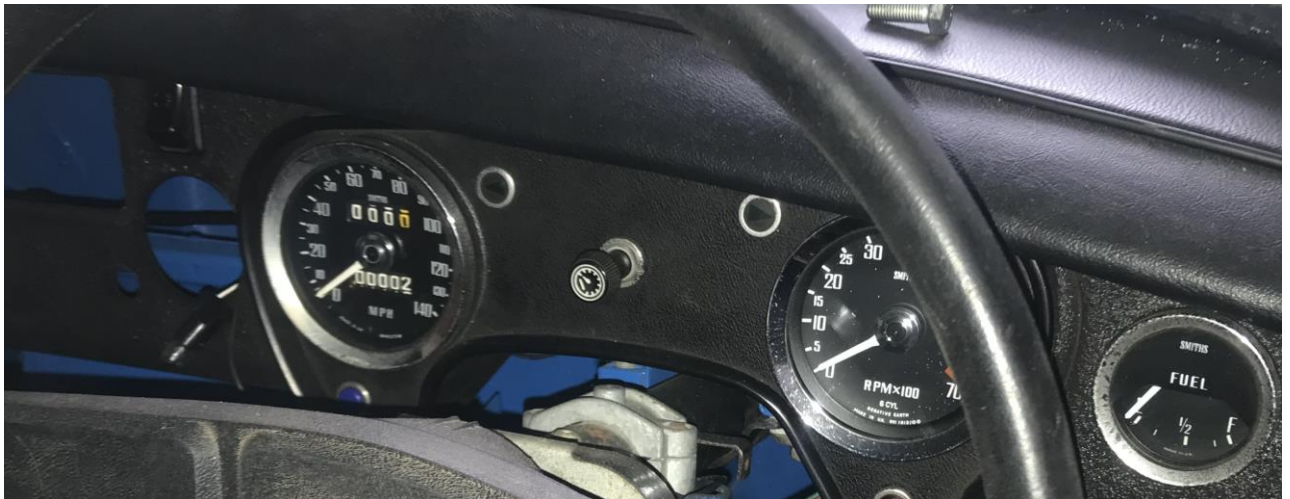
MGBGV8 dashboard instruments

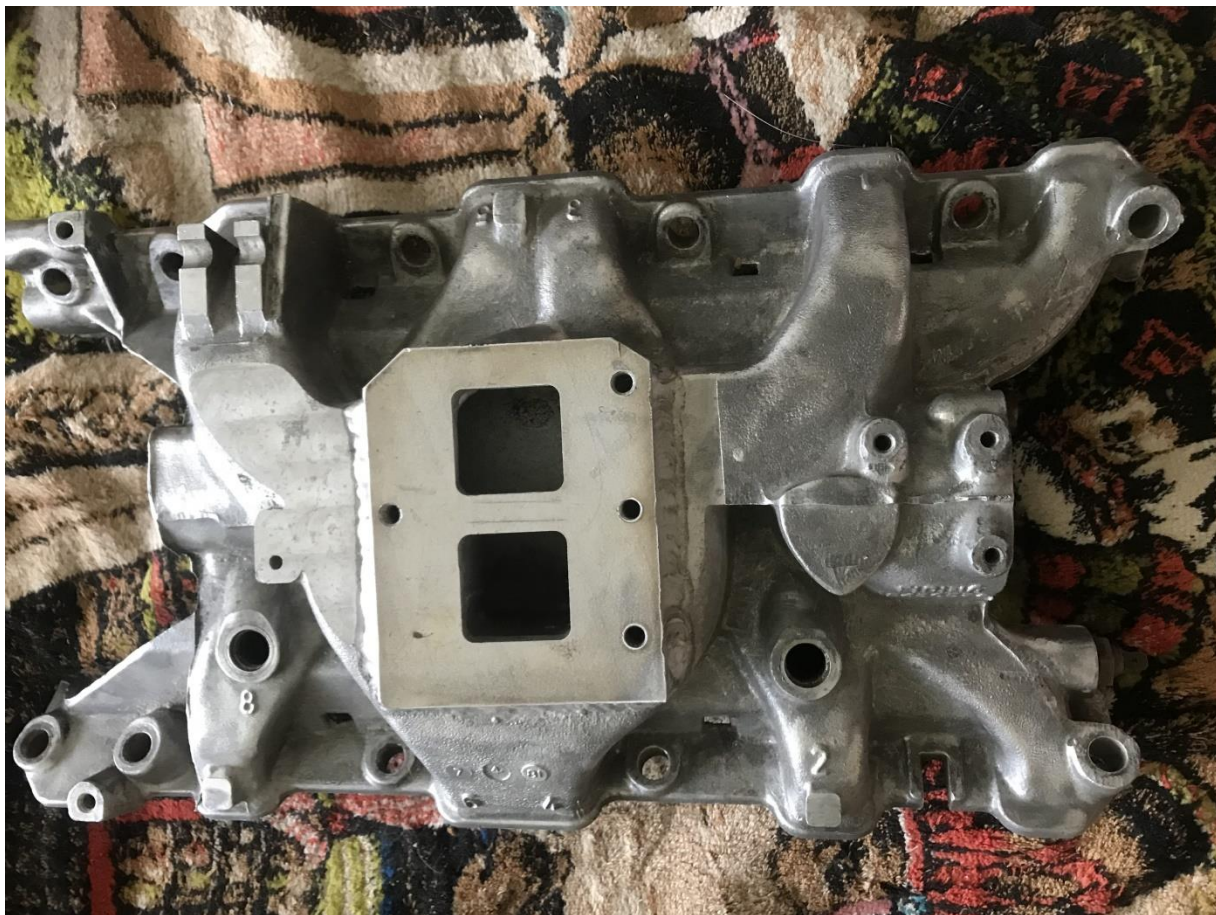
Modified Range Rover inlet manifold, 10mm machined off and 10mm plate welded on to mount the tubular plenum. (1644)

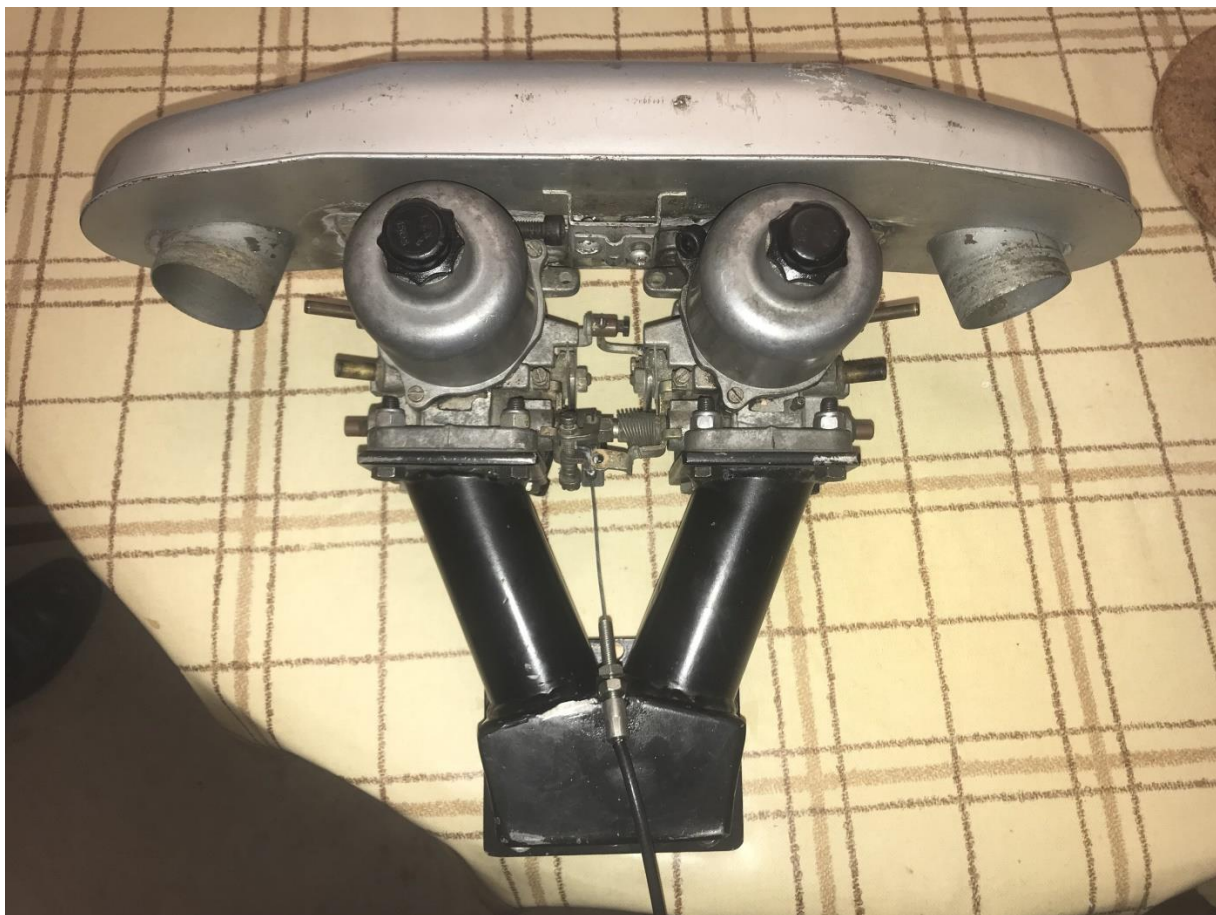
Inlet manifold & plenum with the Rover SD1 carburetors and MGB GT V8 airbox. (2360)

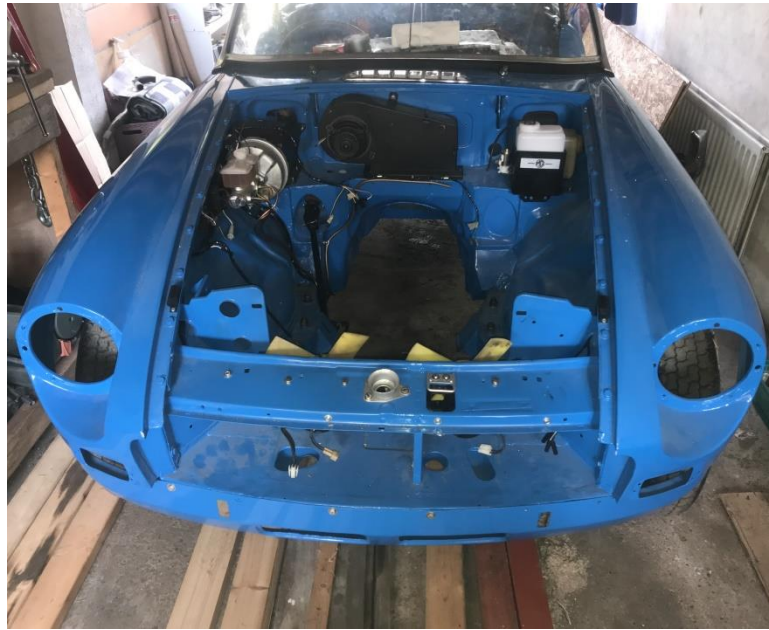
MGB Roadster front converted to chrome bumpers. (2589)

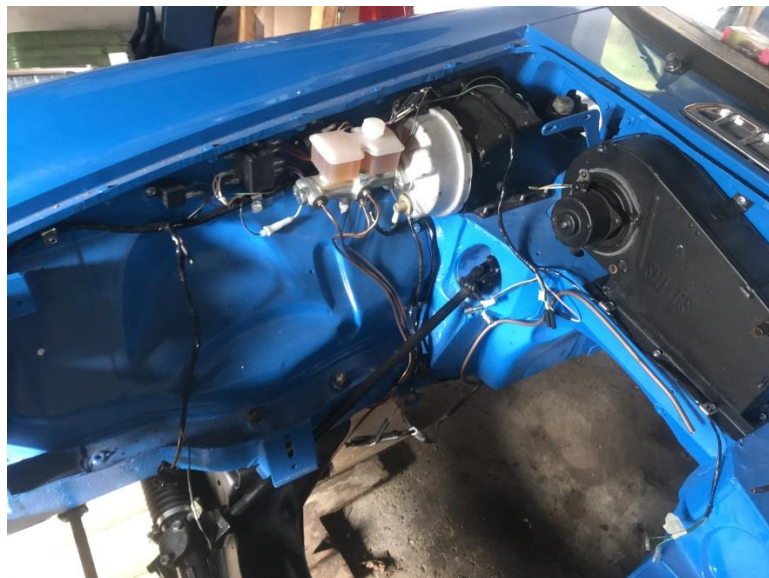
MGB Roadster with new servo and new master cylinder. (2589)

The Clive Wheatley big bore exhaust gives it a throaty roar and the acceleration is really quick. We had a minor problem with the brakes sticking on but that was solved by adjusting the rod between the new servo and the new master cylinder.

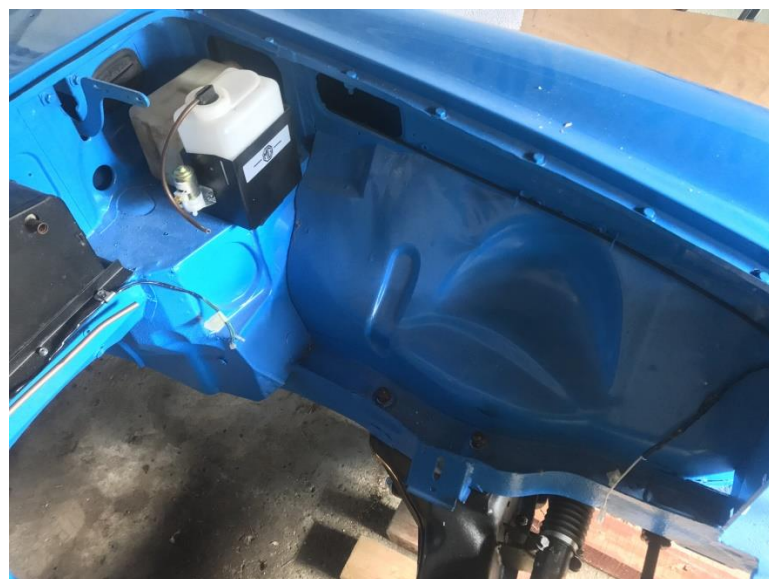
MGB Roadster with MGB GT V8 washer bottle. (2593)

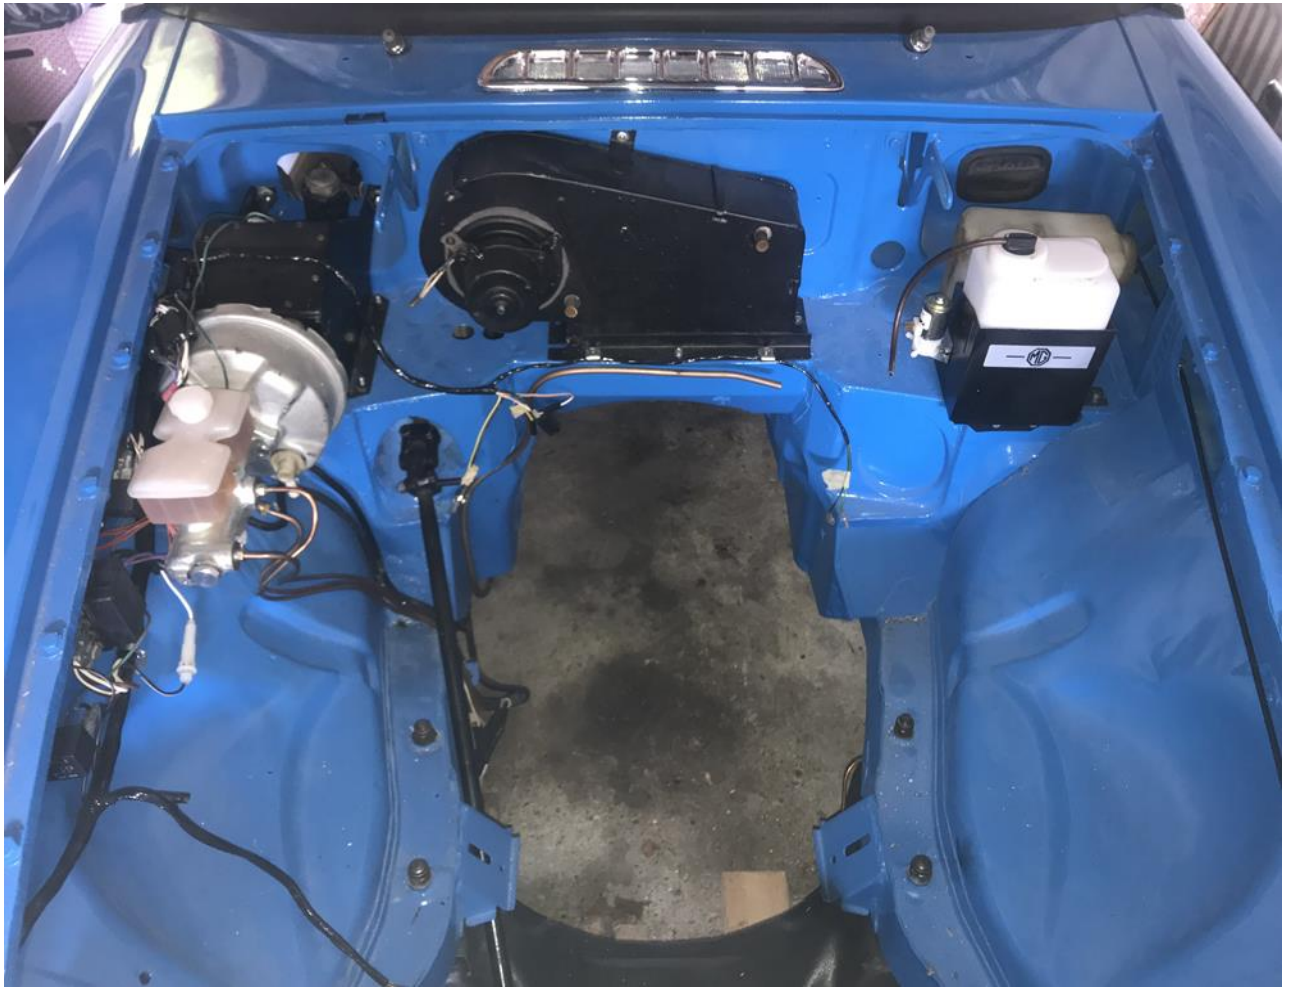
MGB Roadster engine bay ready for engine to be installed. (2588)

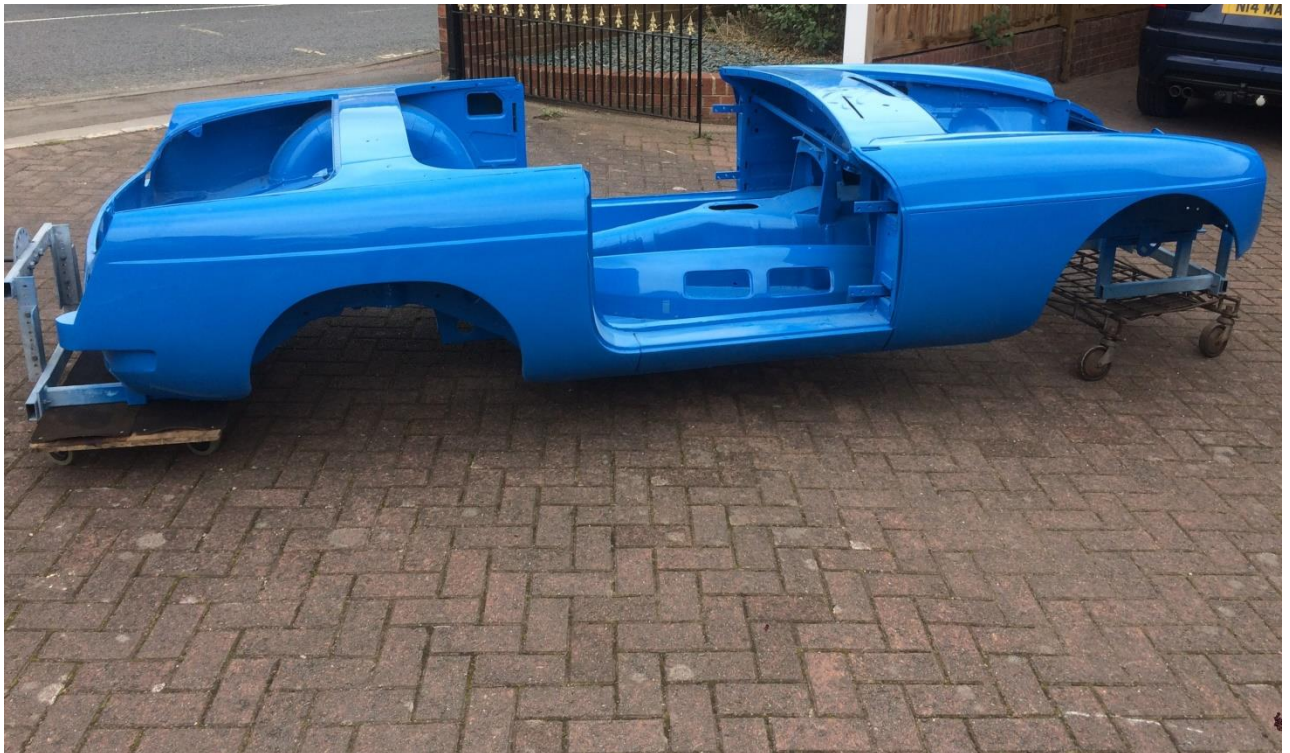
MGB Roadster bodyshell back from the paint shop, finished in Pageant Blue (0512)

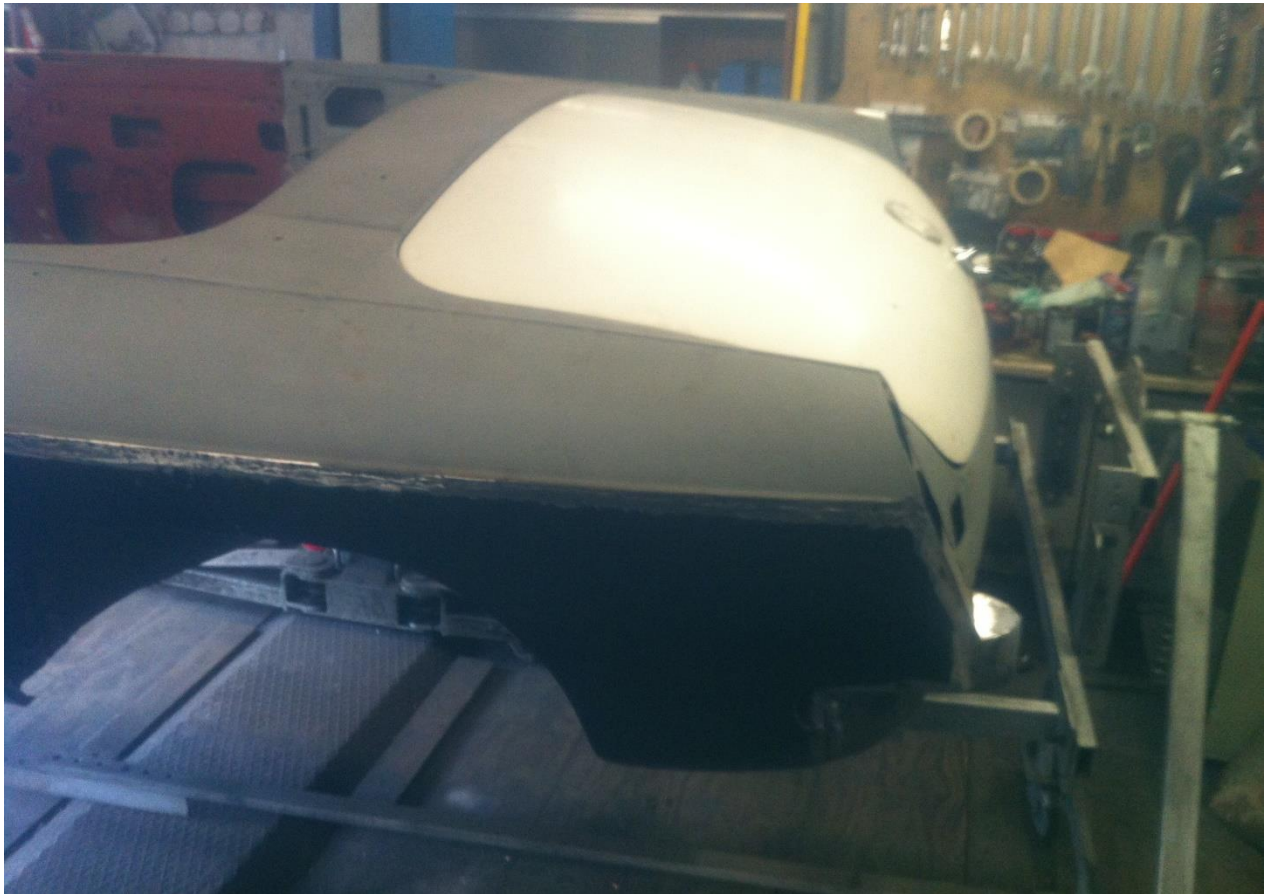
New rear half wing welded into place. (2315)

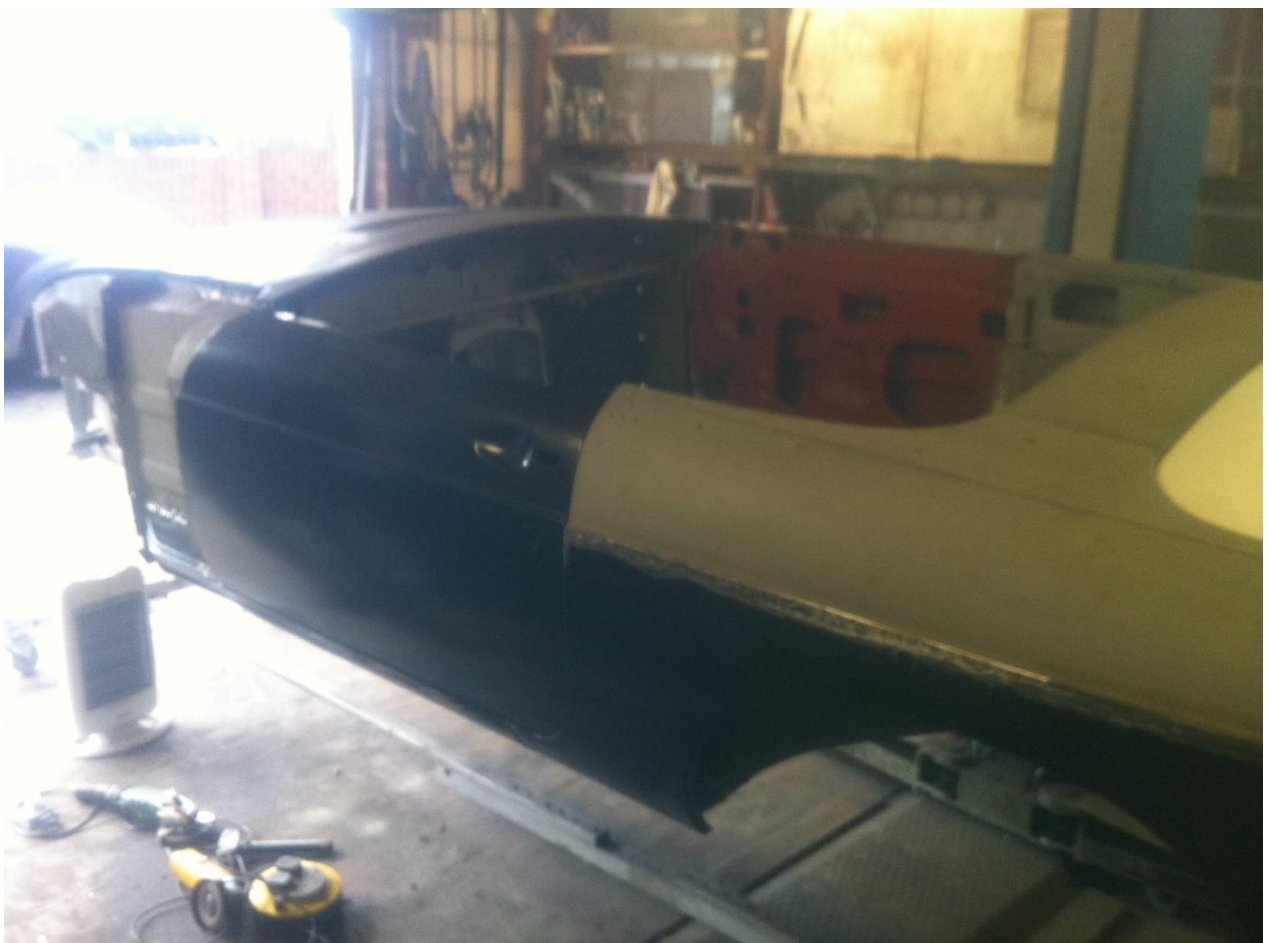
Lining up the new rear half wing and door prior to welding in the wing. (2314)

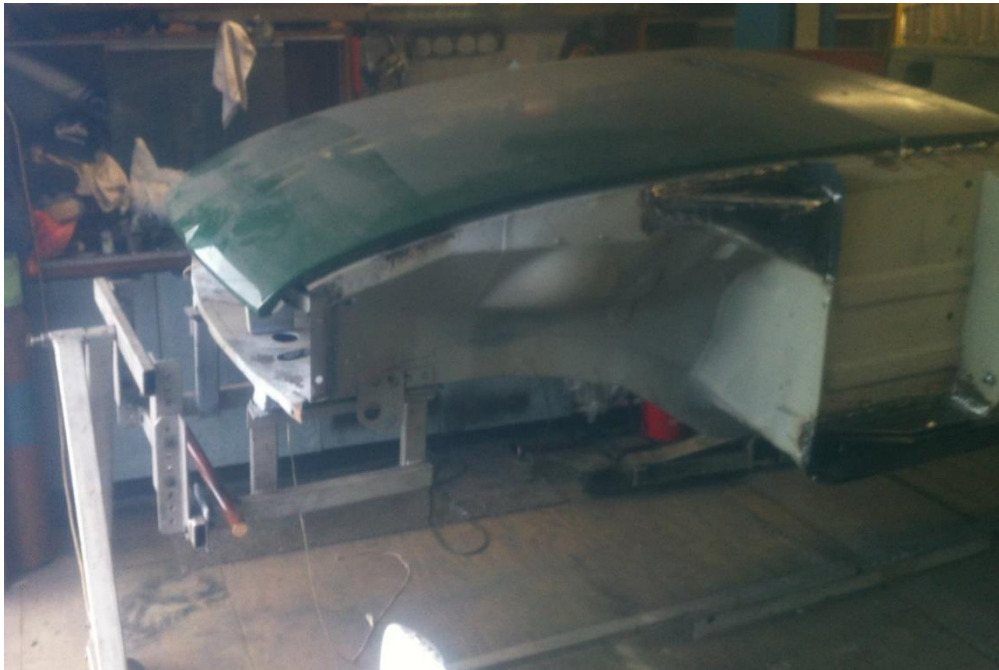
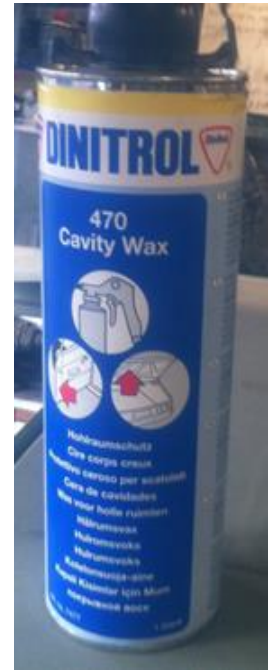
Front left side prior to fitting the new front chrome wing, the rotisserie makes it so much easier to do the welding by being able to turn the body to the best access position. (2313)

Liberal doses of cavity wax were applied into each box section after the welding up was completed, using an extension tube on the aerosol can, some engine oil was also sprayed in with temporary plugs in the drain holes as the body was rotated 360 degrees. (2282)

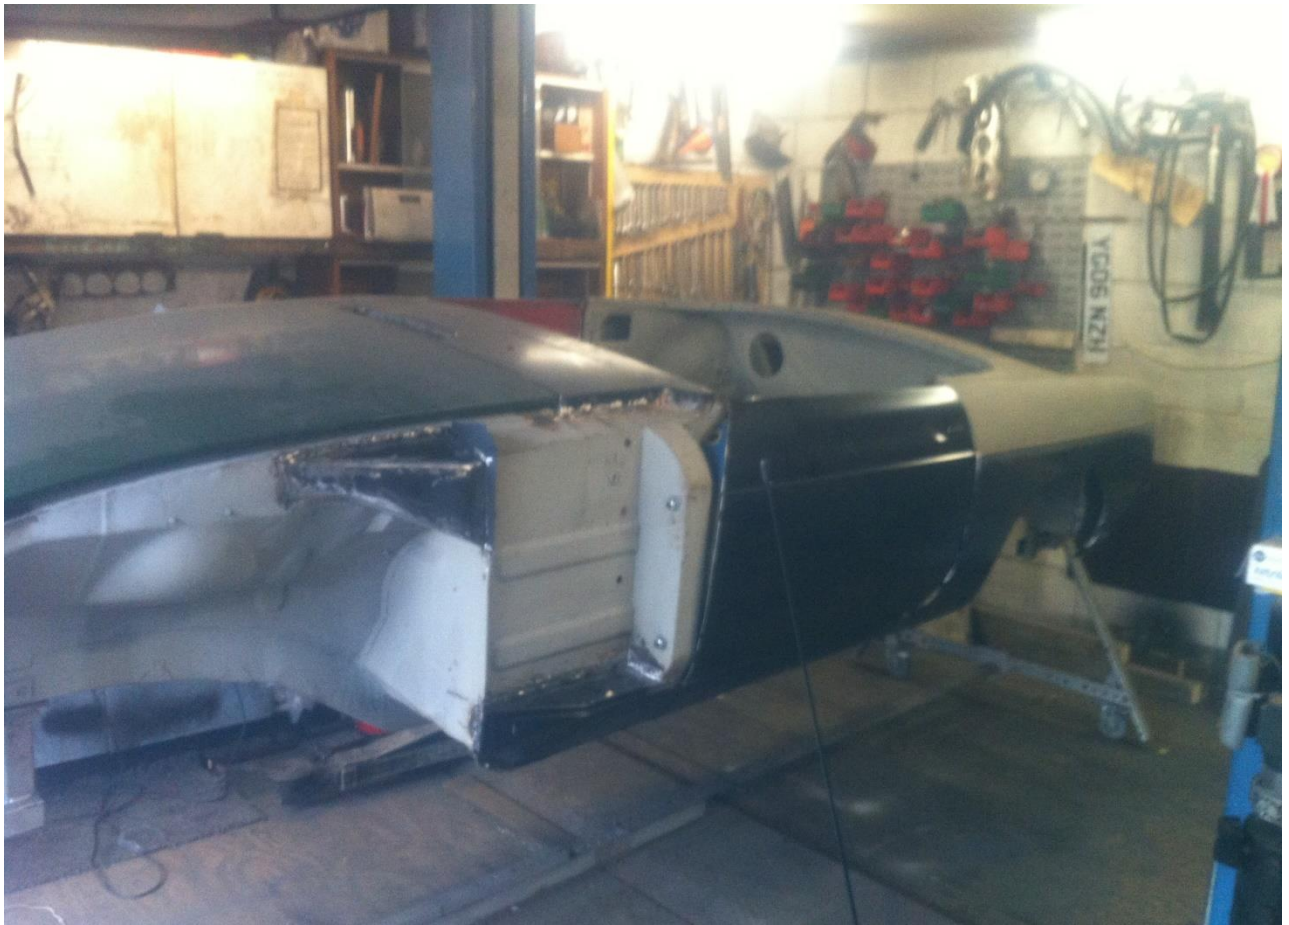
Bonnet, new rear half wing & door on prior to fitting the new front wing to ensure the chrome strip line and door fit were good. (2312)

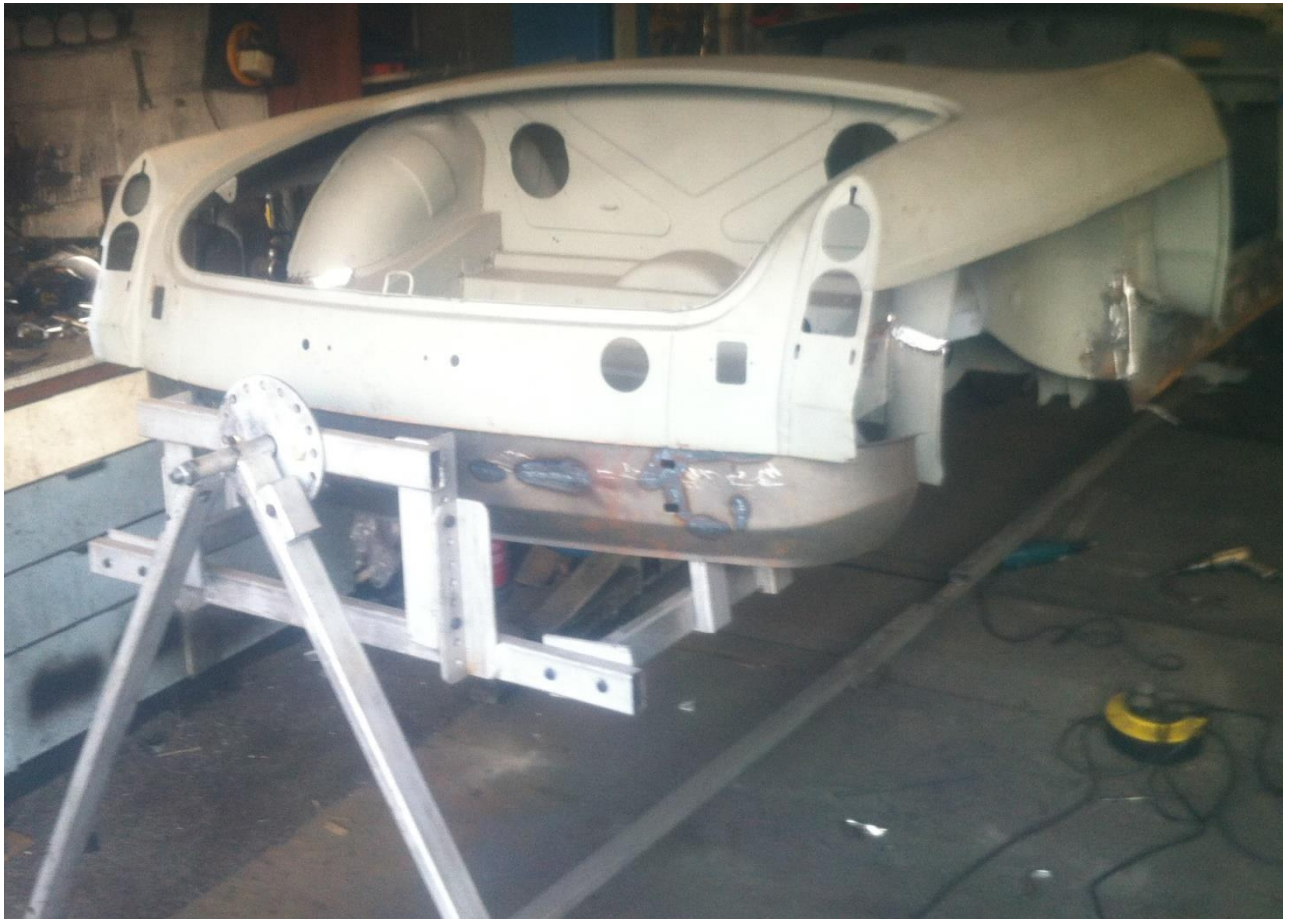
Stripped car body on the rotisserie - the rear wings were cut at the swage line for new rear half wings to be fitted, the joins are hidden behind the chrome strip. (2281)

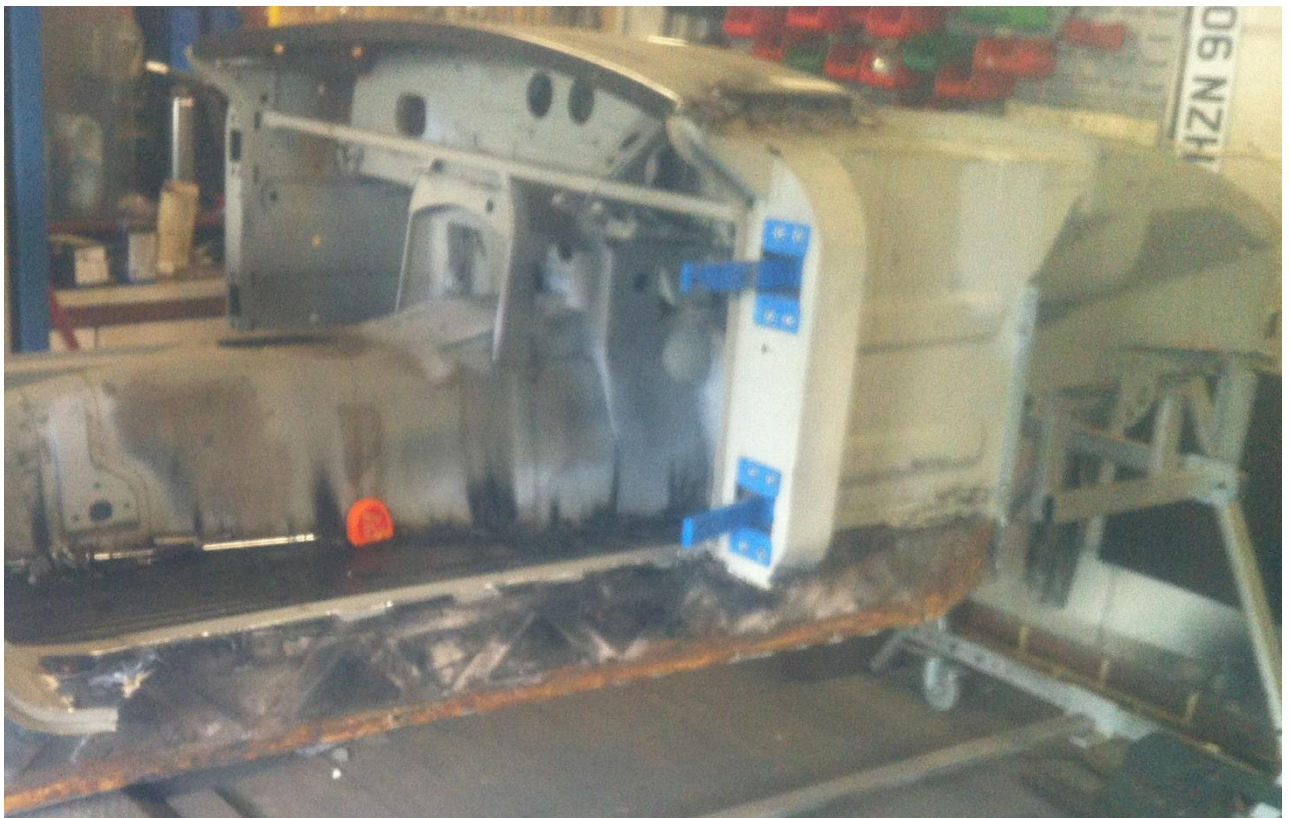
Indication of the extent of the rot in the outer sills, fortunately apart from surface rust on the side member behind the sill there was nothing much to do except bead blast off the rust, paint with acid etch and then weld on the new sills. (2279)

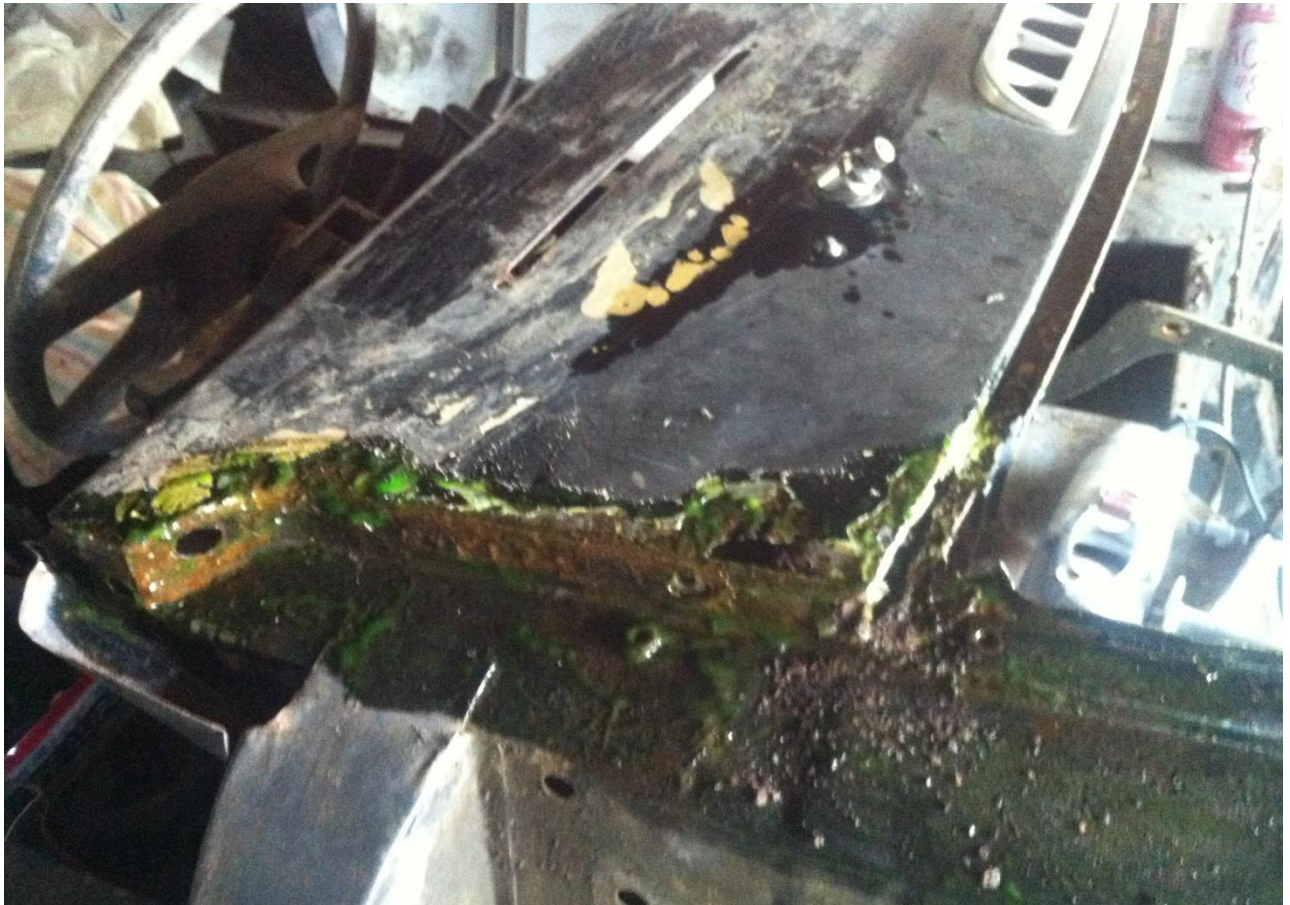
The state of the shroud panel on the rust bucket, the state of the shroud panel was the reason for its replacement with a new panel suitable for new chrome bumper front wings. (1106)

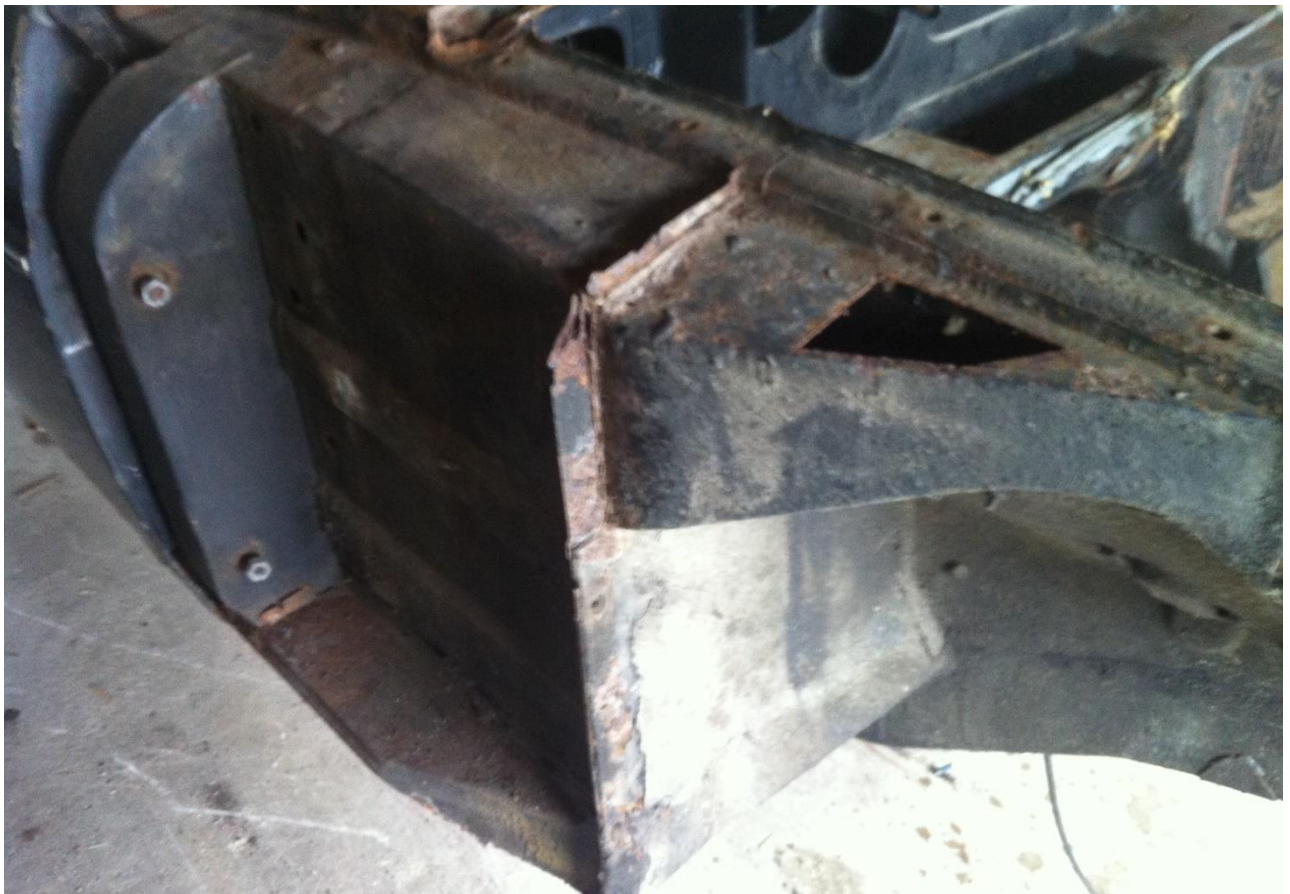
The state of the reinforcement panel behind the front wing on the rust bucket. (1091)

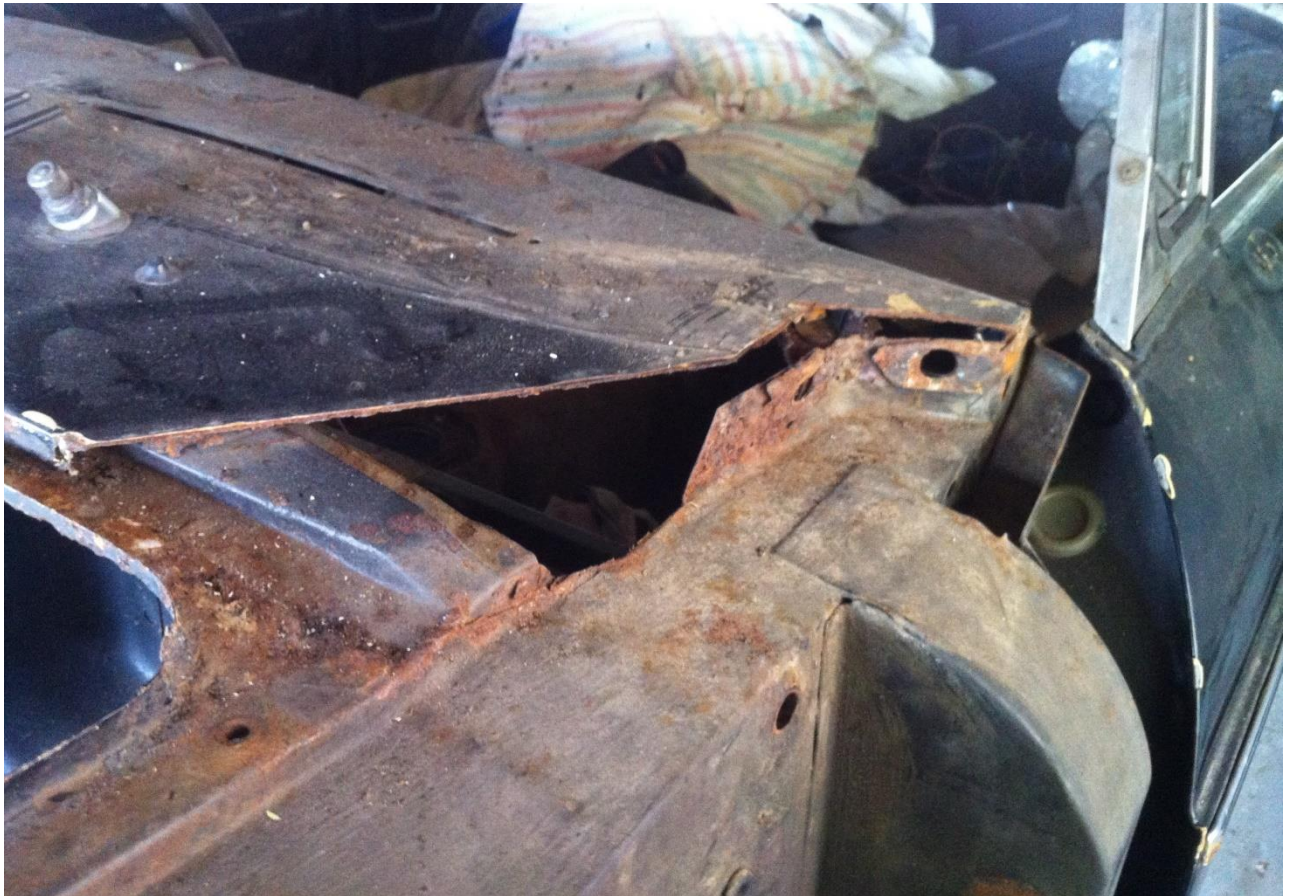
What you find on a rust bucket when you remove the front wings, the bubbling paintwork tells you there is a problem behind the shroud panel which was well past recovery. (1088)

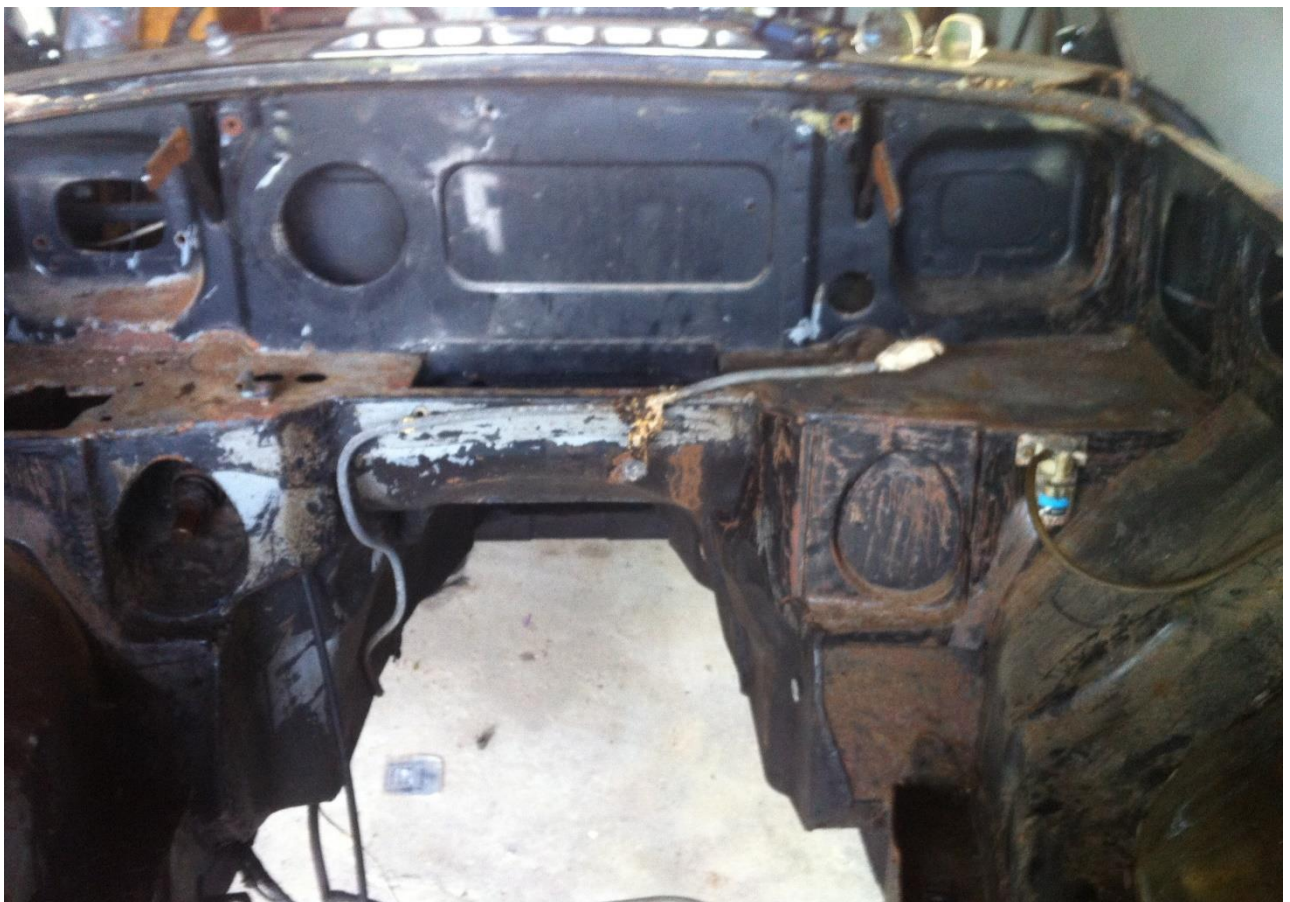
Engine bay not a pretty sight, that is why the body was bead blasted to clean it up. (1086)
